Inspection report

Date: 7/14/2025	Work Order:	Weather:	Surveyed By: Walker	Certificate Number: U0218070300337	Pipe Segment Ref.: 000047-000041
Year laid:	Pre-cleaning: No Pre-Cleaning	Direction: Downstream	Pipe Joint Length:	Total Length: 97.4 '	Length Surveyed: 97.4 '

City: Alexandria	Drainage Area:	Upstream MH: 000047
Street: King St	Media Label:	Up Rim to Invert:
Location Code: Secondary roads, non-numbered suburban/rural	Flow Control:	Downstream MH: 000041
Location Details:	Sheet Number:	Down Rim to Invert:
Pipe shape: Circular	Sewer Use: Sanitary Sewage Pipe	Total gallons used: 0.0
Pipe size: 12 "	Sewer Category: SEC	Joints passed: 0
Pipe material: Reinforced Concrete Pipe	Purpose:	Joints failed: 0
Lining Method:	Owner:	
Additional Info: Pipe has been lined

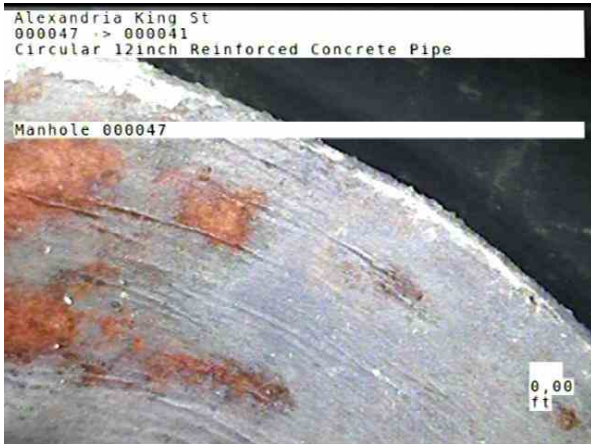
1, 00:00:00, 0.00ft
Manhole / 000047

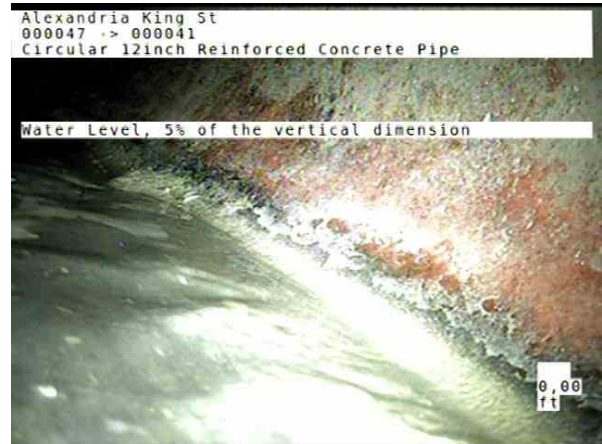
2, 00:00:12, 0.00ft
Water Level, 5% of the vertical dimension

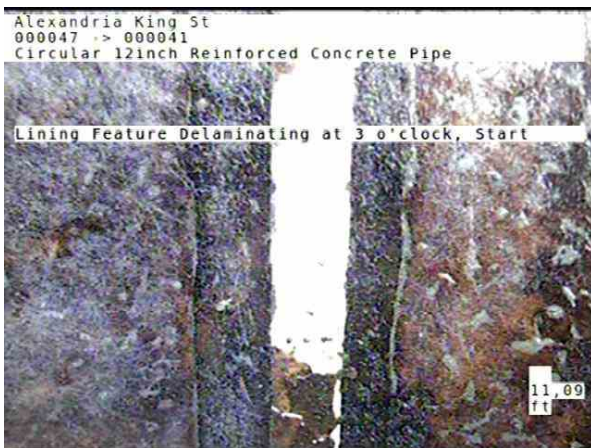
63.5	F01	LFDL Lining Feature Delaminating at 3 o'clock, Finish	00:05:03		S3
	63.5	MWL	Water Level, 20% of the vertical dimension	00:05:07	7	
	72.4	OBR	Obstruction Rocks, 5% of cross sectional area at 6 o'clock	00:05:38	8	M2

3, 00:01:12, 11.09ft
Lining Feature Delaminating at 3 o'clock, Start

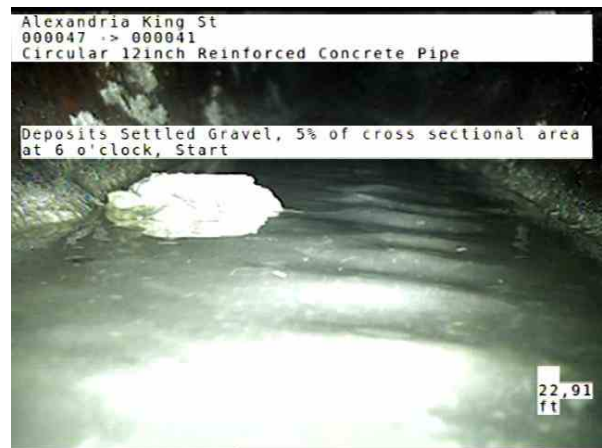
4, 00:02:15, 22.91ft
Deposits Settled Gravel, 5% of cross sectional area at 6 o'clock, Start

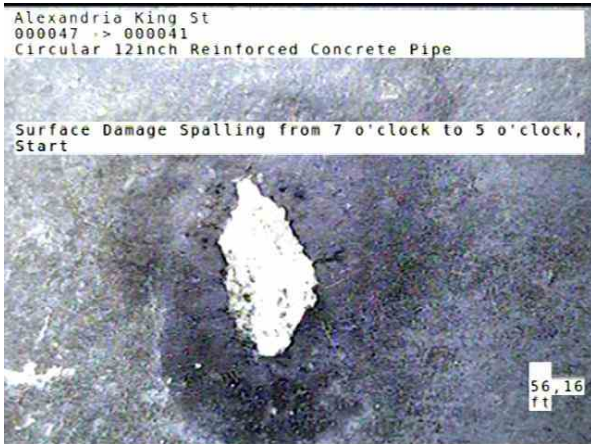
59.3	F03	SSS Surface Damage Spalling from 7 o'clock to 5 o'clock, Finish	00:04:36		S2
	59.3	S04	LFDC Lining Feature Discoloration from 7 o'clock to 5 o'clock, Start	00:04:39	6

5, 00:04:05, 56.17ft
Surface Damage Spalling from 7 o'clock to 5 o'clock, Start

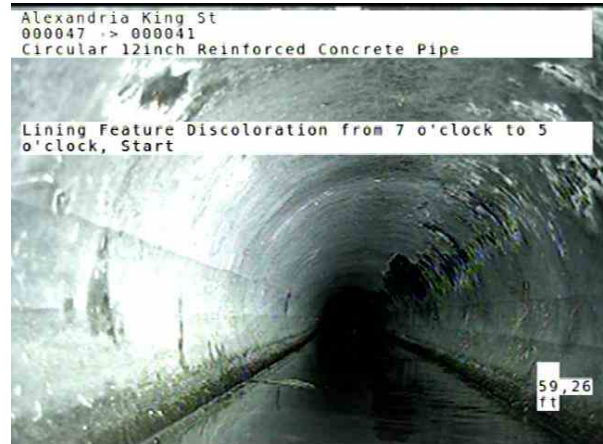
95.5	F02	DSGV Deposits Settled Gravel, 5% of cross sectional area at 6 o'clock, Finish	00:06:44		M2
	95.5	F04	LFDC Lining Feature Discoloration from 7 o'clock to 5 o'clock, Finish	00:06:48		S3

6, 00:04:39, 59.26ft
Lining Feature Discoloration from 7 o'clock to 5 o'clock, Start

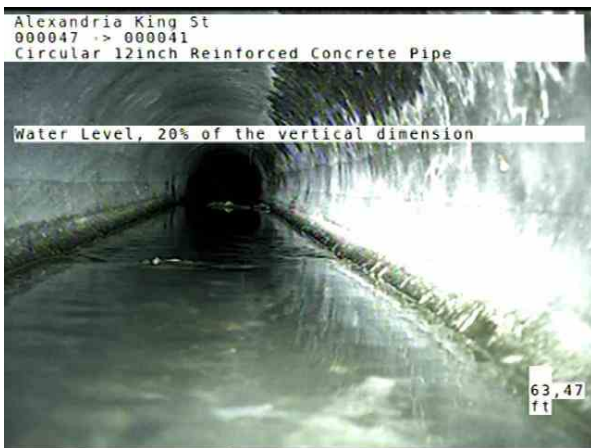
7, 00:05:07, 63.47ft
Water Level, 20% of the vertical dimension

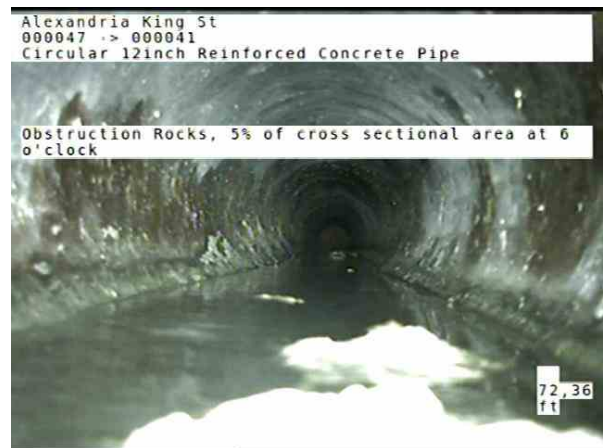
8, 00:05:38, 72.36ft
Obstruction Rocks, 5% of cross sectional area at 6 o'clock

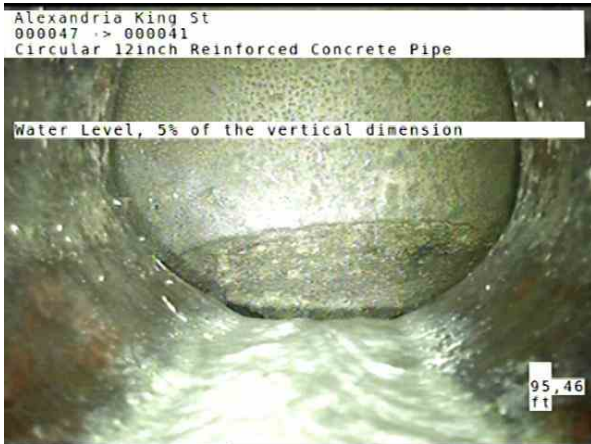
9, 00:06:53, 95.46ft
Water Level, 5% of the vertical dimension

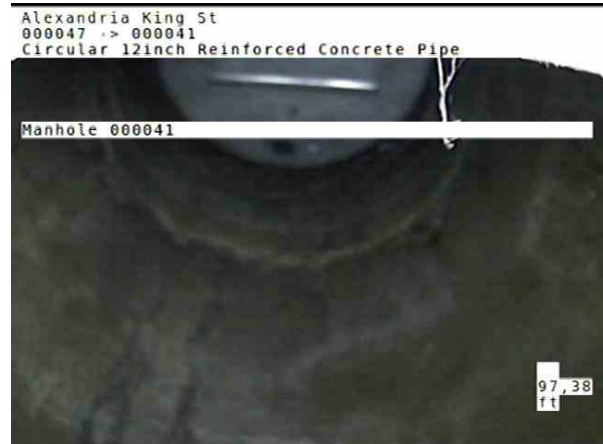
10, 00:07:19, 97.38ft
Manhole / 000041

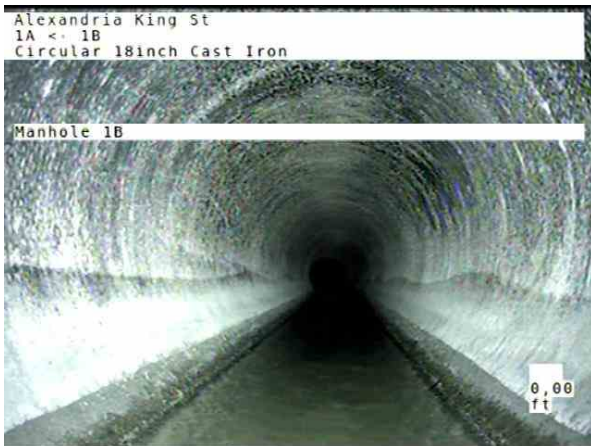
1, 00:00:00, 0.00ft
Manhole / 1B

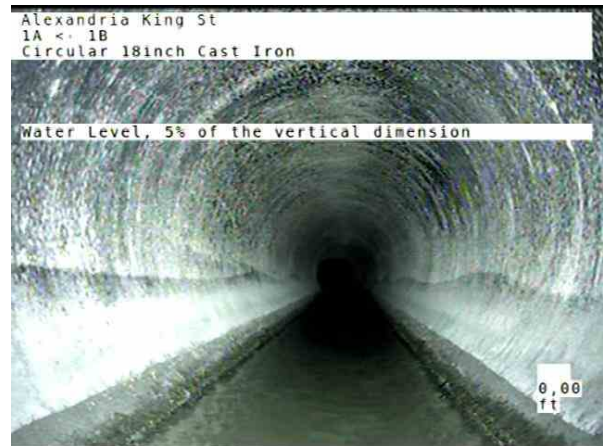
2, 00:00:11, 0.00ft
Water Level, 5% of the vertical dimension

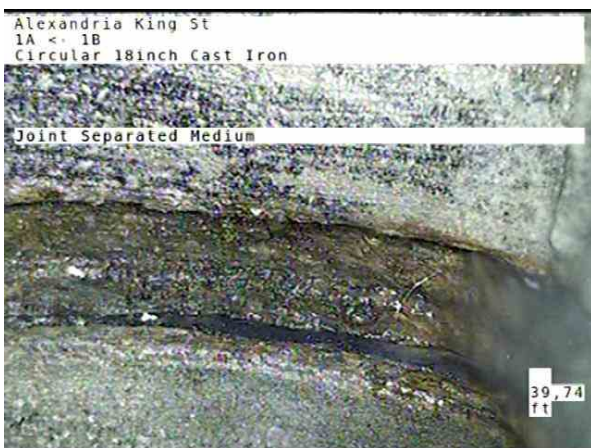
3, 00:02:34, 39.74ft
Joint Separated Medium

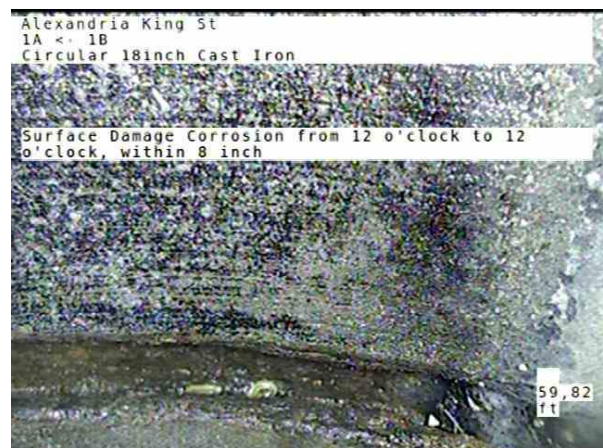
4, 00:03:32, 59.82ft
Surface Damage Corrosion from 12 o'clock to 12 o'clock, within 8 inch

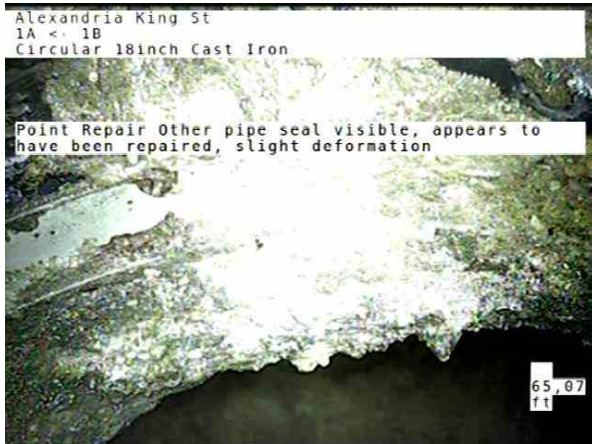
5, 00:04:24, 65.07ft
Point Repair Other / pipe seal visible, appears to have been repaired, slight deformation
