Taylor Run Stream Restoration

60742359

SITE PHOTOGRAPH LOG

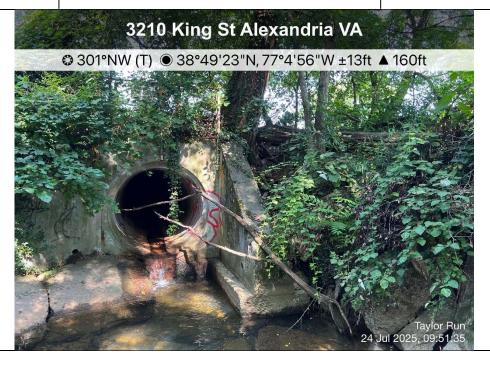
1

72-inch outfall condition. Gully next to right wingwall (look upstream) and beginning of plunge pool (Project Area 1)

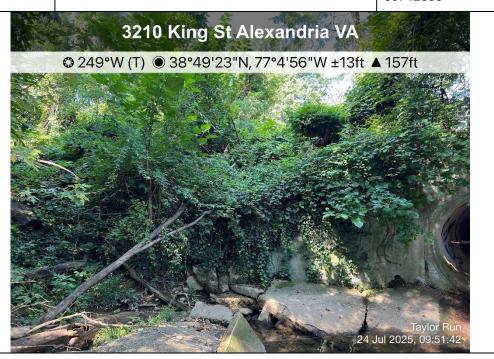
Left wingwall (looking upstream) condition. (Project Area 1)

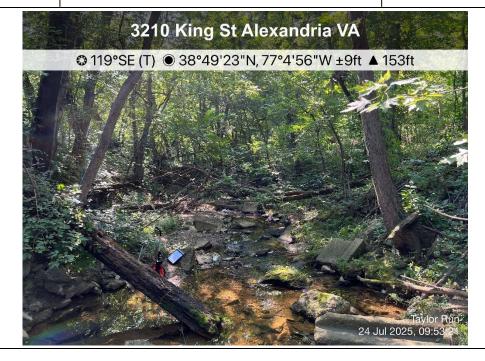
3

Downstream condition of stream with concrete debris, unstable (soon to fall) trees, woody debris build up

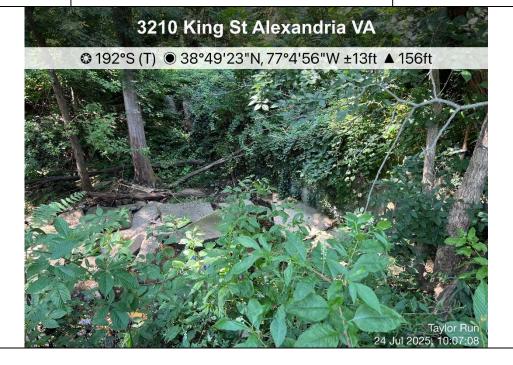
Concrete debris in the channel, downstream of Project Area 1

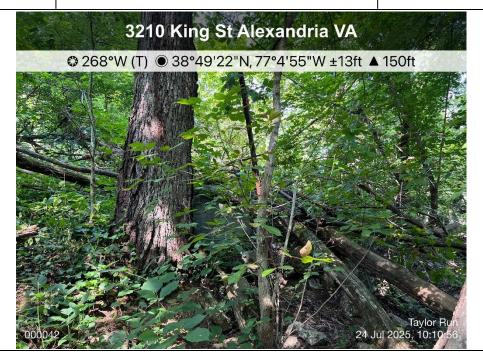
5

Fallen trees causing debris build up in the channel. View from left bank. Between Project Area 1 and 2

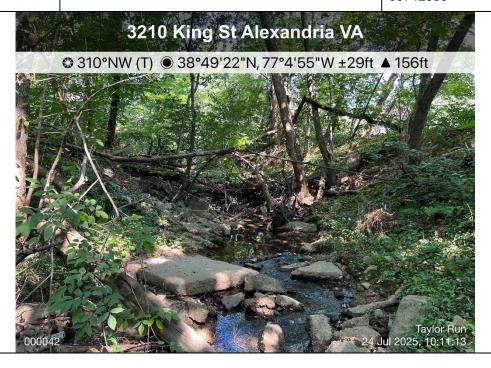
Concrete debris in the channel, fallen trees, bank erosion and woody debris build up in channel between Project Area 1 and 2

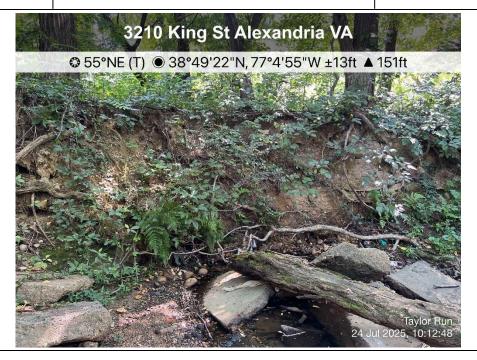
7

Eroding channel bank between Project Area 1 and 2

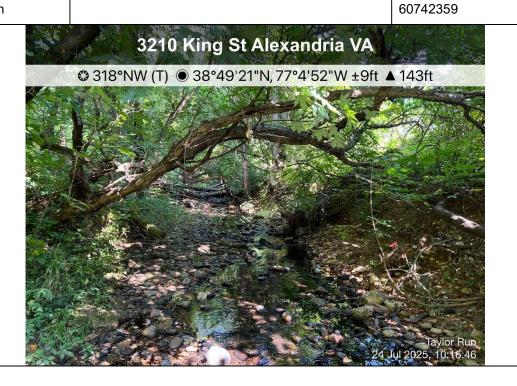
Photo No. 8

Falling trees and debris build up in the stream between Project Area 1 and 2

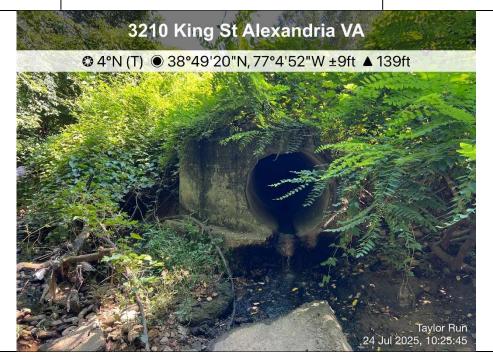
9

36-inch outfall showing undercut of headwall and erosion of the left side

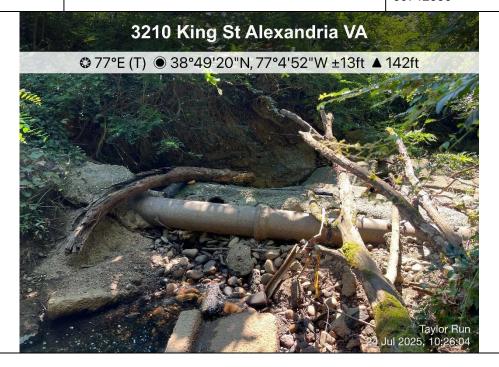
Exposed sanitary sewer pipe next to 36-inch outfall (Project Area 2)

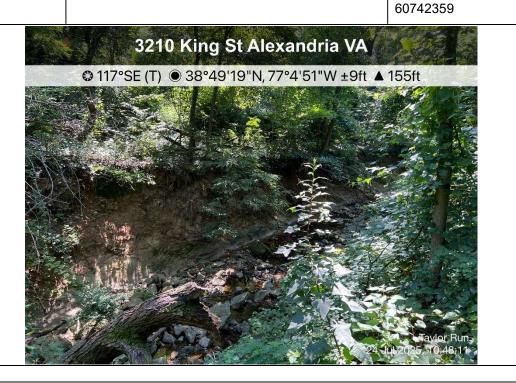
Photo No. 11

Severe bank erosion immediately downstream from the 36-inch outfall (Project Area 2)

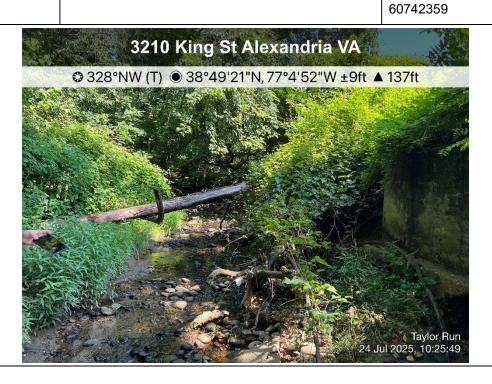
Photo No. 12

Upstream stream condition, standing at the 36-inch outfall. Fallen tree(s) due to bank instability (Project Area 2)

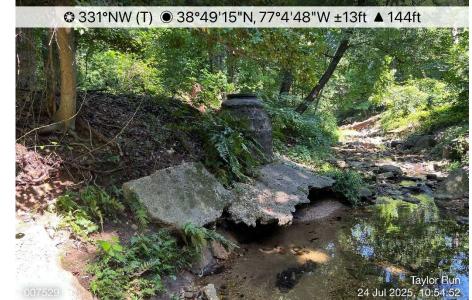
Exposed sanitary sewer manhole with undercut of concrete skirt

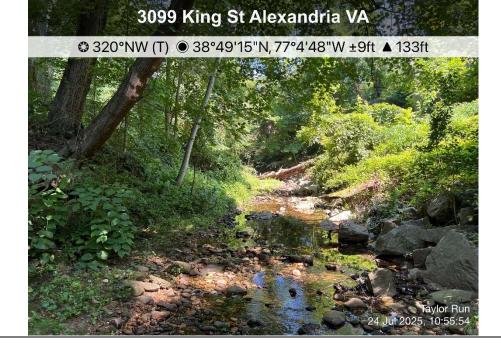
Upstream stream condition from exposed sanitary sewer manhole (Project Area 3)

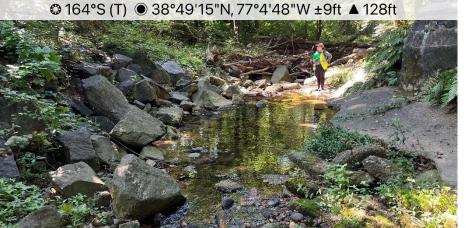
Photo No. 15

Downstream conditions of the exposed sanitary sewer manhole. Woody Debris build up in the back. (Project Area 3)

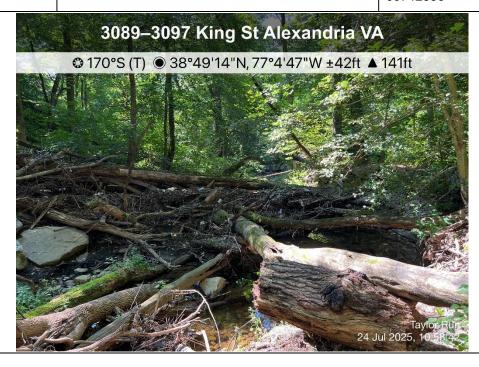
Photo No. 16

Woody debris build up between Project Area 3 and Project Area 4. Falling trees from bank instalbility

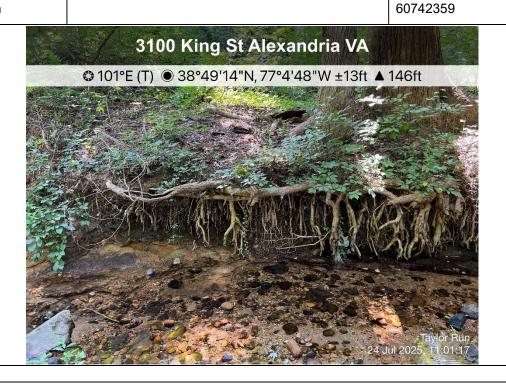
Photo No. 17

Exposed root exposure of champion tree (Project Area 4)

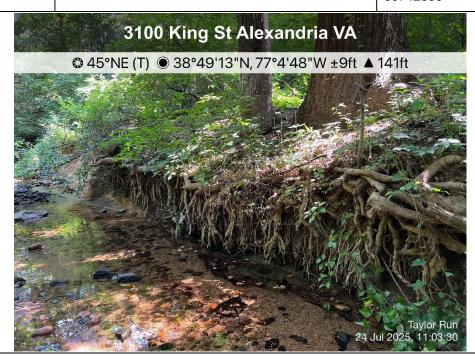
Photo No. 18

Horizontal extent of root exposure of the champion tree (Project Area 4)

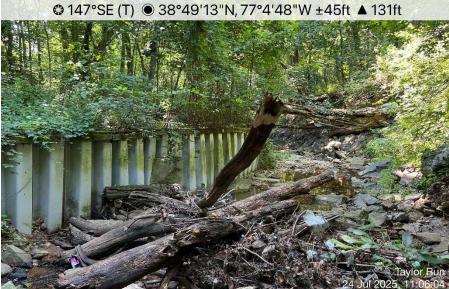
Photo No. 19

Leaning sheet pile wall and build of debris within the channel (Project Area 4)

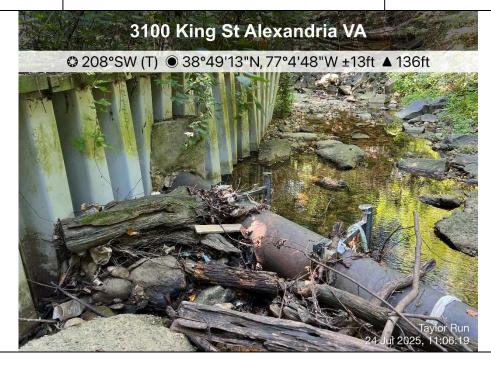
Photo No. 20

Exposed sanitary sewer pipe near sheet pile wall (Project Area 4)

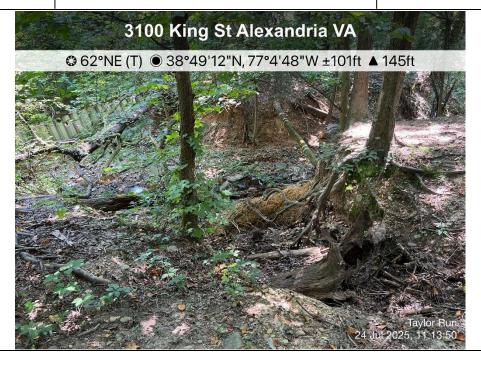
Photo No. 21

Exposed roots, stream bank erosion and gully formed from trail side runoff

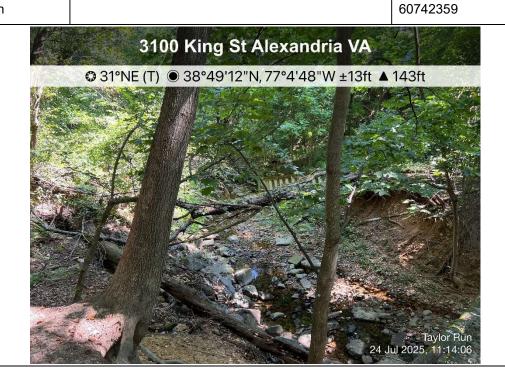
Photo No. 22

Condition of right bank, downstream of study extent

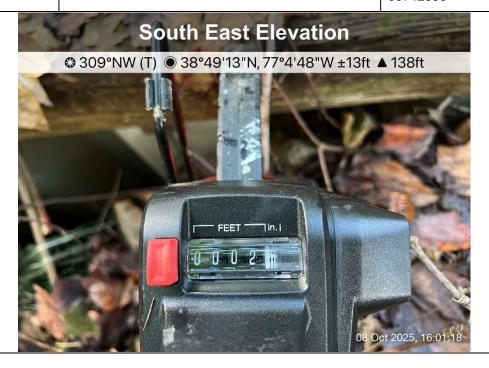
Photo No. 24

From center of sanitary manhole it is 2 feet from the sheet pile wall

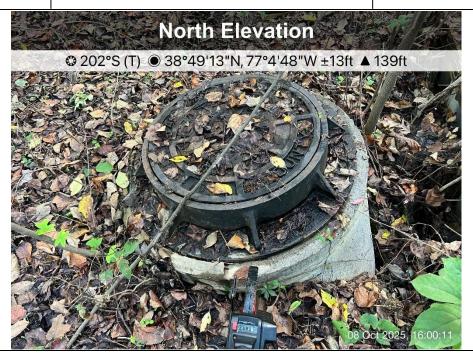
Photo No. 25

Outer extent of sanitary sewer manhole is 10 inches from the sheet pile wall

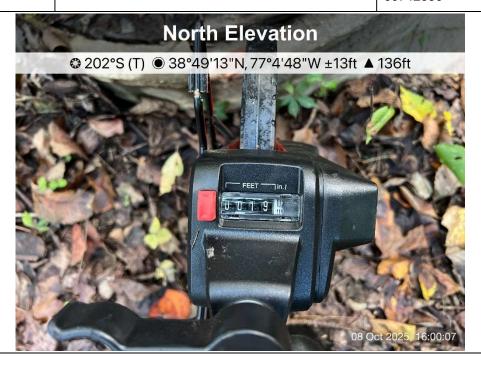
Photo No. 26

Sanitary Sewer manhole is 19 feet from the start of the sheet pile wall
