Executive Summary

The Taylor Run Stream Stabilization Design Project (Project) is located in the City of Alexandira, Virginia. The goal of the project is to implement a 'minimal stabilization' approach to protect at-risk infrastructure and provide stream stabilization along approximately 590 linear feet of non-continuous stream necessary to provide long-term infrastructure protection.

1 Introduction

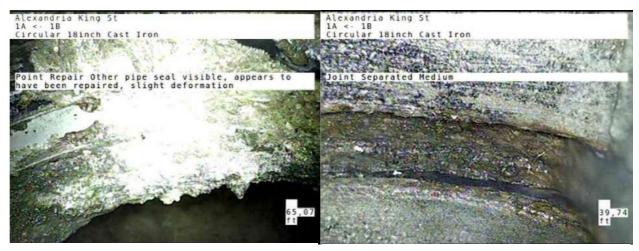
The 18-inch circular cast iron sanitary sewage pipe in Project Area 4 was assessed for approximately 67 linear feet from manhole ID 007531 to ID 006571. There was evidence of a crown repair within the first foot of the upstream manhole (007531). The area shows minor deformation but there was no active infiltration observed during investigation. Additionally, medium joint separation and surface damage corrosion were noted. The CCTV Inspection reports can be found in **Appendix B**.

Point repair of pipe crown but has slight deformation

Pipe joint separation

Portions of sanitary sewer pipes cross Taylor Run in Project 2 and Project 4. Both pipes will be encased in concrete. The boulder cascades, described in **Section 0**, will provide protection. No cover will be placed on top of the concrete encasements. The gravity walls, described in **Section 5.2**, will stabilize the banks and protect the sanitary manhole behind the existing sheet pile wall.
