## **Appendix B CCTV Assessment Report**

## Inspection report

| Date:<br><b>7/14/2025</b> | Work Order: | Weather: | Surveyed By:<br><b>Walker</b> | Certificate Number:<br><b>U0218070300337</b> | Pipe Segment Ref.:<br><b>000047-000041</b> |

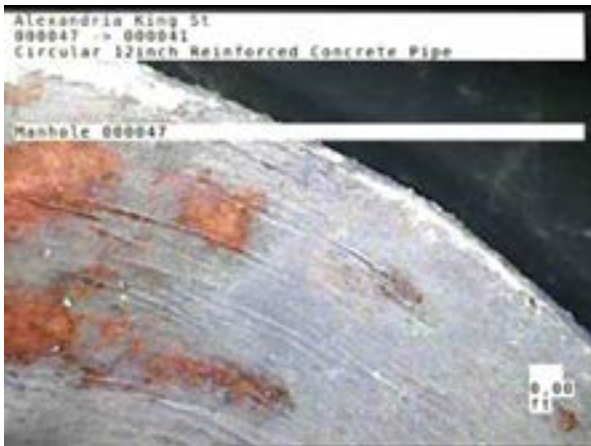
1, 00:00:00, 0.00ft  
Manhole / 000047

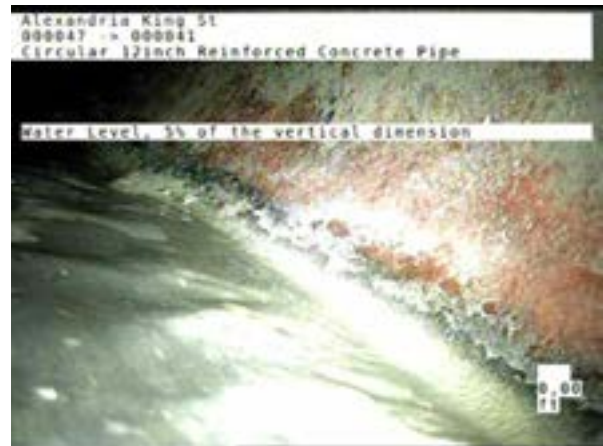
| 1:735 | Distance | Code | Observation | Counter | Photo | Grade |
|---|---|---|---|---|---|---|
| | 0.0 | MWL | Water Level, 5% of the vertical dimension | 00:00:12 | 2 | |

2, 00:00:12, 0.00ft  
Water Level, 5% of the vertical dimension

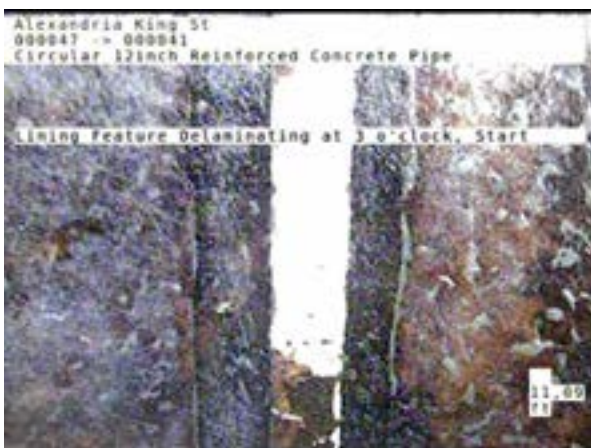
| 1:735 | Distance | Code | Observation | Counter | Photo | Grade |
|---|---|---|---|---|---|---|
| | 11.1 | S01 | LFDL Lining Feature Delaminating at 3 o'clock, Start | 00:01:12 | 3 | |
| | 63.5 | F01 | LFDL Lining Feature Delaminating at 3 o'clock, Finish | 00:05:03 | | S3 |

3, 00:01:12, 11.09ft  
Lining Feature Delaminating at 3 o'clock, Start

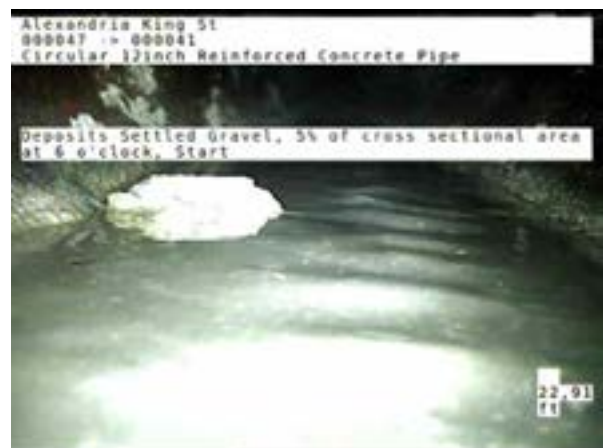
| 1:735 | Distance | Code | Observation | Counter | Photo | Grade |
|---|---|---|---|---|---|---|
| | 22.9 | S02 | DSGV Deposits Settled Gravel, 5% of cross sectional area at 6 o'clock, Start | 00:02:15 | 4 | |
| | 95.5 | F02 | DSGV Deposits Settled Gravel, 5% of cross sectional area at 6 o'clock, Finish | 00:06:44 | | M2 |

4, 00:02:15, 22.91ft  
Deposits Settled Gravel, 5% of cross sectional area at 6 o'clock, Start

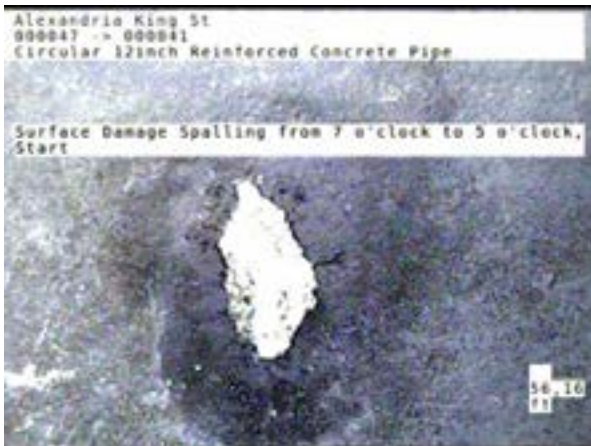
| 1:735 | Distance | Code | Observation | Counter | Photo | Grade |
|---|---|---|---|---|---|---|
| | 56.2 | S03 | SSS Surface Damage Spalling from 7 o'clock to 5 o'clock, Start | 00:04:05 | 5 | |
| | 59.3 | F03 | SSS Surface Damage Spalling from 7 o'clock to 5 o'clock, Finish | 00:04:36 | | S2 |

5, 00:04:05, 56.17ft  
Surface Damage Spalling from 7 o'clock to 5 o'clock, Start

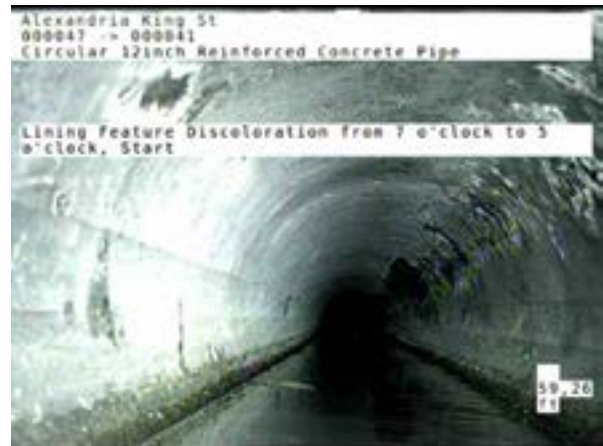
| 1:735 | Distance | Code | Observation | Counter | Photo | Grade |
|---|---|---|---|---|---|---|
| | 59.3 | S04 | LFDC Lining Feature Discoloration from 7 o'clock to 5 o'clock, Start | 00:04:39 | 6 | |
| | 95.5 | F04 | LFDC Lining Feature Discoloration from 7 o'clock to 5 o'clock, Finish | 00:06:48 | | S3 |

6, 00:04:39, 59.26ft  
Lining Feature Discoloration from 7 o'clock to 5 o'clock, Start

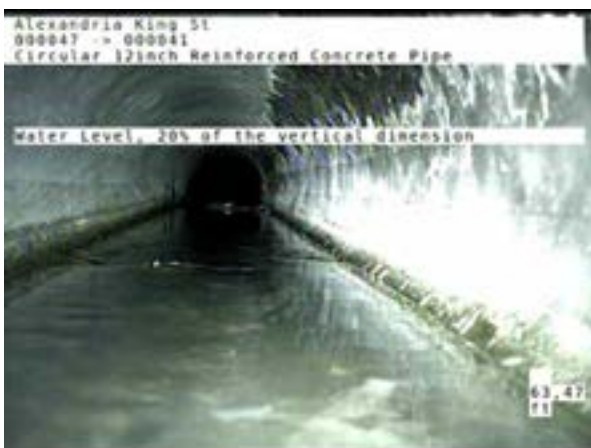
| 1:735 | Distance | Code | Observation | Counter | Photo | Grade |
|---|---|---|---|---|---|---|
| | 63.5 | MWL | Water Level, 20% of the vertical dimension | 00:05:07 | 7 | |

7, 00:05:07, 63.47ft  
Water Level, 20% of the vertical dimension

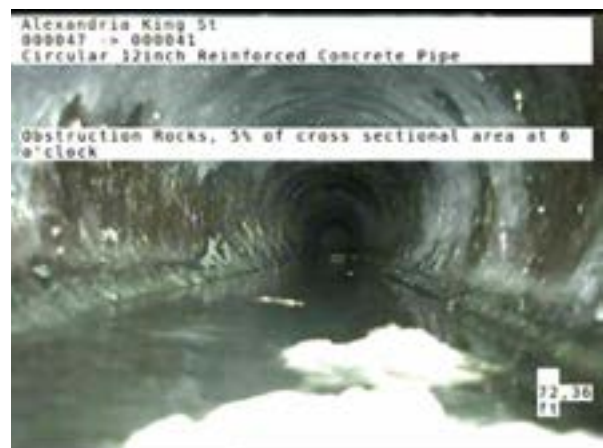
| 1:735 | Distance | Code | Observation | Counter | Photo | Grade |
|---|---|---|---|---|---|---|
| | 72.4 | OBR | Obstruction Rocks, 5% of cross sectional area at 6 o'clock | 00:05:38 | 8 | M2 |

8, 00:05:38, 72.36ft  
Obstruction Rocks, 5% of cross sectional area at 6 o'clock

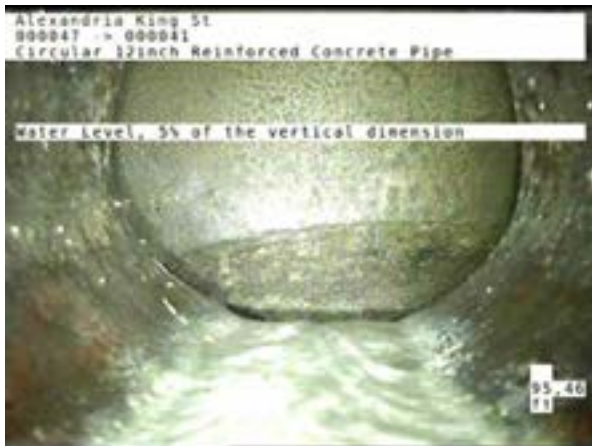
| 1:735 | Distance | Code | Observation | Counter | Photo | Grade |
|---|---|---|---|---|---|---|
| | 95.5 | MWL | Water Level, 5% of the vertical dimension | 00:06:53 | 9 | |

9, 00:06:53, 95.46ft  
Water Level, 5% of the vertical dimension

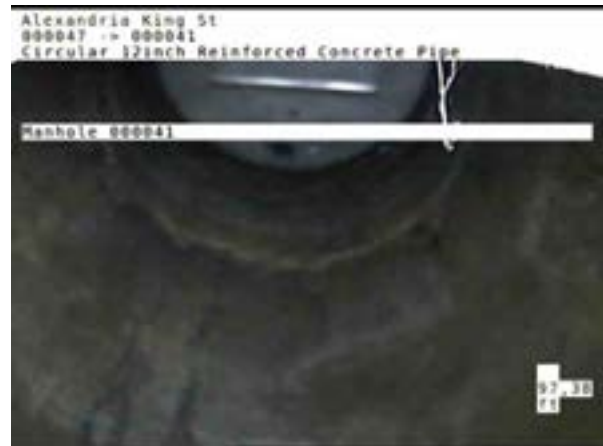
10, 00:07:19, 97.38ft  
Manhole / 000041

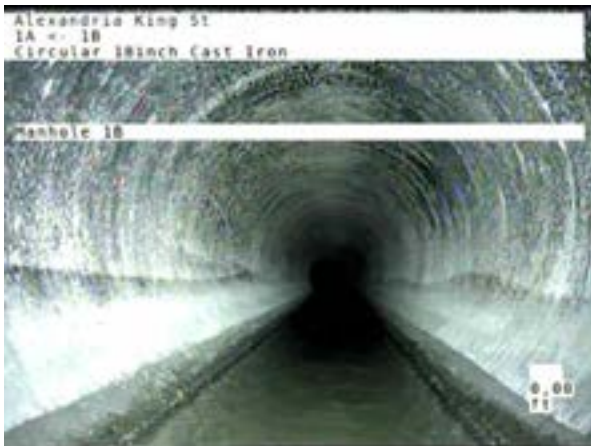
1, 00:00:00, 0.00ft  
Manhole / 1B

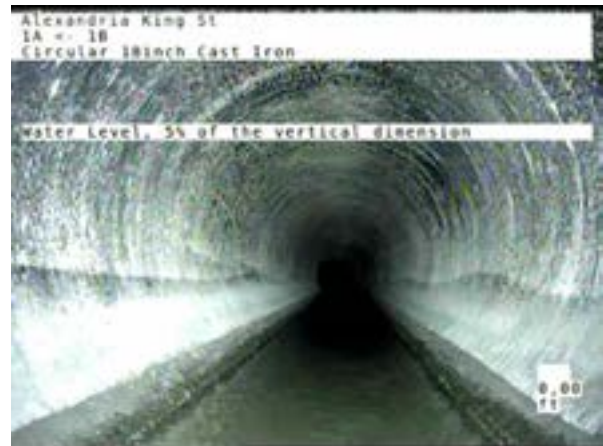
| 1:504 | Distance | Code | Observation | Counter | Photo | Grade | | |
|---|---|---|---|---|---|---|---|---|
| | 0.0 | MWL | Water Level, 5% of the vertical dimension | 00:00:11 | 2 | | | |

2, 00:00:11, 0.00ft  
Water Level, 5% of the vertical dimension

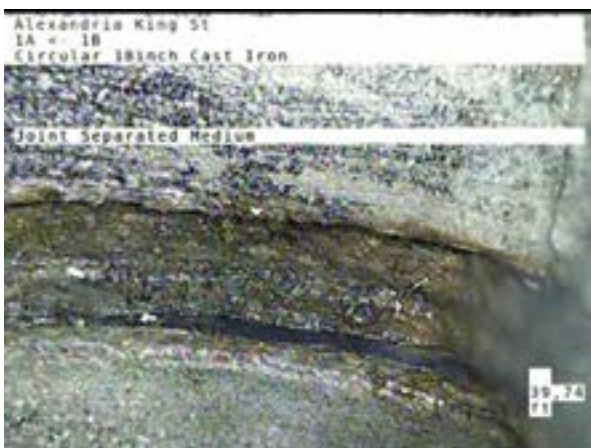
| 1:504 | Distance | Code | Observation | Counter | Photo | Grade | | |
|---|---|---|---|---|---|---|---|---|
| | 39.7 | JSM | Joint Separated Medium | 00:02:34 | 3 | S3 | | |

3, 00:02:34, 39.74ft  
Joint Separated Medium

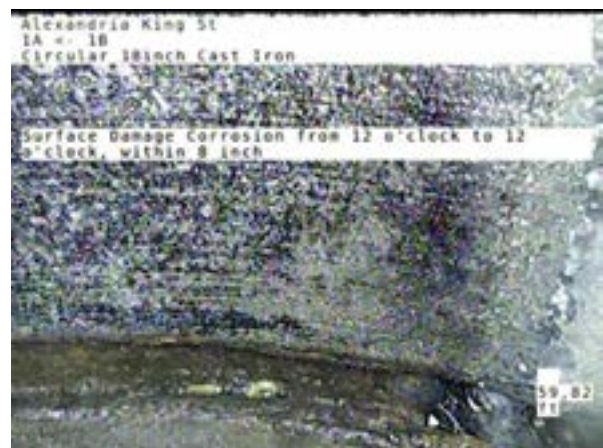
| 1:504 | Distance | Code | Observation | Counter | Photo | Grade | | |
|---|---|---|---|---|---|---|---|---|
| | 59.8 | SCP | Surface Damage Corrosion from 12 o'clock to 12 o'clock, within 8 inch | 00:03:32 | 4 | S3 | | |

4, 00:03:32, 59.82ft  
Surface Damage Corrosion from 12 o'clock to 12 o'clock,  
within 8 inch

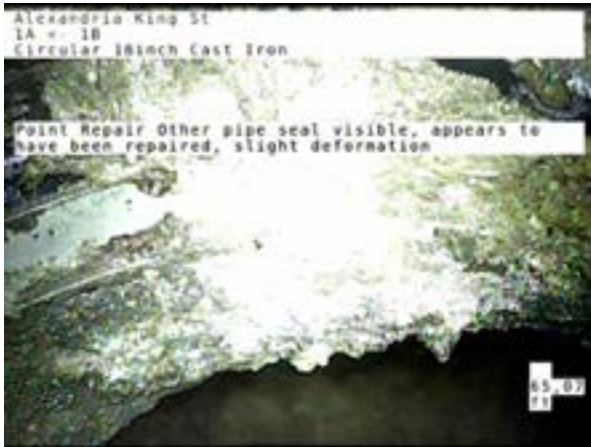
| 1:504 | Distance | Code | Observation | Counter | Photo | Grade | | |
|---|---|---|---|---|---|---|---|---|
| | 65.1 | RPZ | Point Repair Other / pipe seal visible, appears to have been repaired, slight deformation | 00:04:24 | 5 | | | |

5, 00:04:24, 65.07ft  
Point Repair Other / pipe seal visible, appears to have been repaired, slight deformation
