# **60% Basis of Design Report**

## **Taylor Run Infrastructure Stabilization**

**City of Alexandria  
Department of Project Implementation**

**May 2026**

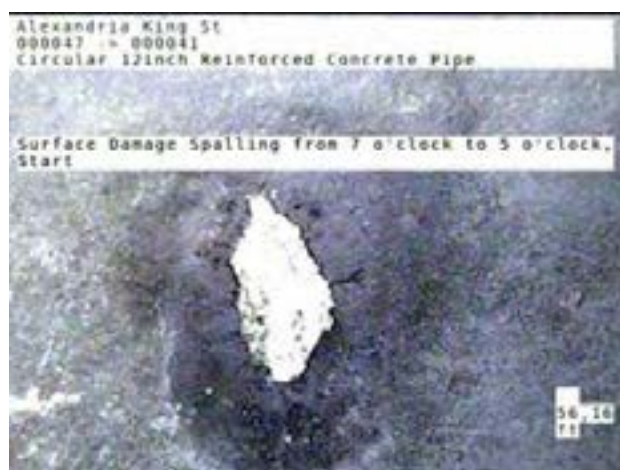
*Spalling damage of pipe surface*

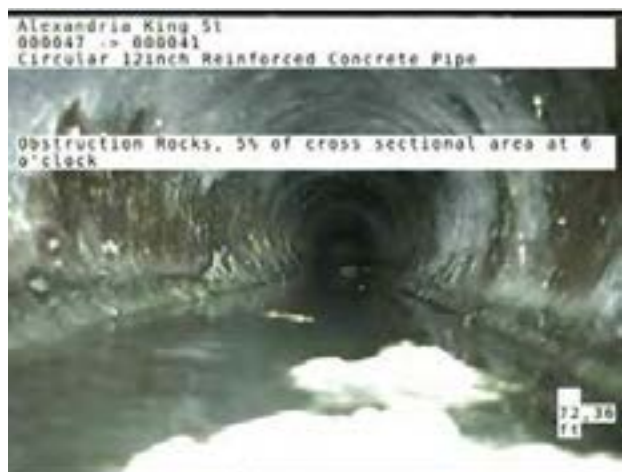
*Sediment and rock obstructions and discoloration of pipe lining.*

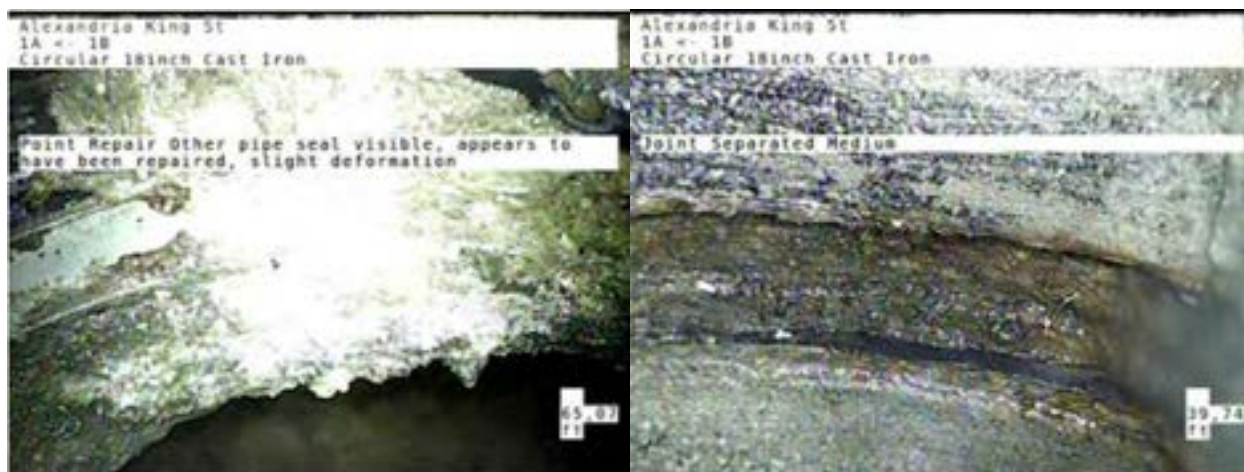
The 18-inch circular cast iron sanitary sewage pipe in Project Area 4 was assessed for approximately 67 linear feet from manhole ID 007531 to ID 006571. There was evidence of a crown repair within the first foot of the upstream manhole (007531). The area shows minor deformation but there was no active infiltration observed during investigation. Additionally, medium joint separation and surface damage corrosion were noted. The CCTV Inspection reports can be found in **Appendix B**.

*Point repair of pipe crown but has slight deformation*

*Pipe joint separation*

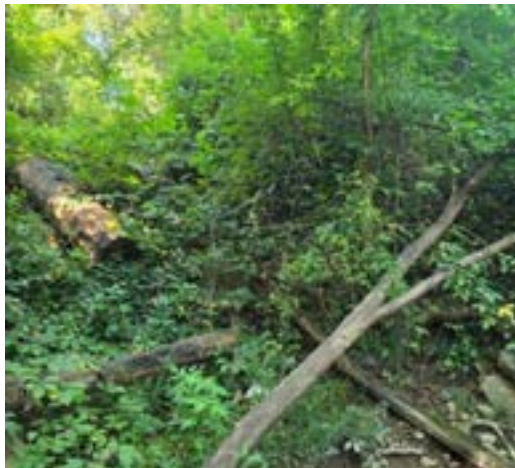
Bank erosion has undermined many trees along the streambank slopes, causing them to fall into the channel and producing debris blockages. Evidence of stream head cut was noted next to the outfall right wingwall (looking upstream) where a gully has developed, contributing to the outfall being unstable. The plunge pool does not meet the most recent Virginia Department of Transportation (VDOT) standards. Large concrete debris was observed in the plunge pool and the immediate downstream section of stream.

*Recently downed trees on the left bank, immediately downstream of the outfall*

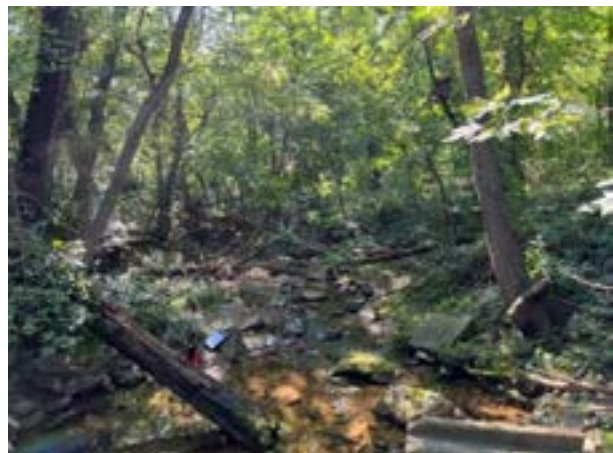
*Debris accumulation obstructing flow downstream of the outfall*

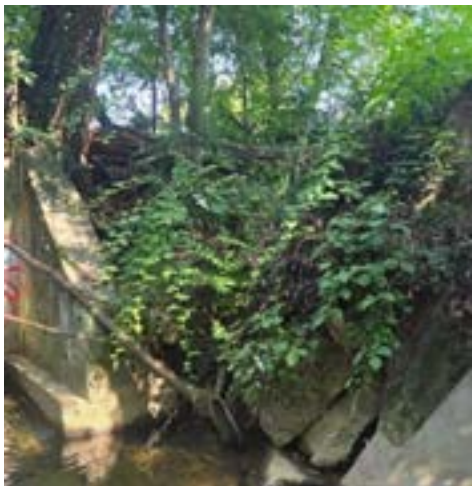
Erosion observed behind the right wingwall of the outfall  
(viewed looking upstream)

Project Areas 1 and 2 exhibit signs of outfall instability due to erosion. In Project Area 1, the right wingwall of the existing 72-inch reinforced concrete pipe (RCP) outfall will be replaced to match the specifications of the left wingwall, with minor modifications proposed to meet the elevations of the proposed gravity walls. In Project Area 2, the existing 36-inch RCP outfall will be replaced with a new cast-in-place endwall constructed in accordance with Virginia Department of Transportation (VDOT) standards. To mitigate future erosion during high-flow events, riprap will be installed around the headwall perimeter. The outfalls will feature a rock façade finish to match the gravity walls and blend with the natural environment.

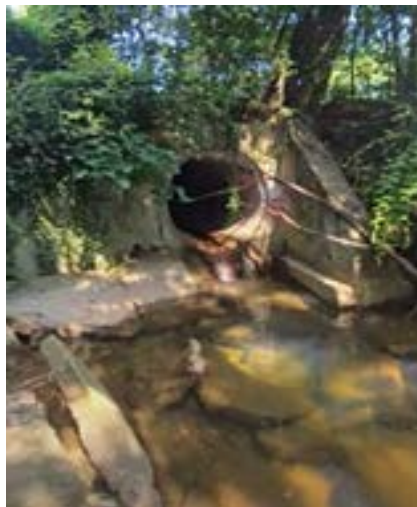
Deteriorating outfall and concrete debris in plunge pool

The plunge pool immediately downstream of the 72-inch outfall in Project Area 1 will be modified to meet National Resource Conservation Service (NRCS) design note 6. This plunge pool design was selected over the Virginia Department of Environmental Quality (VDEQ) Type I or II plunge pool due to the size requirements and current scour pattern from the self-formed plunge pool. This detail utilizes flow rate to size the plunge pool. AECOM

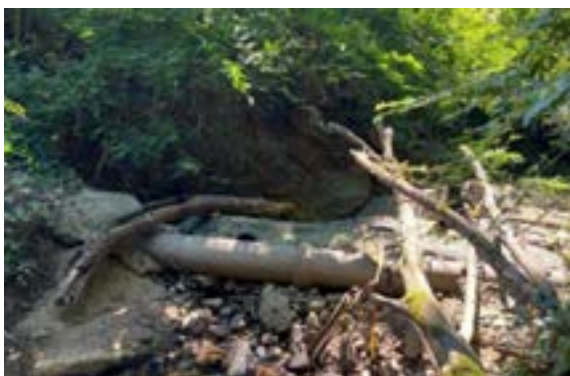
Exposed sanitary sewer line vulnerable to erosion and  
structural damage

Portions of sanitary sewer pipes cross Taylor Run in Project 2 and Project 4. Both pipes will be encased in concrete. The boulder cascades, described in **Section 5.3**, will provide protection. No cover will be placed on top of the concrete encasements. The gravity walls, described in **Section 5.2**, will stabilize the banks and protect the sanitary manhole behind the existing sheet pile wall.

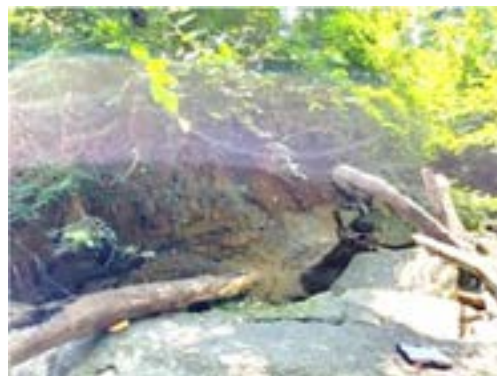
Immediately downstream of the rock cascade, the left bank shows signs of significant erosion, including raw, vertical banks that exceed 6 feet in height. Lateral erosion of the left bank has exposed a dense clay layer and tree roots, which will cause the trees to fall into the channel and produce debris blockages. The erosion extends upstream where a 36-inch RCP outfall has an approximate 18-inch undercut that is eroding the headwall. Construction of the gravity wall may be more difficult where it intersects with dense clay layer. Extensive concrete and woody debris were noted in the channel, contributing to the development of mid-channel bars, increasing near bank stress and accelerating stream bank erosion rates.

Severely eroded streambank with visible tree root  
exposure

In Project Area 2, the gravity wall will tie into the proposed headwall upstream at elevation 146.0 feet, with wall heights ranging from 9 to 15 feet over 95 linear feet. The wall will then transition to elevation 143 feet over 28 linear feet, with a maximum height of 12 feet spanning 69 linear feet.

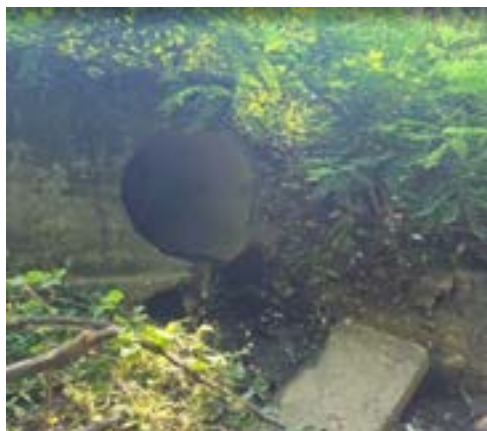
36-inch stormwater outfall showing significant undercutting and headwall deterioration

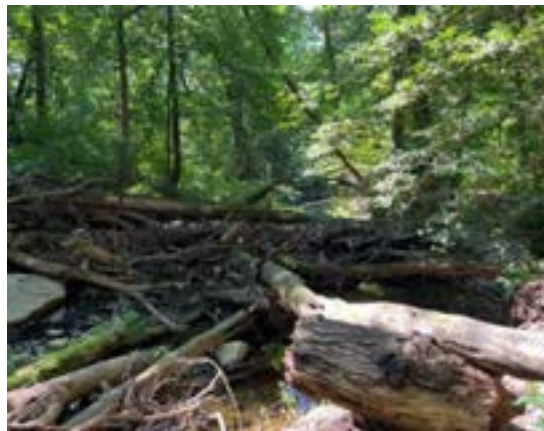
Accumulation of woody debris contributing to channel instability and bank erosion

Channel blockages, consisting mostly of woody and concrete debris, occur throughout the stream and were created from erosion of the City infrastructure and channel banks. Removal of the large debris blockages in Project Areas 2 through 4 will require the realignment of the thalweg towards the center of the channel and performing grading to stabilize the channel.

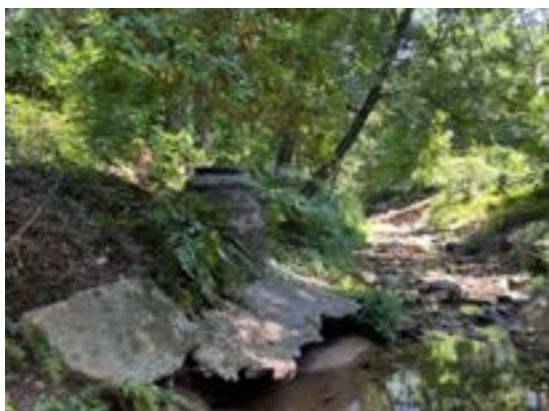
Project Area 3 originates approximately 520 feet downstream of Project Area 2. On the right stream bank there is an exposed sanitary sewer manhole that sits on a concrete skirt. The concrete skirt has an undercut of approximately 24 inches. A large accumulation of woody debris in the channel has contributed to channel migration, bank stress and erosion which can cause root erosion and more trees to fall into the channel and compromise the park's trail network as a portion of the trail has collapsed into the stream.

Exposed sanitary sewer manhole with undercut concrete base, indicating potential structural vulnerability

A gravity wall will be used to protect the exposed sanitary sewer manhole in Project Area 3. To meet the minimum radius recommended for convex curves (14.5 feet), the wall extends up and downstream of the sanitary sewer manhole. The wall ties into existing bank grade at elevations 133' for approximately 38.5 linear feet, wall heights ranging from 5-9 feet. The maximum height of the wall is 9 feet for approximately 7.7 linear feet. The wall height steps down to tie into existing grade at elevation 131.5', with wall heights ranging from 1.5-7.5 feet.

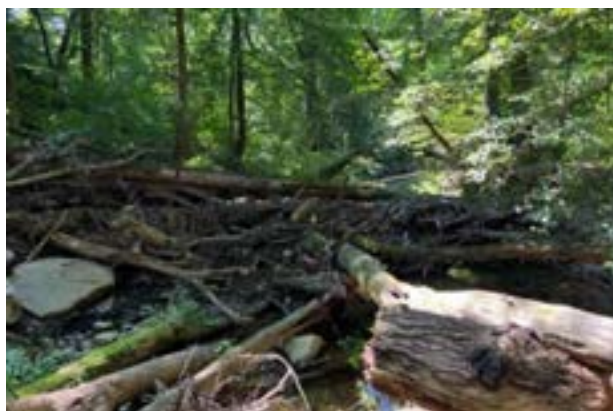
Significant accumulation of woody debris contributing to channel migration and increased streambank erosion

In Project Area 3, following the removal of large woody debris, the banks will be stabilized using native plantings. Rock packing will be used to reinforce undercut roots and will extend through the critical root zone of the large tulip poplar tree in Project Area 4. Additionally, 3'x2'x2' boulders will be placed at the toe of the bank to prevent future erosion beneath the tree.

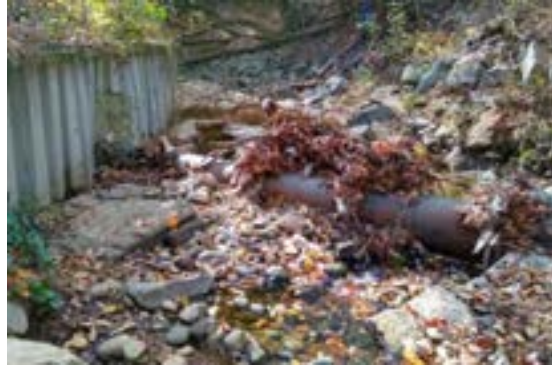
Directly downstream, the existing sheet pile retaining wall is failing from erosion and hydrostatic pressure. A sanitary sewer manhole behind the sheet pile wall risks damage once the wall collapses. The distance of the center of the manhole to the top of the wall is approximately 3 feet and the edge of the manhole is approximately 10 inches. The exposed sewer pipe crossing the channel has no concrete encasement, making it susceptible to damage. The exterior of the sanitary sewer pipe is intact and has accumulated leafy and woody debris behind the structure, acting as a channel blockage. Refer to **Section 2.5** for details on interior conditions.

Exposed sanitary pipe adjacent to a deteriorating sheet pile wall (left), with a riprap-lined channel bank providing erosion control on the right.

In Project Area 4, the existing sheet pile wall on the left bank will be replaced with a gravity wall that ties into existing grade at elevation 133.0 feet. Wall heights vary from 3 to 19 feet over 38 linear feet, with the tallest section (9 feet) spanning 6 linear feet. The wall will then taper over 31 linear feet to tie into existing grade at elevation 131.5 feet, with wall heights ranging from 6 to 7.5 feet depending on base elevation.

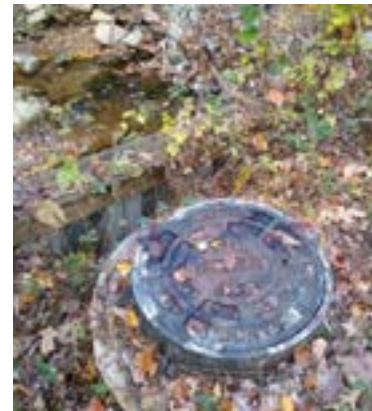
Sanitary sewer manhole behind failing sheet pile wall

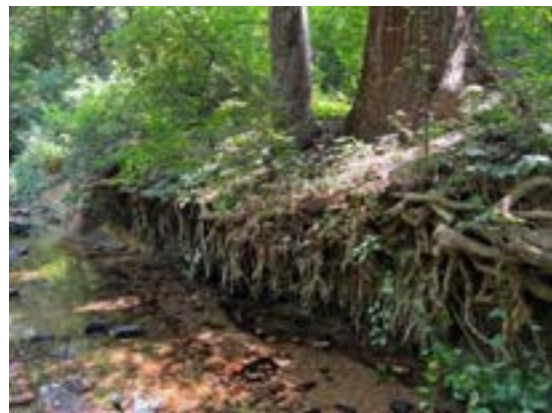
Exposed roots of large tulip poplar tree, looking upstream
