BAR Review Levels

SIDING+TRIM

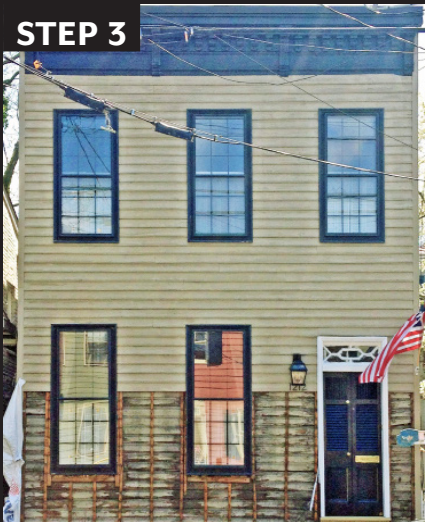
STEP 3

^ BEFORE

More of the historic siding is exposed for Staff to assess its condition. In this case, the historic siding is in very good condition and will be stripped and painted for reuse on this building.

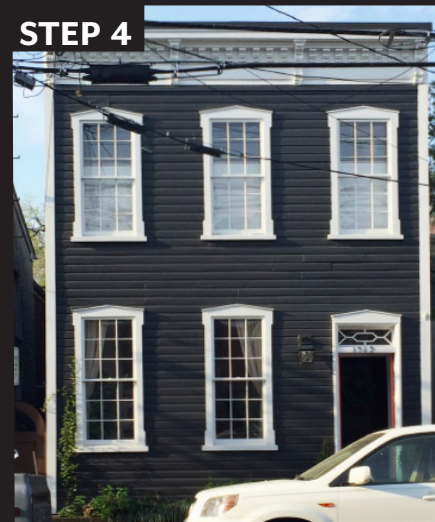
STEP 4

^ AFTER

In this case, removal of the contemporary siding also revealed ghost marks in the old paint from which the original window and door trim was able to be recreated.
