Fort Ward Park Playground Accessibility Project Community Meeting #7

Virtual Meeting Agenda
June 26, 2024
7:00 p.m.

FORT WARD PARK ACCESSIBILITY IMPROVEMENTS Playground Relocation Site B Design and Construction Schedule

Playground Relocation - Site B, Near the Existing Playground

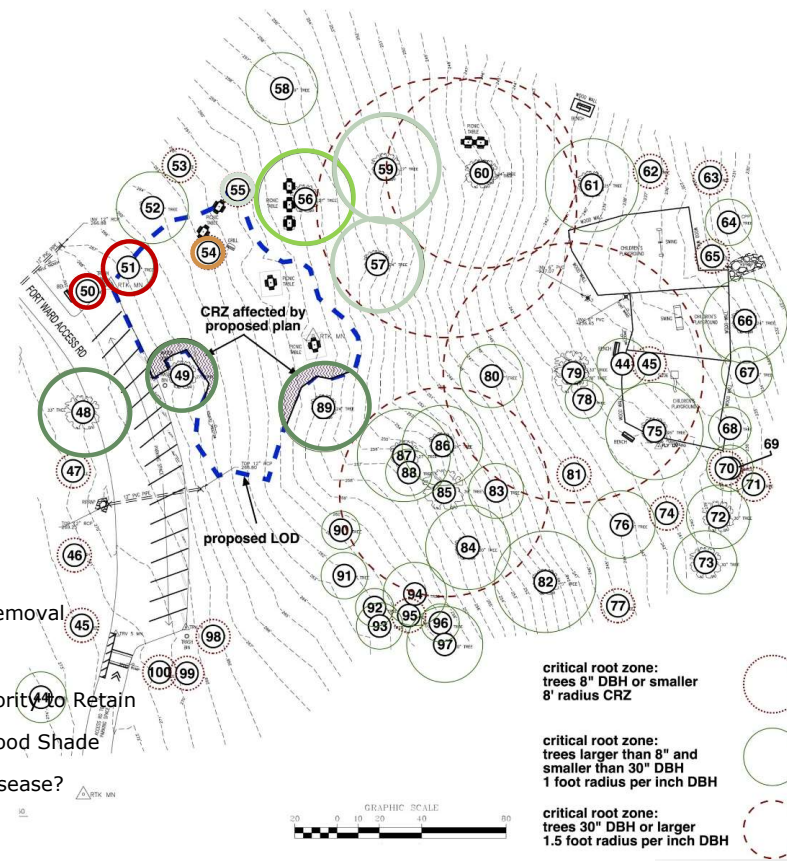
2023 Existing Tree Inventory

Tree #	Name	Size	Condition	Comment	Recommendation
48	hickory <i>Carya</i> spp. Species Rating: 80%	12/12/13	.56	Suitability for preservation: <i>moderate</i> . Chances of survival to be determined. There is decay in the trunk and base of this tree. This is a serious problem for this tree. Included bark is evident. Mowers damaged this tree's trunk and/or roots in the past.	Preservation status to be determined
49	persimmon <i>Diospyros virginiana</i> Species Rating: 85%	12/12	.8	Suitability for preservation: <i>good</i> . Chances of survival to be determined.	Preservation status to be determined
50	flowering dogwood <i>Cornus florida</i> Species Rating: 65%	1	.2	Suitability for preservation: <i>poor</i> . Chances of survival to be determined. Borer damage is evident. This is a severe problem for this tree!	Preservation status to be determined
51	black cherry <i>Prunus serotina</i> Species Rating: 60%	12	.44	Suitability for preservation: <i>moderate</i> . Chances of survival to be determined. There is decay in the trunk and base of this tree. This is a serious problem for this tree. It appears this tree was partially uprooted in the past. Dead branches are a significant problem for this tree.	Preservation status to be determined

52	Virginia pine <i>Pinus virginiana</i> Species Rating: 50%	17	.72	Suitability for preservation: <i>good</i> . Chances of survival to be determined. Mowers damaged this tree's trunk and/or roots in the past. Dead branches in this tree's crown are a minor problem.	Preservation status to be determined
53	southern red oak <i>Quercus falcata</i> Species Rating: 80%	.5	.72	Suitability for preservation: <i>good</i> . Chances of survival to be determined. This tree was recently planted. Tip pruning has been done to shorten branches/main stem.	Preservation status to be determined
54	red oak <i>Quercus</i> spp. Species Rating: 80%	4	.68	Suitability for preservation: <i>good</i> . Chances of survival to be determined. Tip pruning has been done to shorten branches. May be southern red oak.	Preservation status to be determined
55	red oak <i>Quercus</i> spp. Species Rating: 80%	2	.68	Suitability for preservation: <i>good</i> . Chances of survival to be determined. Tip pruning has been done to shorten branches. May be northern red oak.	Preservation status to be determined

56	sawtooth oak <i>Quercus acutissima</i> Species Rating: 75%	22	.8	Suitability for preservation: <i>moderate</i> . Chances of survival to be determined. Sawtooth oak, an exotic, is invasive in some areas.	Preservation status to be determined
57	northern red oak <i>Quercus rubra</i> Species Rating: 80%	22	.8	Suitability for preservation: <i>good</i> . Chances of survival to be determined. Dead branches in this tree's crown are a minor problem. Bacterial leaf scorch may be affecting this tree.	Preservation status to be determined
58	southern red oak <i>Quercus falcata</i> Species Rating: 80%	17	.68	Suitability for preservation: <i>good</i> . Chances of survival to be determined. Dead branches in this tree's crown are a minor problem. Bacterial leaf scorch may be affecting this tree.	Preservation status to be determined
59	northern red oak <i>Quercus rubra</i> Species Rating: 80%	25	.6	Suitability for preservation: <i>good</i> . Chances of survival to be determined. Dead branches are a significant problem for this tree. Bacterial leaf scorch may be affecting this tree. Bleeding cankers are apparent; may be <i>Phytophthora</i> .	Preservation status to be determined

89	mockernut hickory <i>Carya tomentosa</i> Species Rating: 80%	6/15/10/9	.76	Suitability for preservation: <i>good</i> . Chances of survival to be determined. Bark was damaged near the base of the tree years ago. Included bark is evident.	Preservation status to be determined

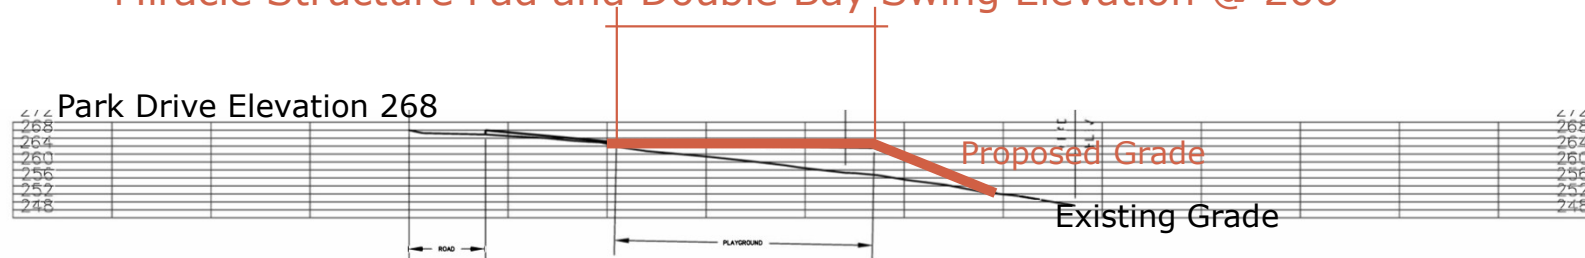
June 2024 Section looking north

- Incorporate vegetative screening along the Rifle Trench and around the playground.
- Limit access to the Rifle Trench from the playground:
 - Relocate the accessible route along the parking lot
 - Enclose the playground with fencing and other barriers

Miracle Structure Pad and Double Bay Swing Elevation @ 266
