## BAR Review Levels

### *Steps for Siding Analysis*

# SIDING+TRIM

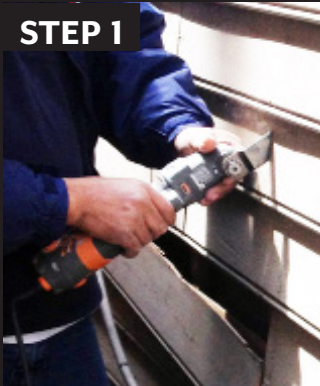
## STEP 1

Carefully remove a 2 foot by 2 foot portion of the surface siding.

Intact historic siding may be hidden beneath layers of siding, such as aluminum, vinyl, artificial brick, or stone. To determine if multiple layers of siding exist, remove at least one portion a minimum of 2 feet by 2 feet to reveal the first layer of siding. Staff will inspect the mock-up in the field prior to any approval. The graphic on the following page gives an overview of this process.

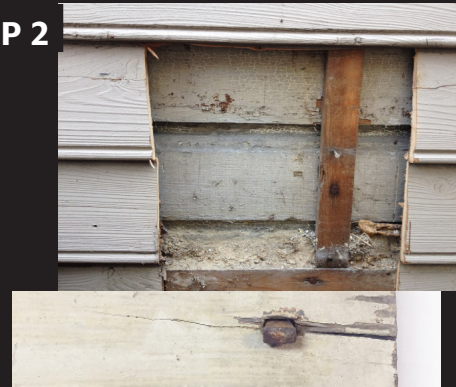
## STEP 2

Using clues such as the siding profile and the type of nails used, Staff makes a determination on the age of the siding.

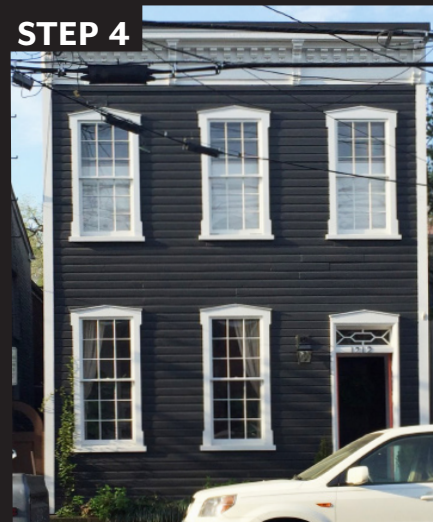
## STEP 4

^ AFTER

In this case, removal of the contemporary siding also revealed ghost marks in the old paint from which the original window and door trim was able to be recreated.
