## BAR Review Levels

### *Steps for Siding Analysis*

# SIDING+TRIM

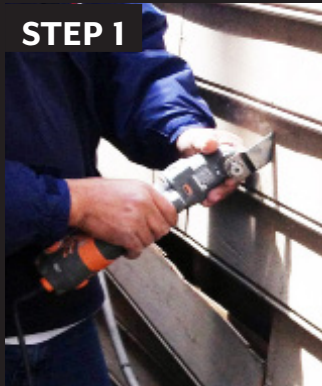
## STEP 1

Carefully remove a 2 foot by 2 foot portion of the surface siding.

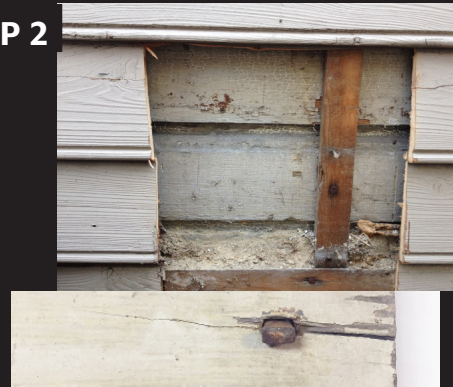
## STEP 2

Using clues such as the siding profile and the type of nails used, Staff makes a determination on the age of the siding.

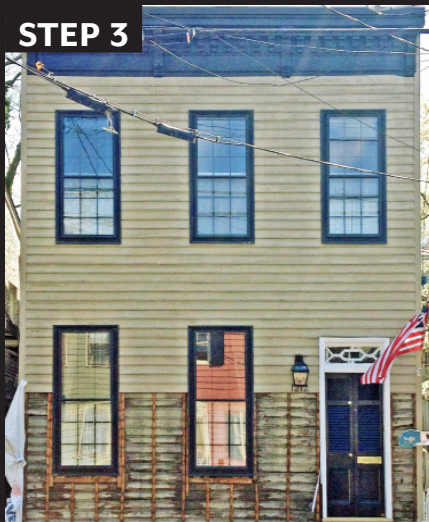
## STEP 3

^ BEFORE

More of the historic siding is exposed for Staff to assess its condition. In this case, the historic siding is in very good condition and will be stripped and painted for reuse on this building.

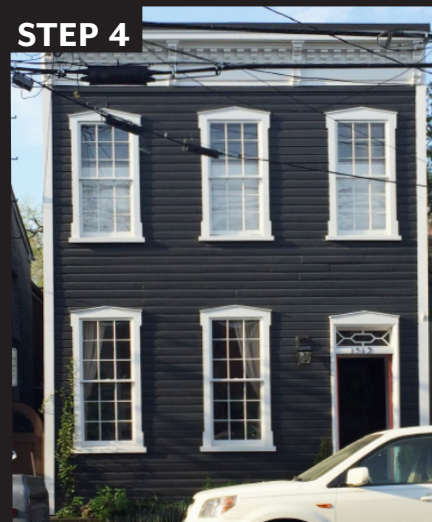
## STEP 4

^ AFTER

In this case, removal of the contemporary siding also revealed ghost marks in the old paint from which the original window and door trim was able to be recreated.
