## SITE PHOTOGRAPH LOG

| <b>Project Name:</b><br>Taylor Run Stream Restoration | | <b>Project No.</b><br>60742359 | |

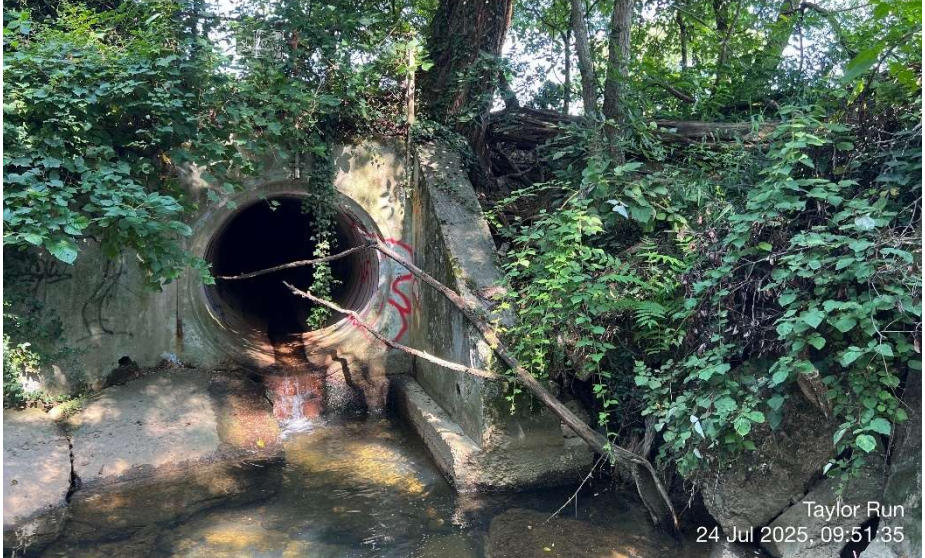
| <b>Description:</b><br>72-inch outfall condition.<br>Gully next to right wingwall (look upstream) and beginning of plunge pool (Project Area 1) | | | |

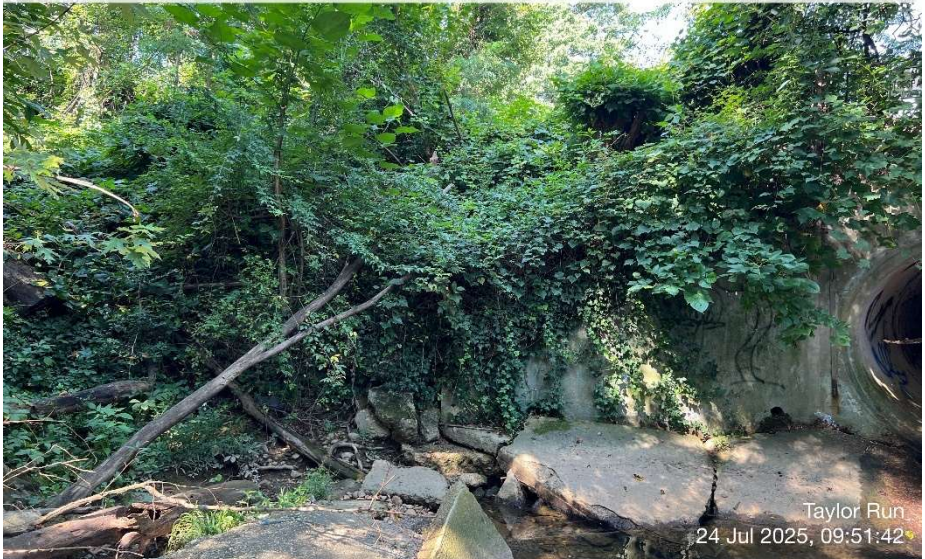
| <b>Photo No.</b><br><b>2</b> | <b>Date:</b><br>07/24/25 | <div>3210 King St Alexandria VA</div> <div>☉ 249°W (T) ● 38°49'23"N, 77°4'56"W ±13ft ▲ 157ft</div> <div>Taylor Run<br/>24 Jul 2025, 09:51:42</div> | |

| <b>Description:</b><br>Left wingwall (looking upstream) condition.<br>(Project Area 1) | | | |

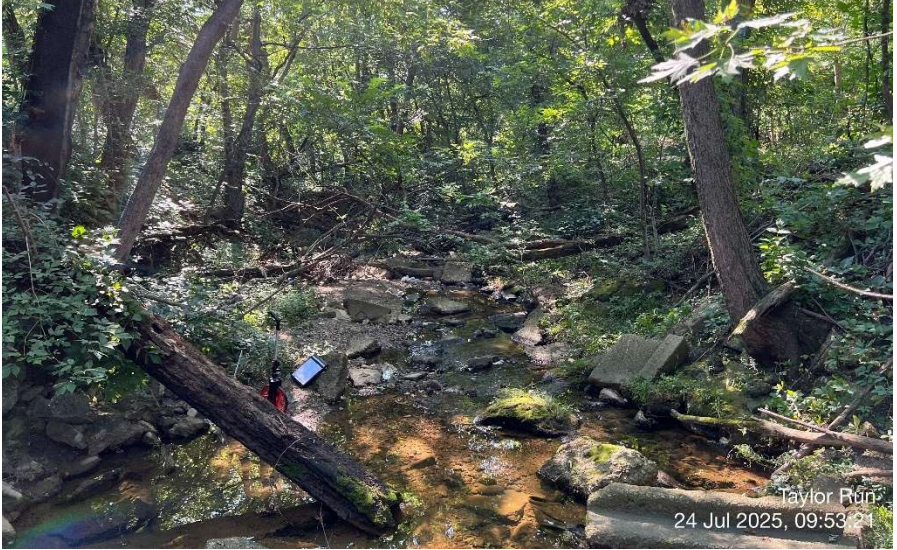
| <b>Description:</b><br>Downstream condition of stream with concrete debris, unstable (soon to fall) trees, woody debris build up | | |

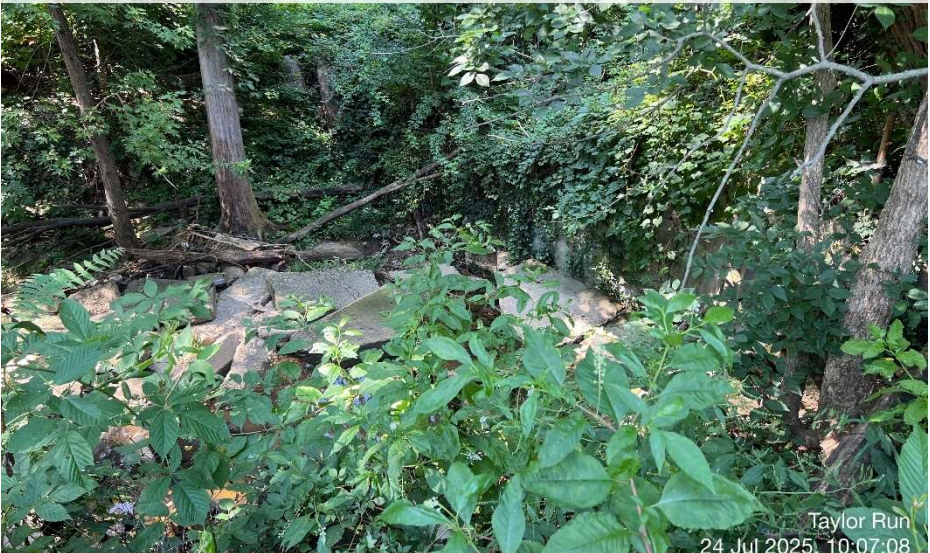
| <b>Photo No.</b><br><b>4</b> | <b>Date:</b><br>07/24/25 | <div>3210 King St Alexandria VA</div> <div>☉ 192°S (T) ● 38°49'23"N, 77°4'56"W ±13ft ▲ 156ft</div> <div>Taylor Run<br/>24 Jul 2025, 10:07:08</div> |

| <b>Description:</b><br>Concrete debris in the channel, downstream of Project Area 1 | | |

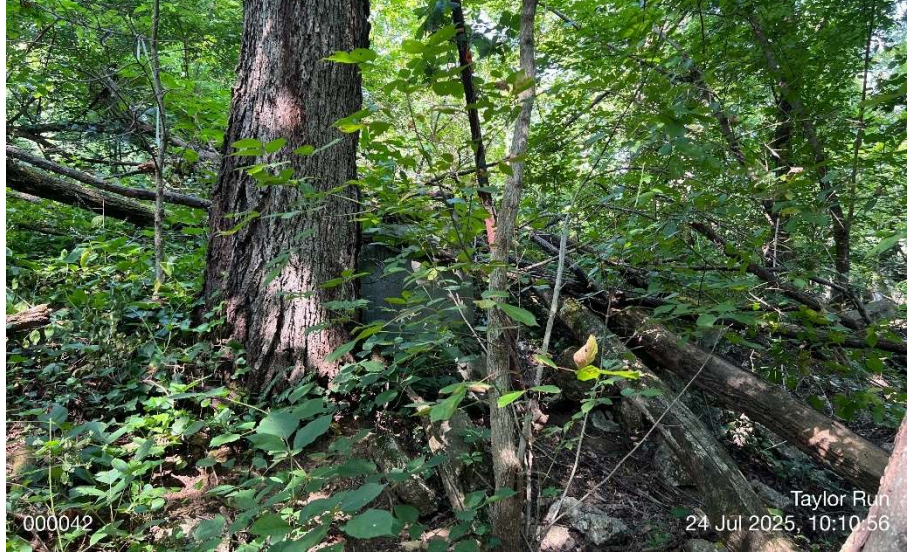
| <b>Description:</b><br>Fallen trees causing debris build up in the channel. View from left bank. Between Project Area 1 and 2 | | |

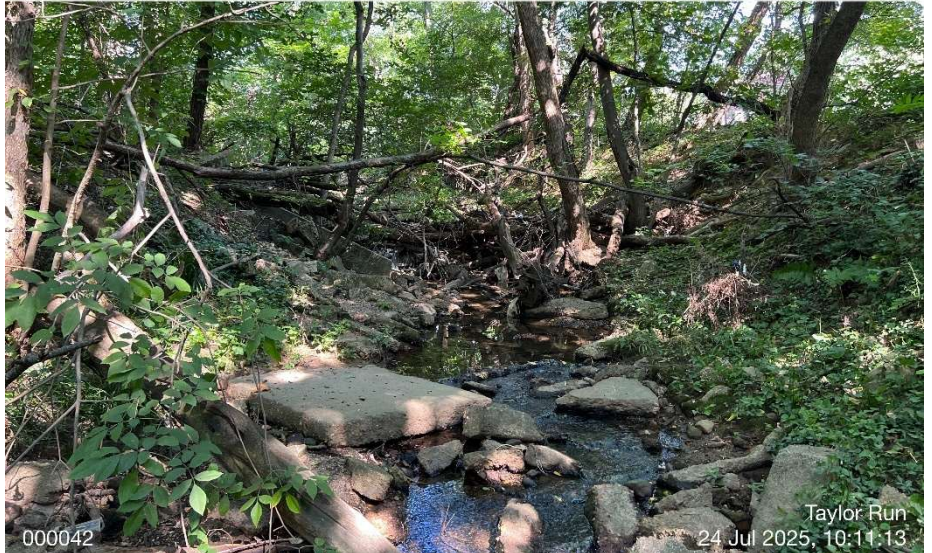
| <b>Description:</b><br>Concrete debris in the channel, fallen trees, bank erosion and woody debris build up in channel between Project Area 1 and 2 | | |

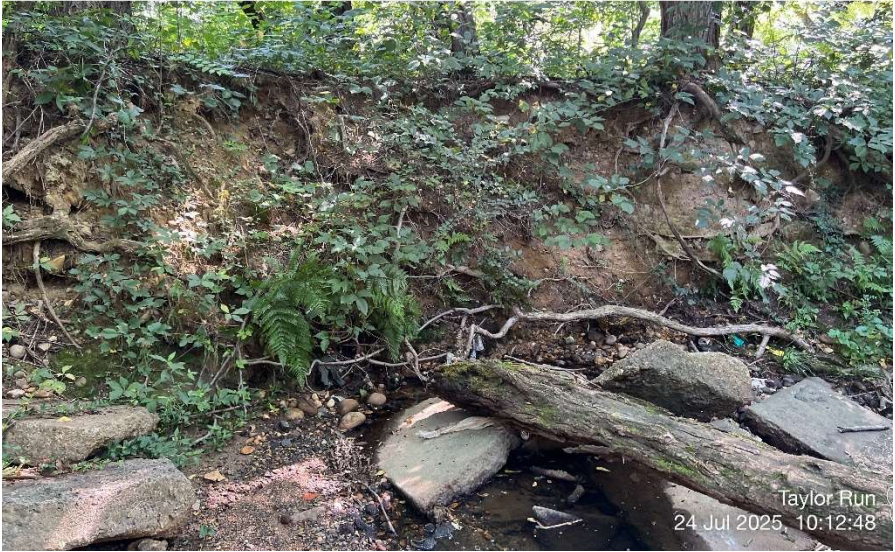
| <b>Photo No.</b><br><b>7</b> | <b>Date:</b><br>07/24/25 | <div>3210 King St Alexandria VA</div> <div>☉ 55°NE (T) ☉ 38°49'22"N, 77°4'55"W ±13ft ▲ 151ft</div> <div>Taylor Run<br/>24 Jul 2025, 10:12:48</div> |

| <b>Description:</b><br>Eroding channel bank between Project Area 1 and 2 | | |

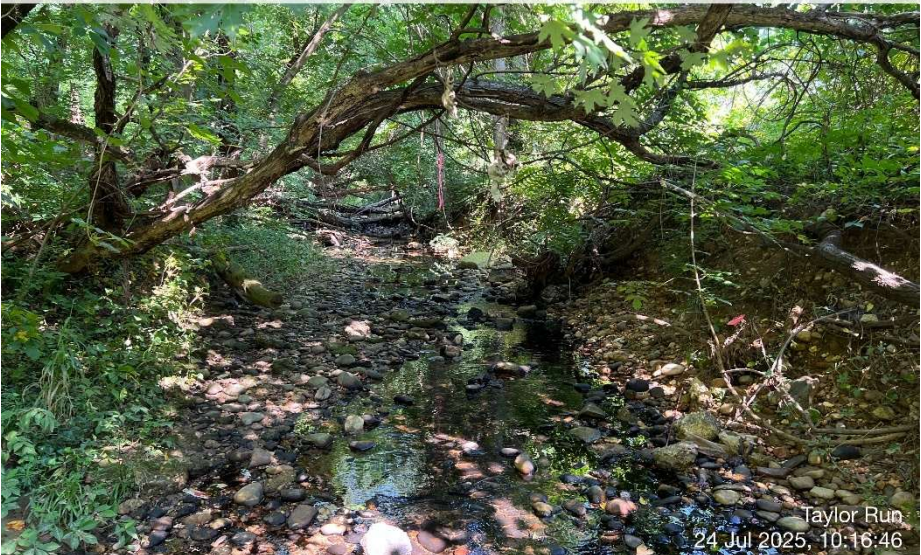
| <b>Photo No.</b><br><b>8</b> | <b>Date:</b><br>07/24/25 | <div>3210 King St Alexandria VA</div> <div>☉ 318°NW (T) ☉ 38°49'21"N, 77°4'52"W ±9ft ▲ 143ft</div> <div>Taylor Run<br/>24 Jul 2025, 10:16:46</div> |

| <b>Description:</b><br>Falling trees and debris build up in the stream between Project Area 1 and 2 | | |

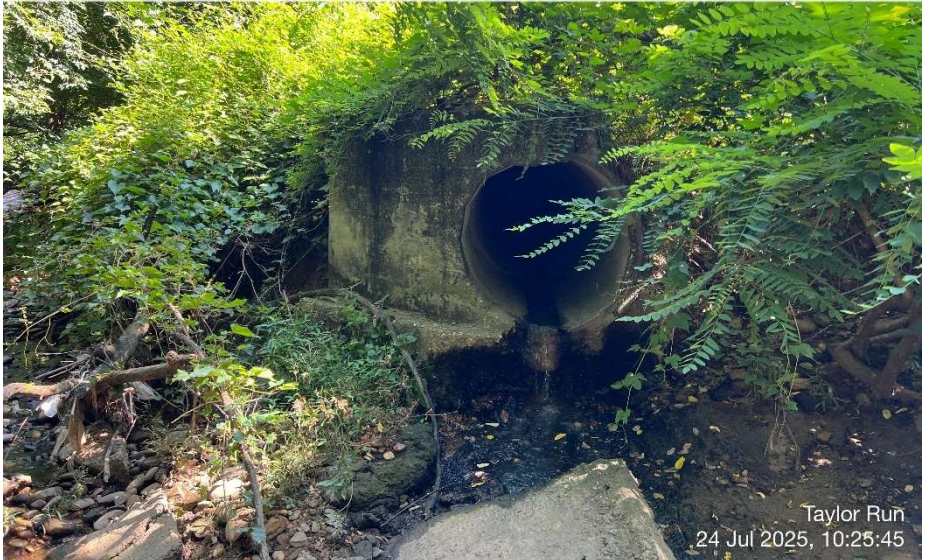
| <b>Photo No.</b><br><b>9</b> | <b>Date:</b><br>07/24/25 | <div>3210 King St Alexandria VA</div> <div>☉ 4°N (T) ☉ 38°49'20"N, 77°4'52"W ±9ft ▲ 139ft</div> <div>Taylor Run<br/>24 Jul 2025, 10:25:45</div> | |

| <b>Description:</b><br>36-inch outfall showing undercut of headwall and erosion of the left side | | | |

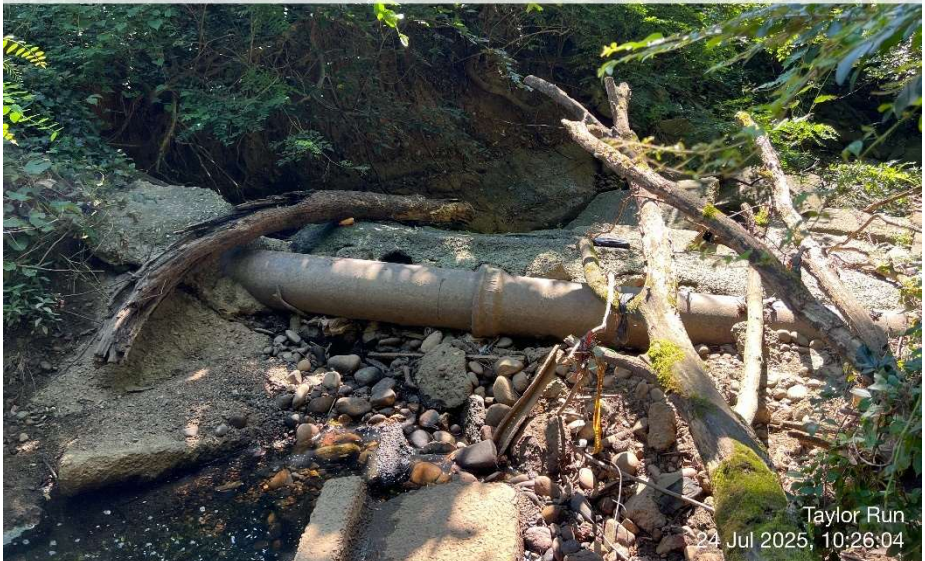
| <b>Photo No.</b><br><b>10</b> | <b>Date:</b><br>07/24/25 | <div>3210 King St Alexandria VA</div> <div>☉ 77°E (T) ☉ 38°49'20"N, 77°4'52"W ±13ft ▲ 142ft</div> <div>Taylor Run<br/>24 Jul 2025, 10:26:04</div> | |

| <b>Description:</b><br>Exposed sanitary sewer pipe next to 36-inch outfall (Project Area 2) | | | |

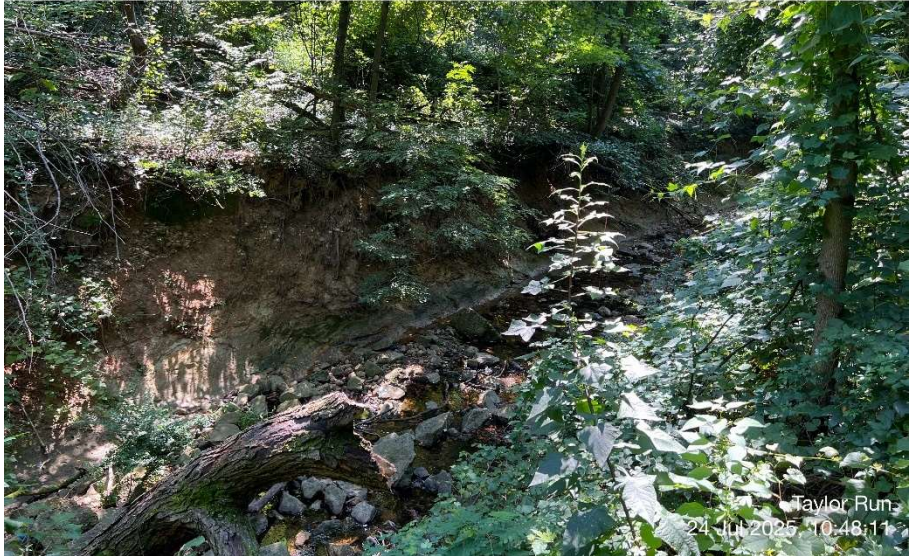
| <b>Photo No.</b><br><b>11</b> | <b>Date:</b><br>07/24/25 | <div>3210 King St Alexandria VA</div> <div>☀ 117°SE (T) ● 38°49'19"N, 77°4'51"W ±9ft ▲ 155ft</div> <div>Taylor Run<br/>24 Jul 2025, 10:48:11</div> |

| <b>Description:</b><br>Severe bank erosion immediately downstream from the 36-inch outfall (Project Area 2) | | |

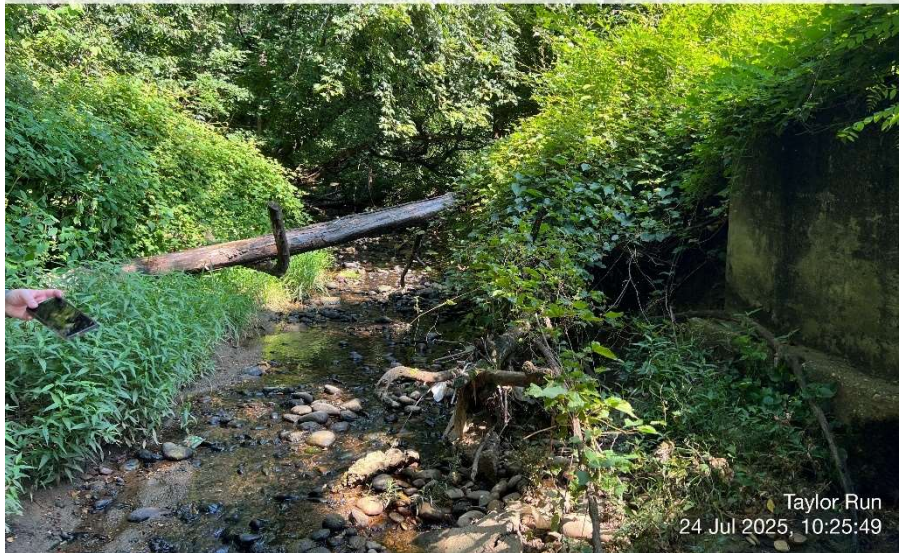
| <b>Description:</b><br>Upstream stream condition, standing at the 36-inch outfall. Fallen tree(s) due to bank instability (Project Area 2) | | |

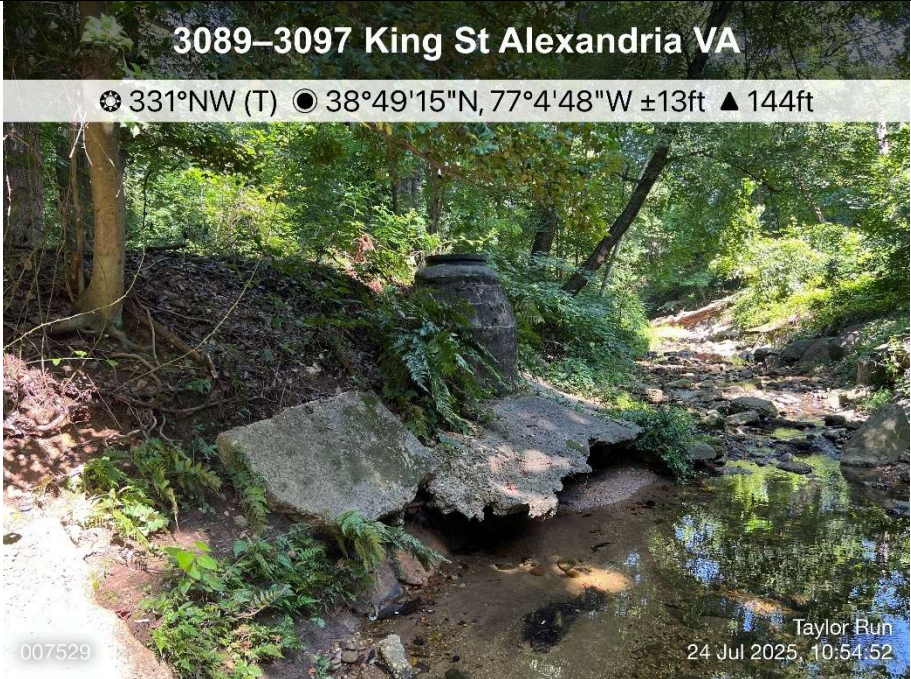
| <b>Photo No.</b><br><b>13</b> | <b>Date:</b><br>07/24/25 | <div>3089–3097 King St Alexandria VA</div> <div>☉ 331°NW (T) ☉ 38°49'15"N, 77°4'48"W ±13ft ▲ 144ft</div> <div>Taylor Run<br/>24 Jul 2025, 10:54:52</div> | |

| <b>Description:</b><br>Exposed sanitary sewer manhole with undercut of concrete skirt | | | |

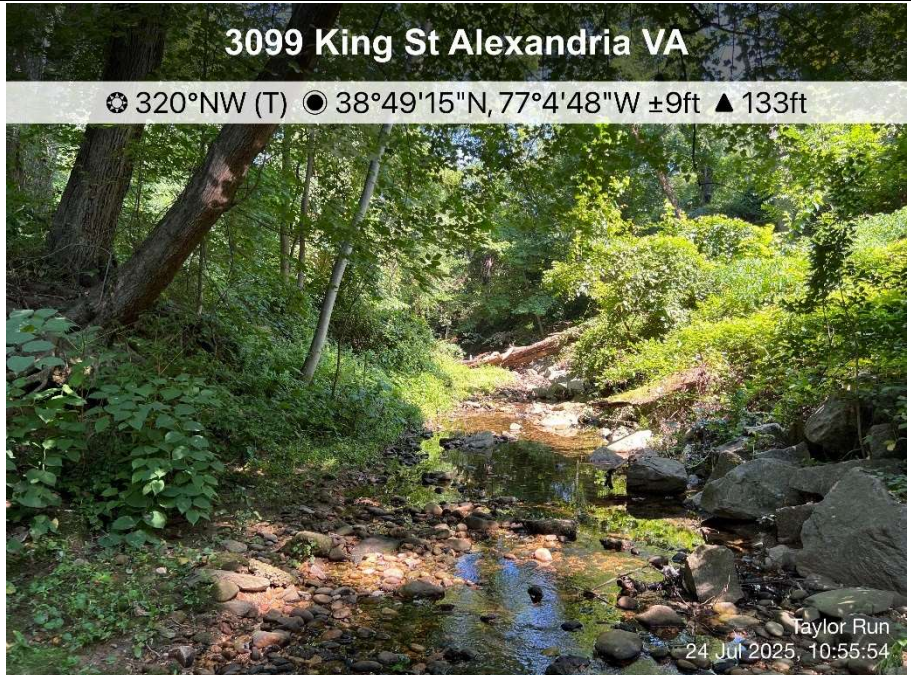
| <b>Photo No.</b><br><b>14</b> | <b>Date:</b><br>07/24/25 | <div>3099 King St Alexandria VA</div> <div>☉ 320°NW (T) ☉ 38°49'15"N, 77°4'48"W ±9ft ▲ 133ft</div> <div>Taylor Run<br/>24 Jul 2025, 10:55:54</div> | |

| <b>Description:</b><br>Upstream stream condition from exposed sanitary sewer manhole (Project Area 3) | | | |

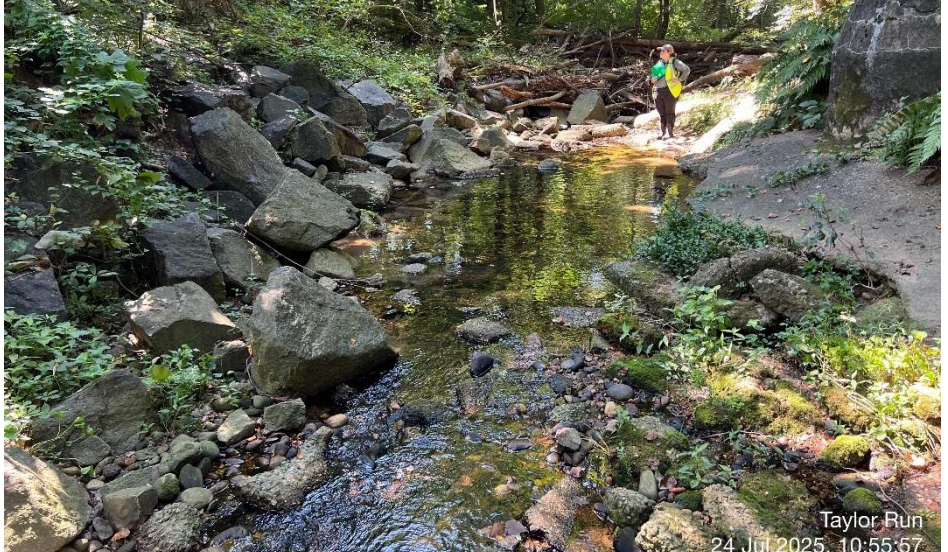
| <b>Description:</b><br>Downstream conditions of the exposed sanitary sewer manhole. Woody Debris build up in the back. (Project Area 3) | | | |

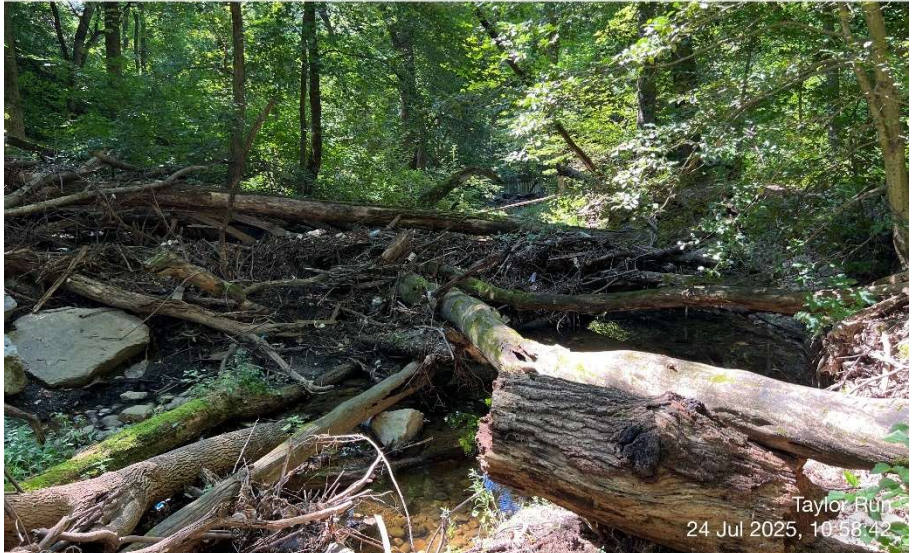
| <b>Description:</b><br>Woody debris build up between Project Area 3 and Project Area 4. Falling trees from bank instability | | | |

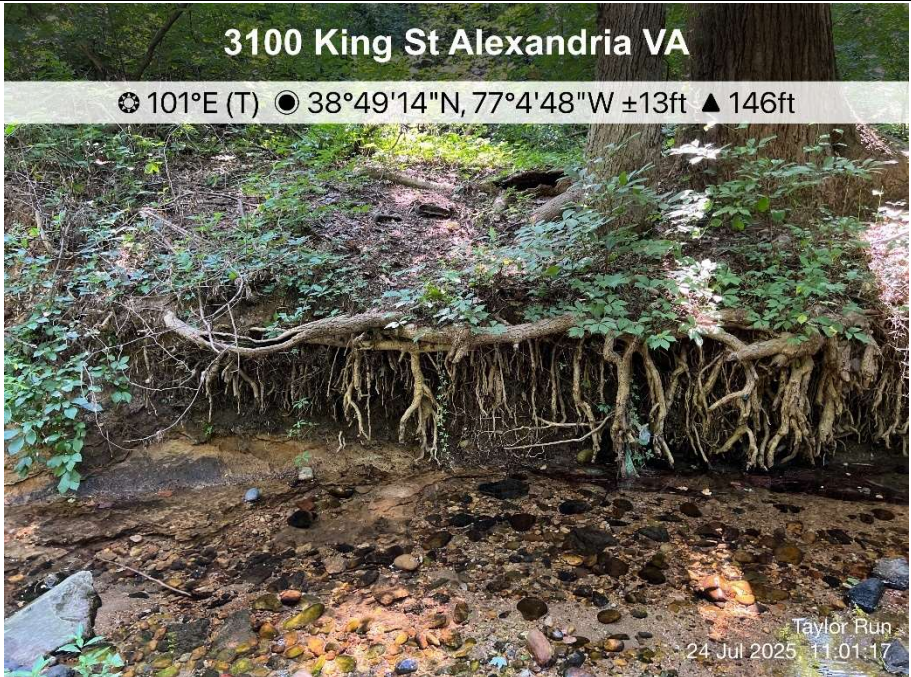
| <b>Photo No.</b><br><b>17</b> | <b>Date:</b><br>07/24/25 | <div>3100 King St Alexandria VA</div> <div>☀ 101°E (T) ● 38°49'14"N, 77°4'48"W ±13ft ▲ 146ft</div> <div>Taylor Run<br/>24 Jul 2025, 11:01:17</div> |

| <b>Description:</b><br>Exposed root exposure of champion tree (Project Area 4) | | |

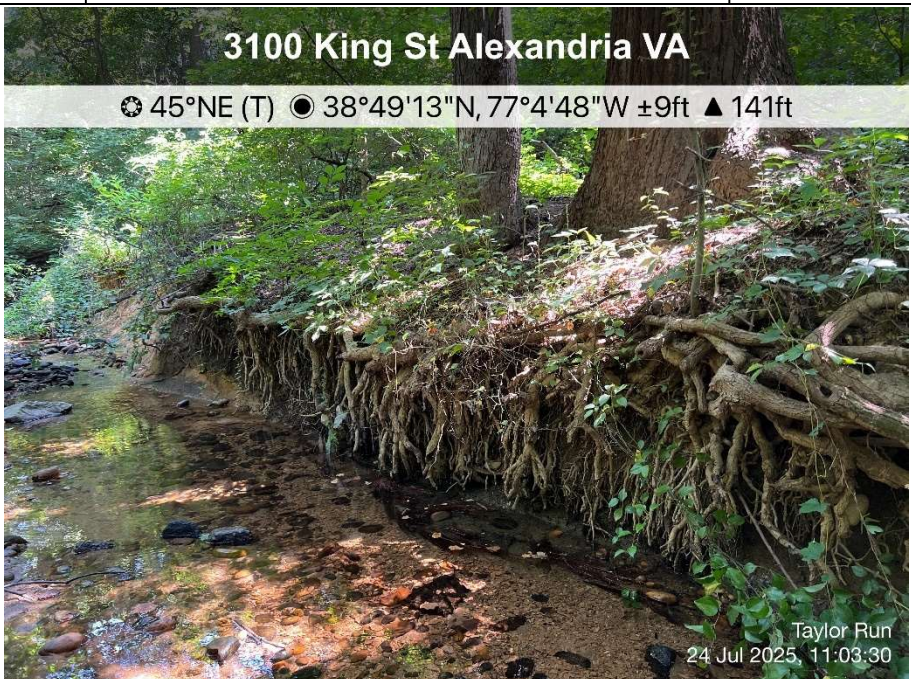
| <b>Photo No.</b><br><b>18</b> | <b>Date:</b><br>07/24/25 | <div>3100 King St Alexandria VA</div> <div>☀ 45°NE (T) ● 38°49'13"N, 77°4'48"W ±9ft ▲ 141ft</div> <div>Taylor Run<br/>24 Jul 2025, 11:03:30</div> |

| <b>Description:</b><br>Horizontal extent of root exposure of the champion tree (Project Area 4) | | |

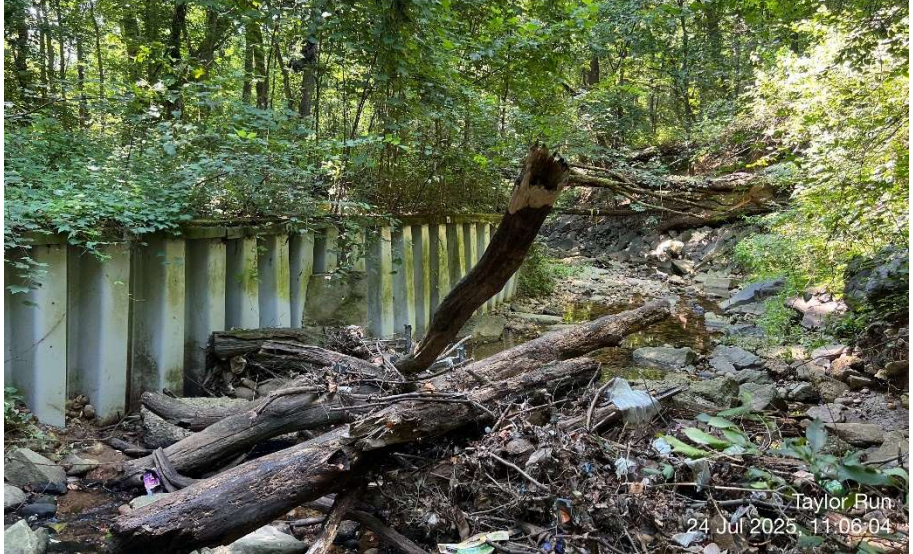
| <b>Photo No.</b><br><b>19</b> | <b>Date:</b><br>07/24/25 | <div>3100 King St Alexandria VA</div> <div>☀ 147°SE (T) ● 38°49'13"N, 77°4'48"W ±45ft ▲ 131ft</div> <div>Taylor Run<br/>24 Jul 2025, 11:06:04</div> |

| <b>Description:</b><br>Leaning sheet pile wall and build of debris within the channel (Project Area 4) | | |

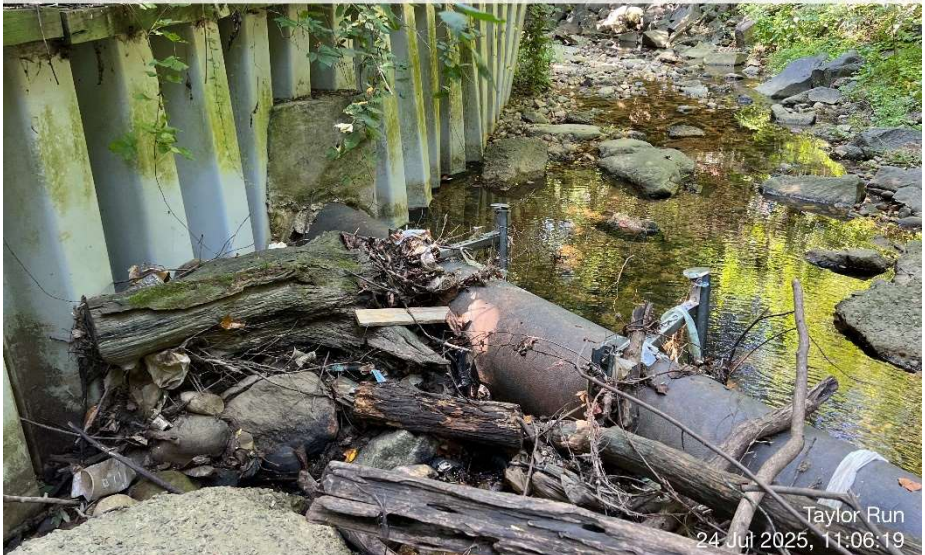
| <b>Photo No.</b><br><b>20</b> | <b>Date:</b><br>07/24/25 | <div>3100 King St Alexandria VA</div> <div>☀ 208°SW (T) ● 38°49'13"N, 77°4'48"W ±13ft ▲ 136ft</div> <div>Taylor Run<br/>24 Jul 2025, 11:06:19</div> |

| <b>Description:</b><br>Exposed sanitary sewer pipe near sheet pile wall (Project Area 4) | | |

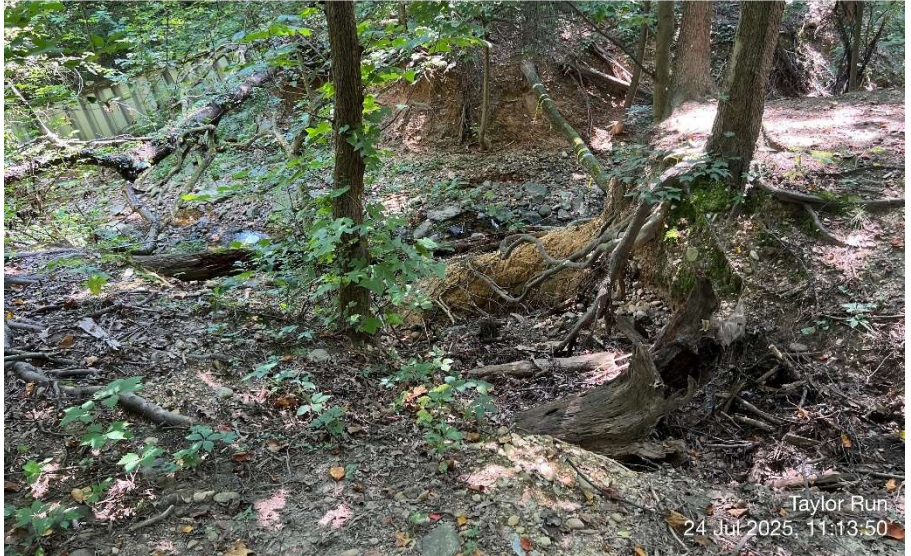
| <b>Photo No.</b><br><b>21</b> | <b>Date:</b><br>07/24/25 | <div>3100 King St Alexandria VA</div> <div>☀ 62°NE (T) ● 38°49'12"N, 77°4'48"W ±101ft ▲ 145ft</div> <div>Taylor Run<br/>24 Jul 2025, 11:13:50</div> | |

| <b>Description:</b><br>Exposed roots, stream bank erosion and gully formed from trail side runoff | | | |

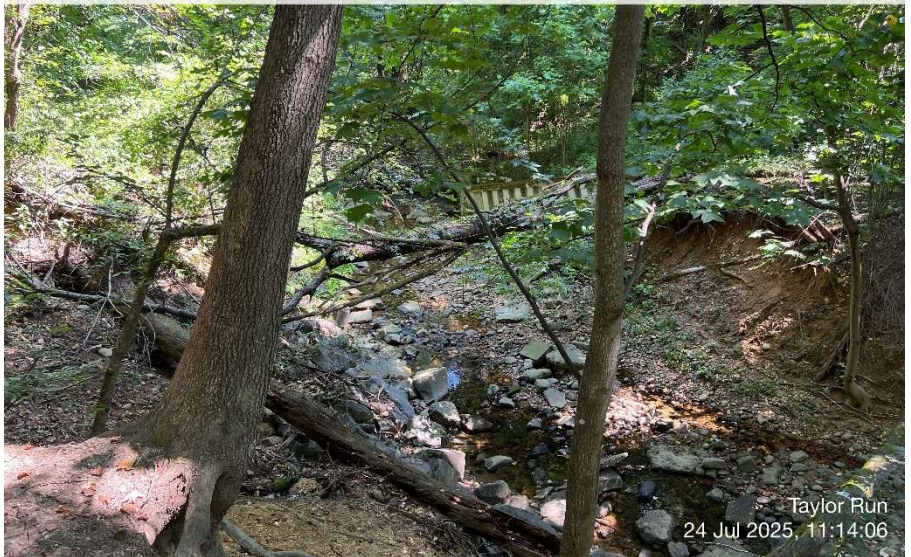
| <b>Photo No.</b><br><b>22</b> | <b>Date:</b><br>07/24/25 | <div>3100 King St Alexandria VA</div> <div>☀ 31°NE (T) ● 38°49'12"N, 77°4'48"W ±13ft ▲ 143ft</div> <div>Taylor Run<br/>24 Jul 2025, 11:14:06</div> | |

| <b>Description:</b><br>Condition of right bank, downstream of study extent | | | |

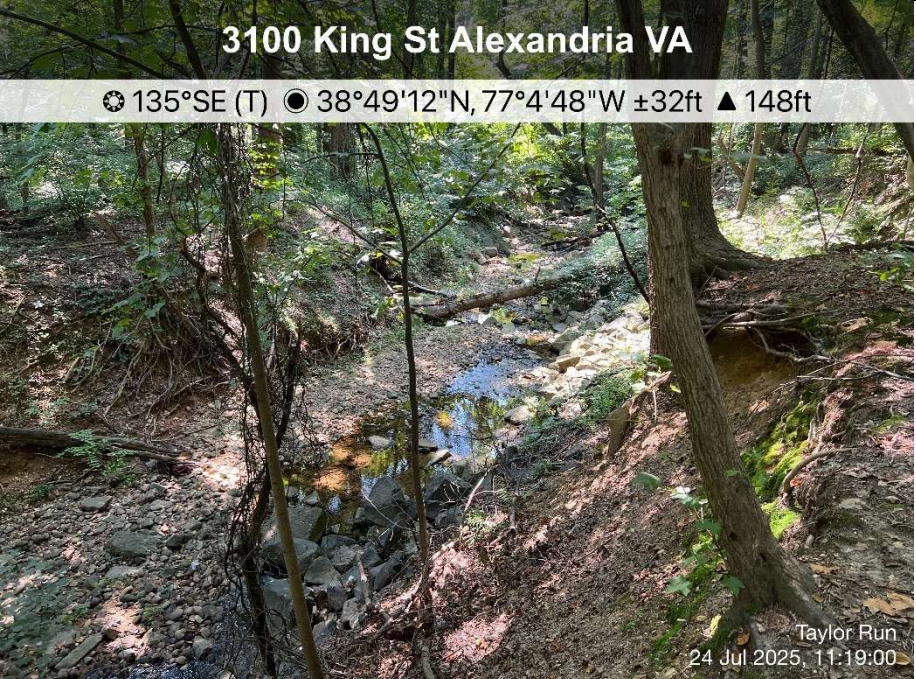
| <b>Photo No.</b><br><b>23</b> | <b>Date:</b><br>07/24/25 | <div>3100 King St Alexandria VA</div> <div>☀ 135°SE (T) ● 38°49'12"N, 77°4'48"W ±32ft ▲ 148ft</div> <div>Taylor Run<br/>24 Jul 2025, 11:19:00</div> | |

| <b>Description:</b><br>Condition of the stream downstream of study extent | | | |

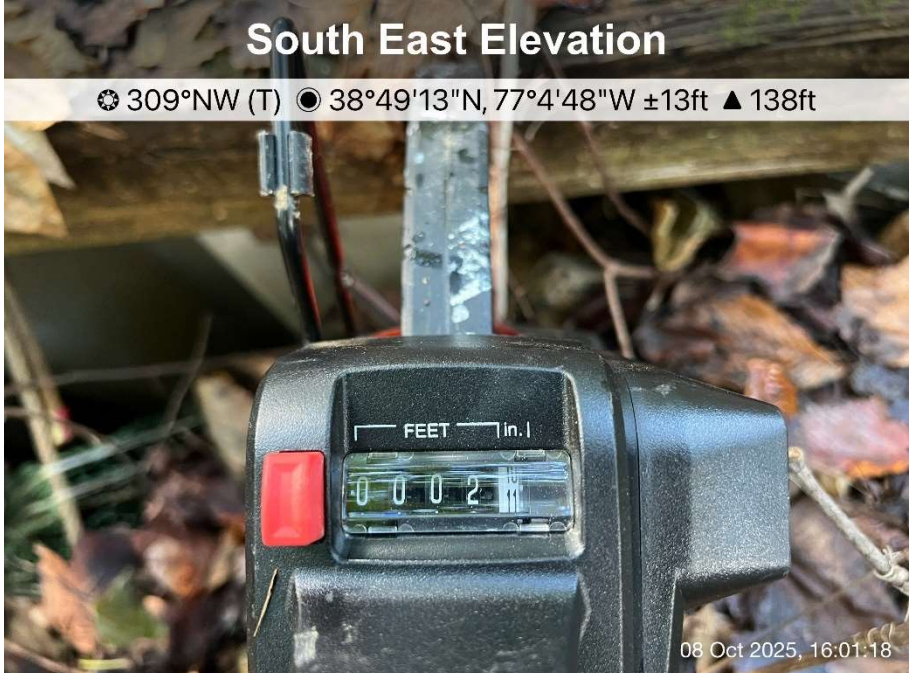
| <b>Photo No.</b><br><b>24</b> | <b>Date:</b><br>10/08/25 | <div>South East Elevation</div> <div>☀ 309°NW (T) ● 38°49'13"N, 77°4'48"W ±13ft ▲ 138ft</div> <div>08 Oct 2025, 16:01:18</div> | |

| <b>Description:</b><br>From center of sanitary manhole it is 2 feet from the sheet pile wall | | | |

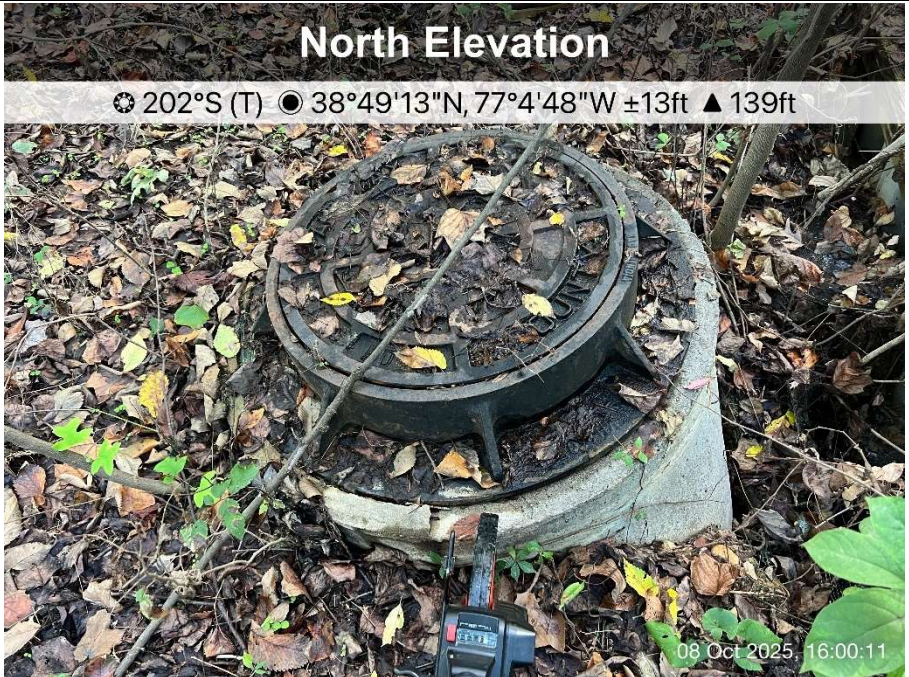
| <b>Photo No.</b><br><b>25</b> | <b>Date:</b><br>10/08/25 | <div><b>North Elevation</b></div> <div>☉ 202°S (T) ☉ 38°49'13"N, 77°4'48"W ±13ft ▲ 139ft</div> <div>08 Oct 2025, 16:00:11</div> |

| <b>Description:</b><br>Outer extent of sanitary sewer manhole is 10 inches from the sheet pile wall | | |

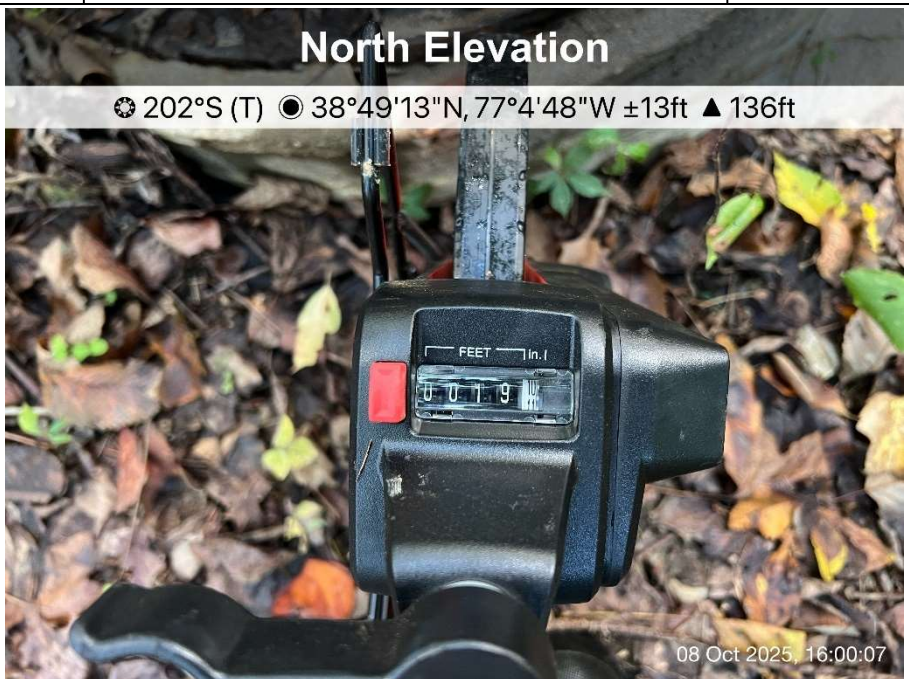
| <b>Photo No.</b><br><b>26</b> | <b>Date:</b><br>10/08/25 | <div><b>North Elevation</b></div> <div>☉ 202°S (T) ☉ 38°49'13"N, 77°4'48"W ±13ft ▲ 136ft</div> <div>08 Oct 2025, 16:00:07</div> |

| <b>Description:</b><br>Sanitary Sewer manhole is 19 feet from the start of the sheet pile wall | | |
