**City of Alexandria's Semi-Annual Report**  
**ATG-Oronoco Site Summary**  
**January 1, 2026 to June 30, 2026**

This Semi-Annual Report summarizes site remedial activities for the former Alexandria Town Gas – Oronoco manufactured gas plant site (ATG-Oronoco) as described in Appendices A, B, and C of the Consent Decree between Potomac Riverkeeper Network and the City of Alexandria, Virginia, as filed January 9, 2024 in the U.S. District Court for the Eastern District of Virginia (Case No. 1:22-cv-00506-CMH-WEF).

October 5, 2026

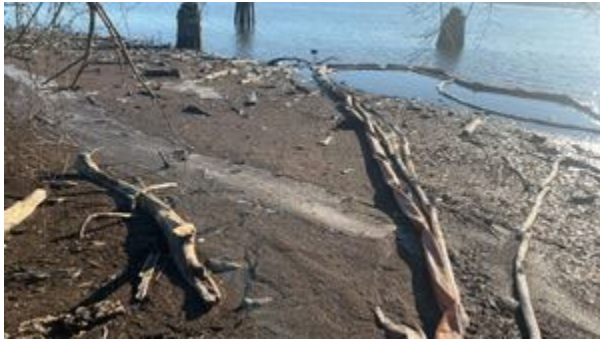
**Outfall Photo #1:**

Repairs needed

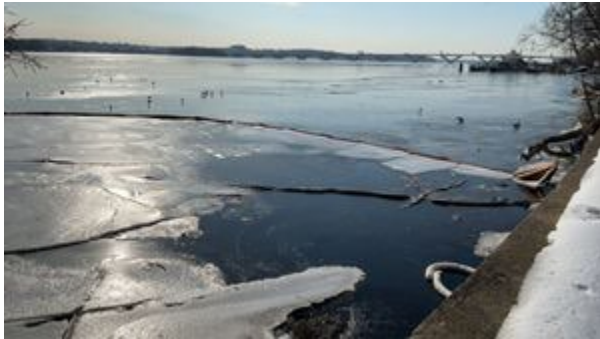
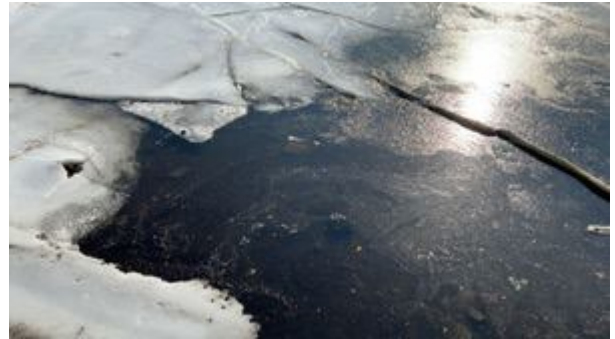
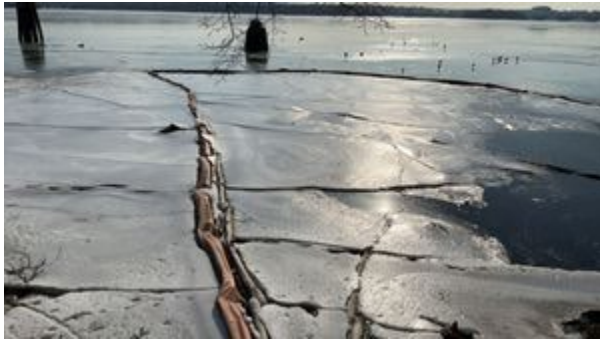
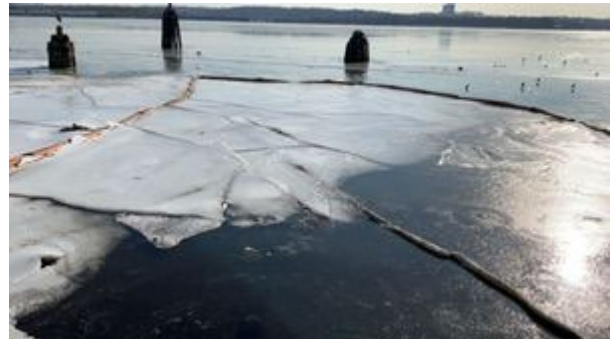
February 10, 2026 10:22 AM

Limited vision with boom due to outfall being iced over. Site observation. Also switched out sweep at MW-93. Did not smell any odor nor saw any staining on used sweep but changed it as a precautionary measure.

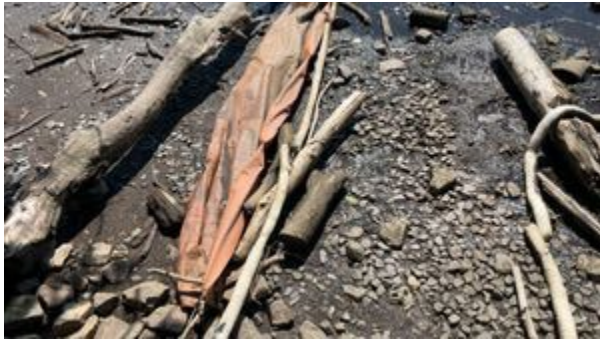
**Outfall Photo #1:**

Replacement needed

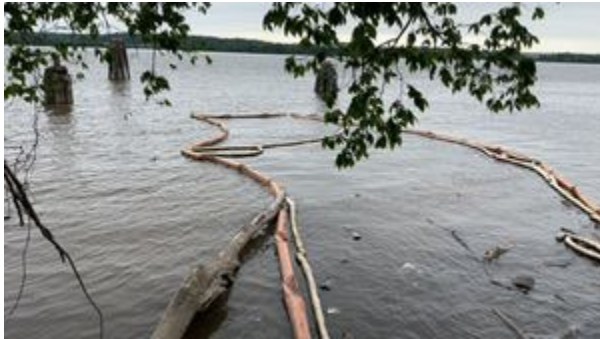
**Outfall Photo #1:**

| <b>Date</b> | <b>Inspect</b> | <b>Repair/<br/>Replace</b> | <b>Comments</b> |
|---|---|---|---|
| 5/21/2026 | X | X | Moderate sheen, contained within booms, all absorbent booms replaced and large storm debris removed |

Replacement needed

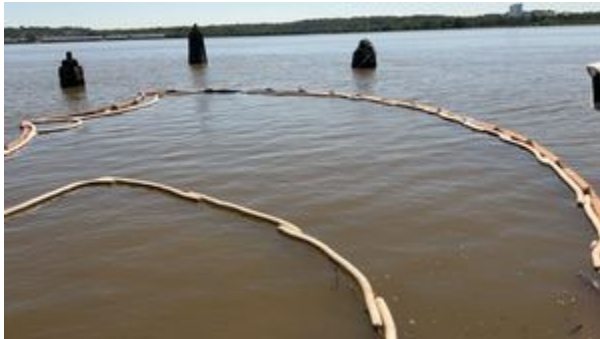
**Outfall Photo #1:**

| Date | Inspect | Repair/<br>Replace | Comments |
|---|---|---|---|
| 5/29/2026 | X | | No sheen observed |
