City of Alexandria's Semi-Annual Report
ATG-Oronoco Site Summary
July 1, 2024 to December 31, 2024

This Semi-Annual Report summarizes site remedial activities for the former Alexandria Town Gas – Oronoco manufactured gas plant site (ATG-Oronoco) as described in Appendices A, B, and C of the Consent Decree between Potomac Riverkeeper Network and the City of Alexandria, Virginia, as filed January 9, 2024 in the U.S. District Court for the Eastern District of Virginia (Case No. 1:22-cv-00506-CMH-WEF).

March 1, 2025

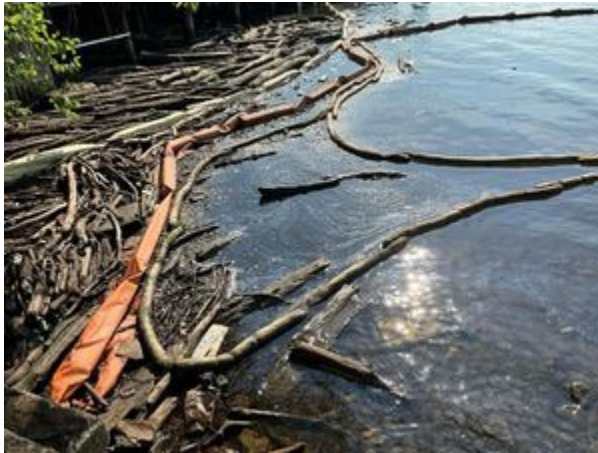
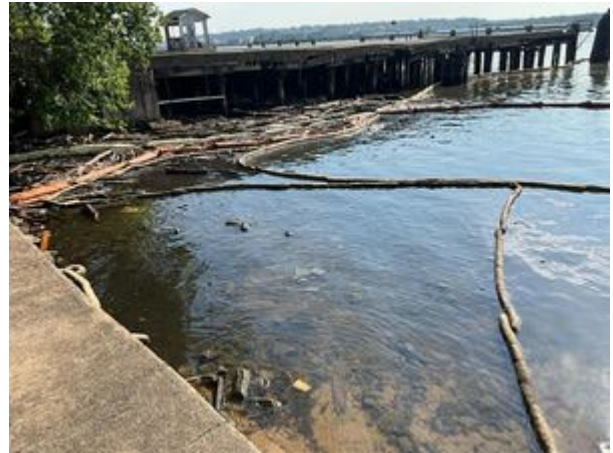
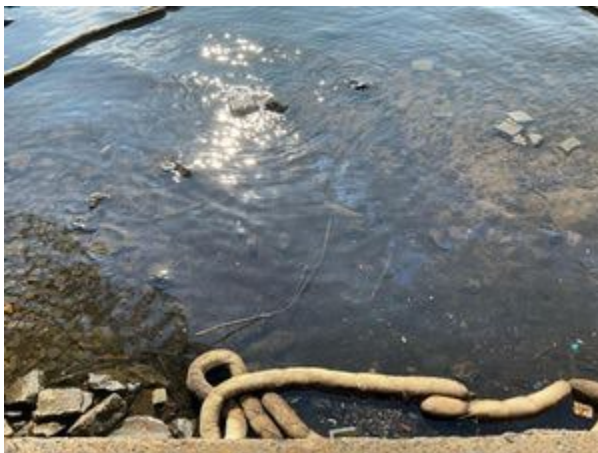
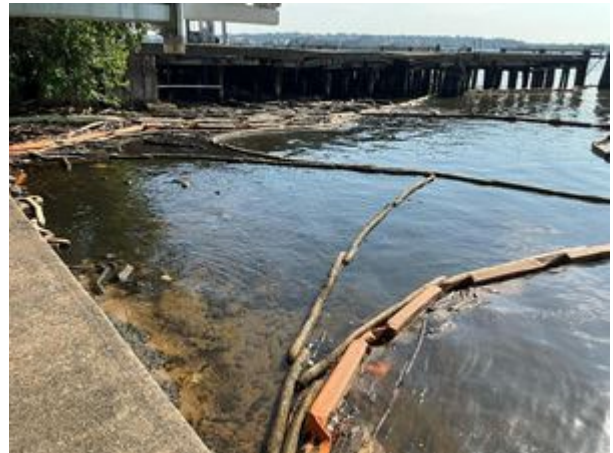
July 17, 2024 8:16 AM

Replace soft boom soon.

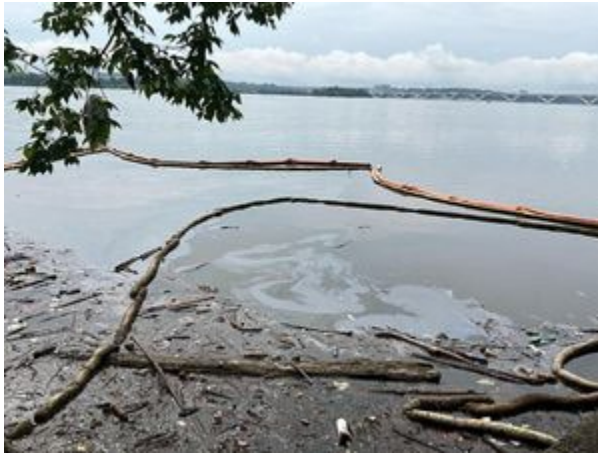
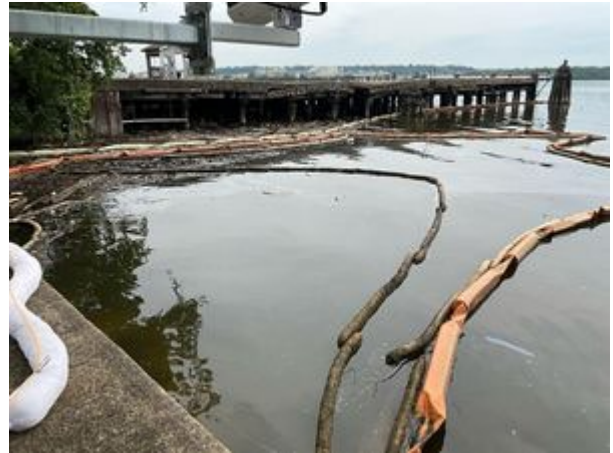
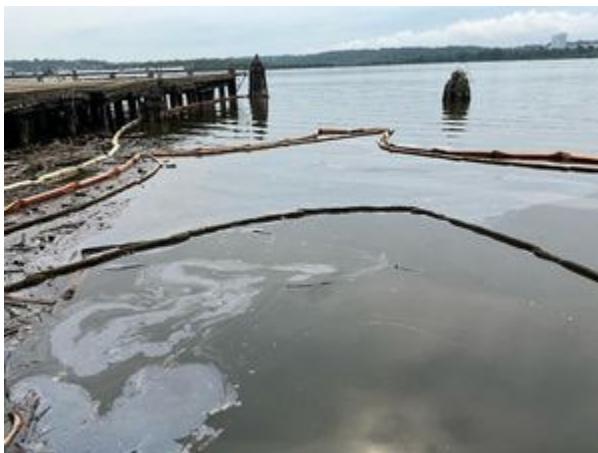
July 25, 2024 9:00 AM

Went to install new boom but that purchase from vendor was defective when Inner boom was installed. No further installment of boom was done due to defective boom. Boom installment will be rescheduled asap.

| Date | Inspect | Repair/ Replace | Comments |
|---|---|---|---|
| 7/25/2024 | X | X | Moderate sheen, partial boom replacement |

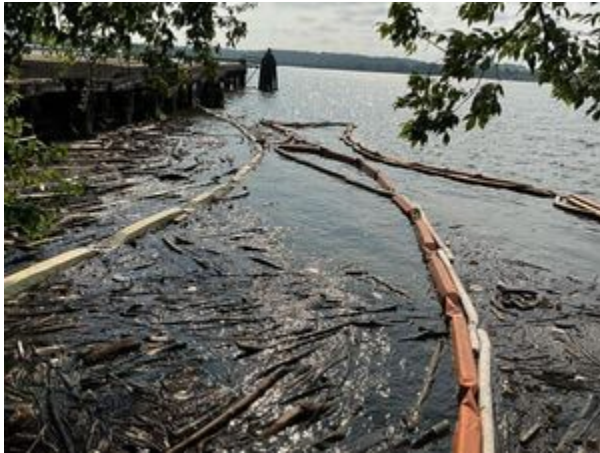
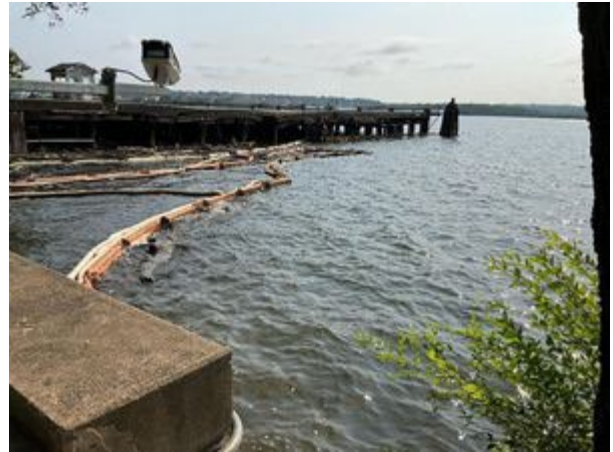
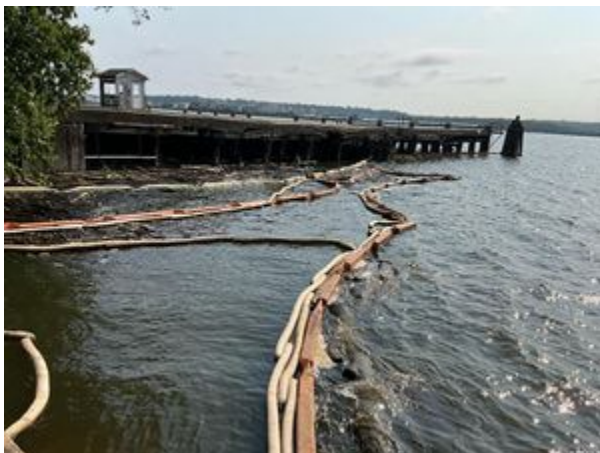
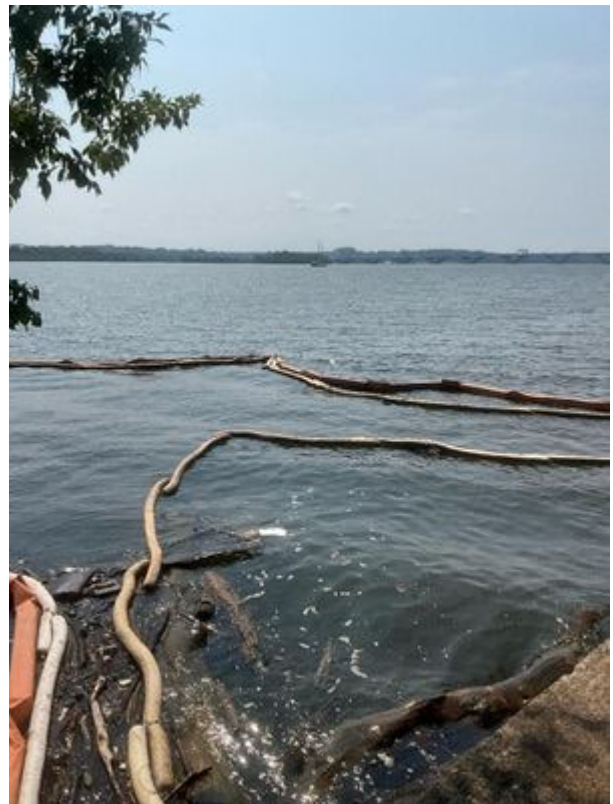
August 6, 2024 8:40 AM

Crew will do repairs to outer boom.

| Date | Inspect | Repair/ Replace | Comments |
|---|---|---|---|
| 8/6/2024 | X | X | No sheen, outer boom re-anchored, absorbent boom replaced |

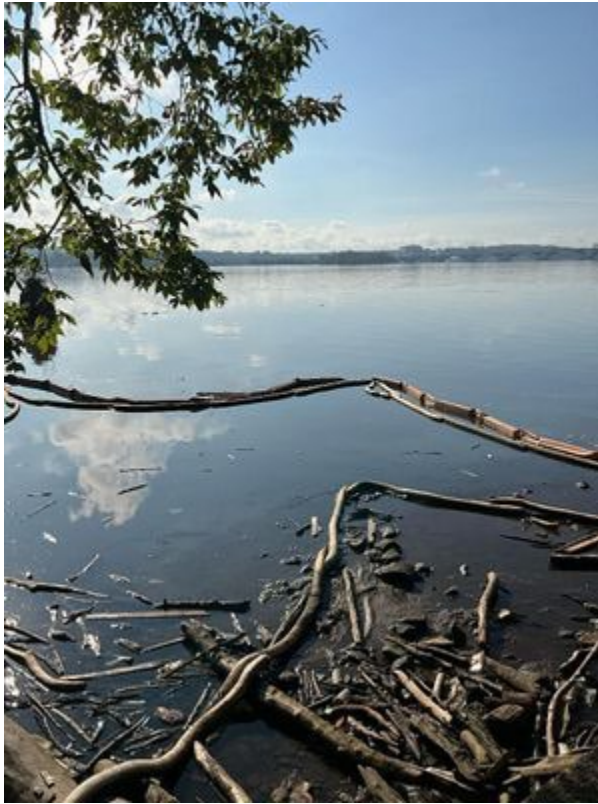
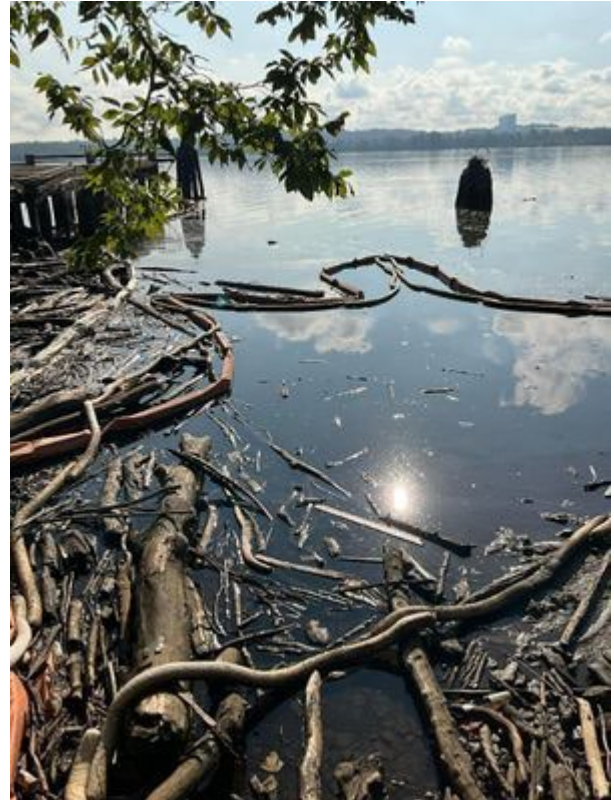
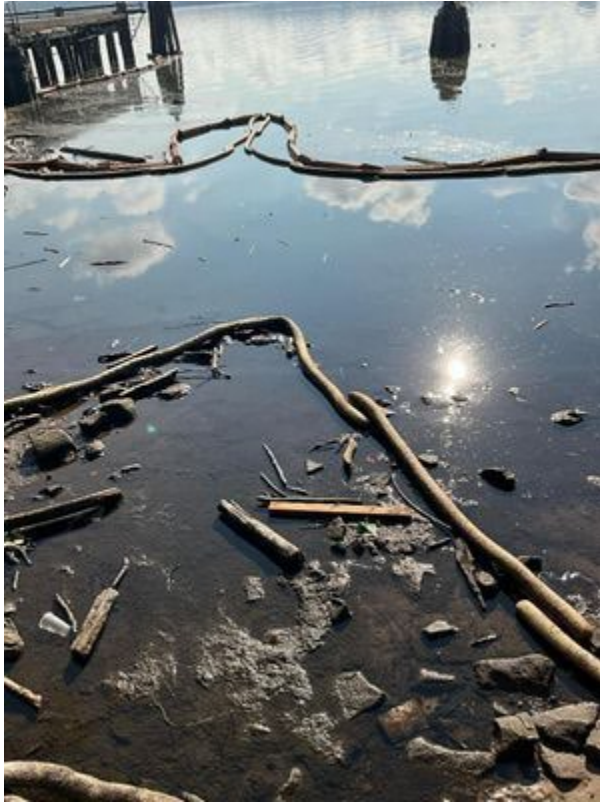
September 12, 2024 8:14 AM

Will need to replace boom soon. Both inner and outer.

| Date | Inspect | Repair/ Replace | Comments |
|---|---|---|---|
| 9/12/2024 | X | X | Spotty sheen (minor), replaced sweep in manholes 92 and 93 |

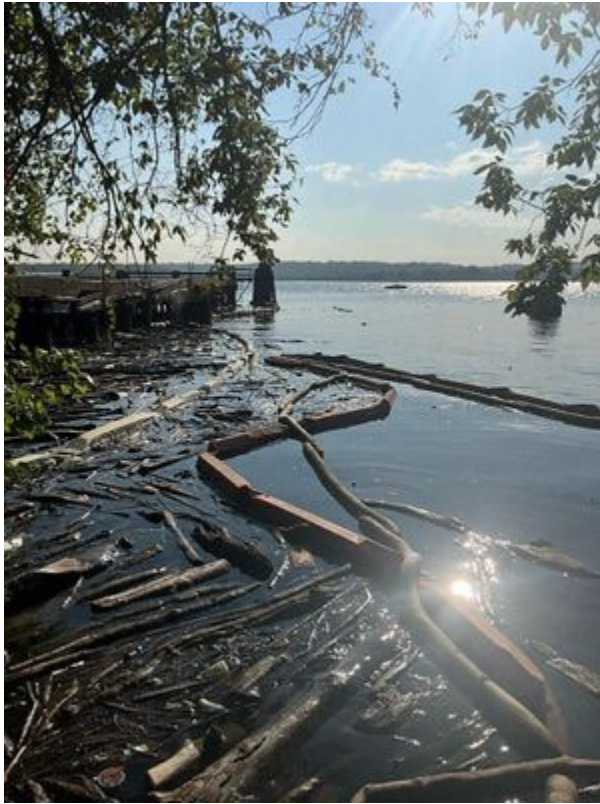
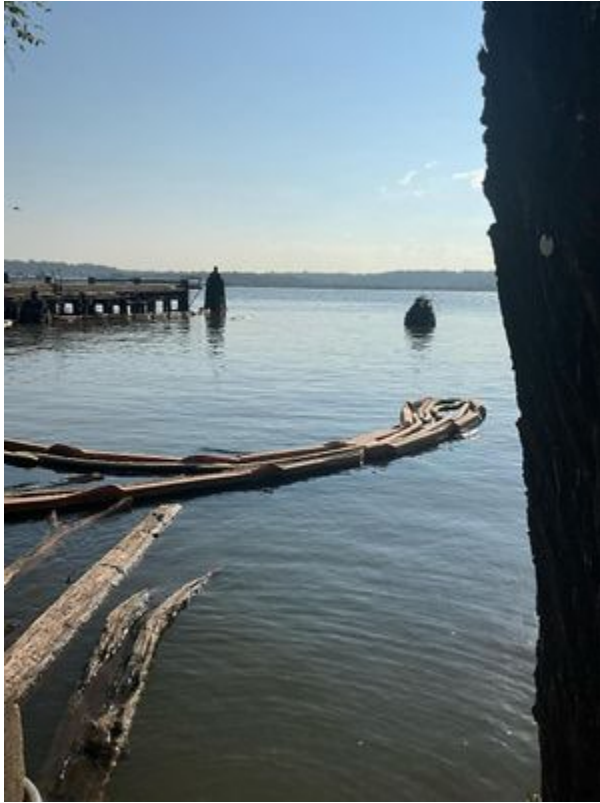
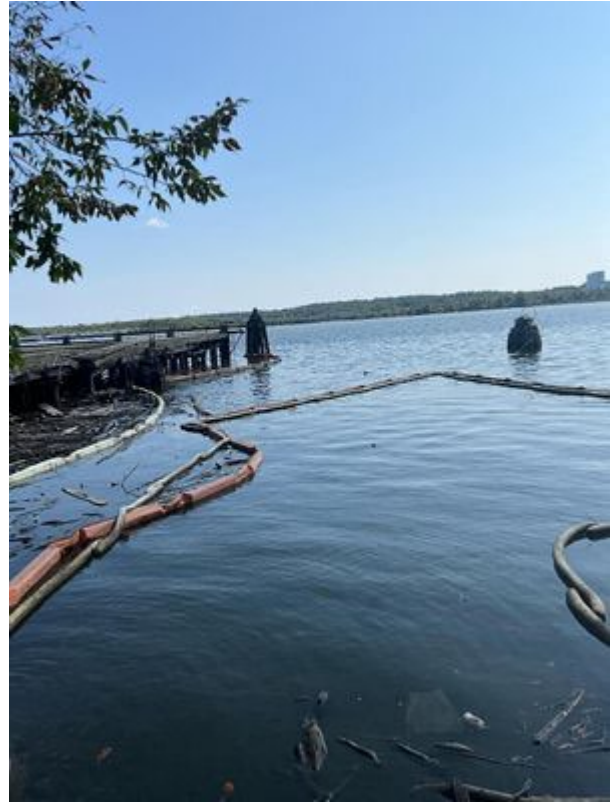
September 20, 2024 8:00 AM

Did repair on hard curtain.

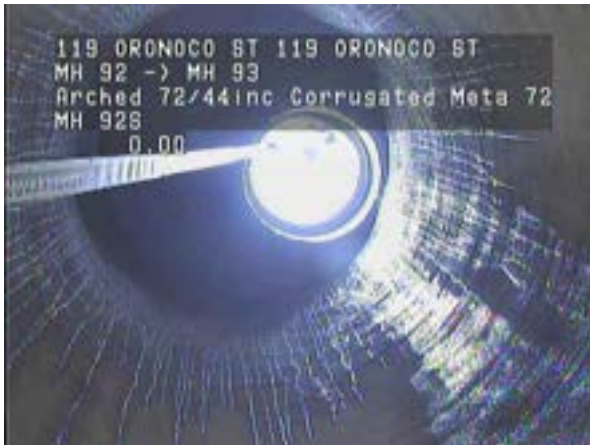
MH
92S_72729cb0-a640-4e53-90c0-1743c39029c5_20241217_1
50639_001.jpg, 00:00:00, 0.00ft
Manhole / MH 92

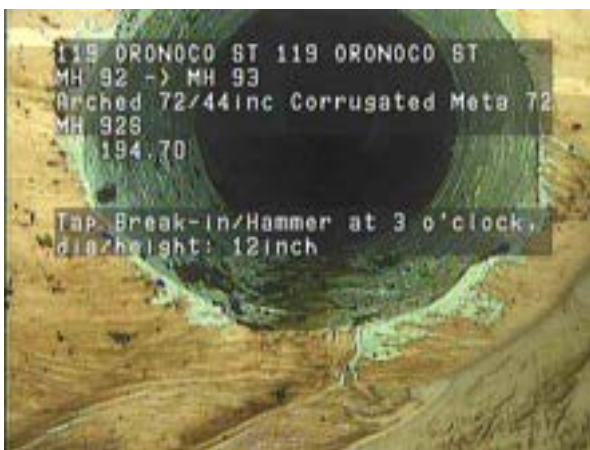
MH
92S_c02d2b53-7e83-4915-8b29-dfc666e74a32_20241217_15
1620_348.jpg, 00:09:00, 194.70ft
Tap Break-in/Hammer at 3 o'clock, dia/height: 12inch

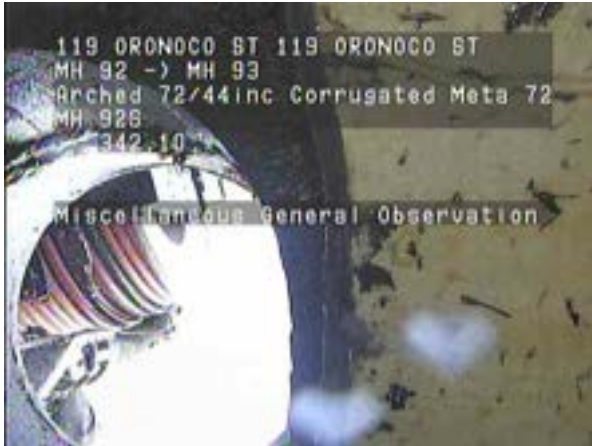
MH
92S_0c5f5bdb-d9d8-44ff-85b3-bc40fab2d1bb_20241217_152
416_249.jpg, 00:16:28, 342.10ft
Miscellaneous General Observation / AEP

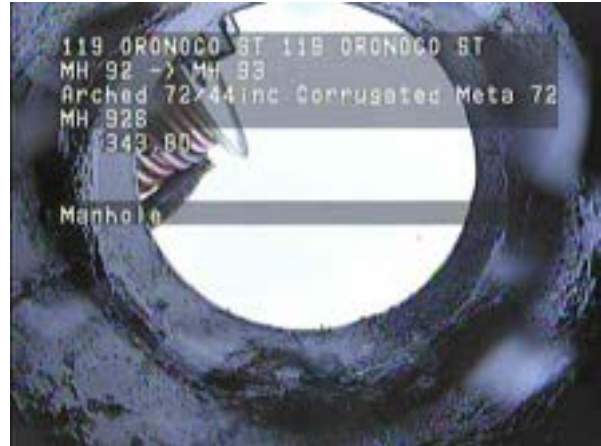
MH
92S_1db21938-dc0f-4716-a16c-9695e7ac3009_20241217_15
2428_101.jpg, 00:16:38, 343.80ft
Manhole / MH 93

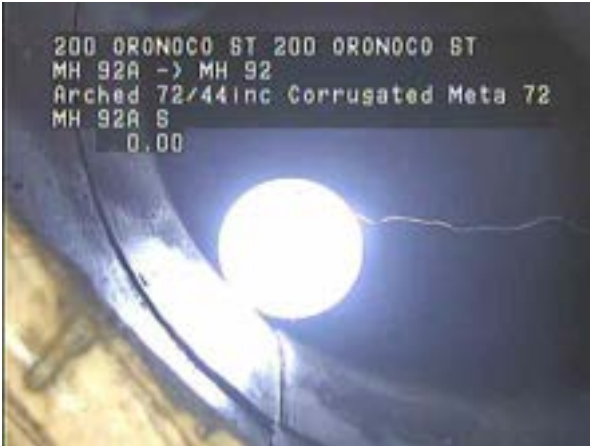
MH 92A
S_8cd28417-d2fb-445a-90b6-560c1da47ee2_20241217_1311
16_835.jpg, 00:00:00, 0.00ft
Manhole / MH 92A

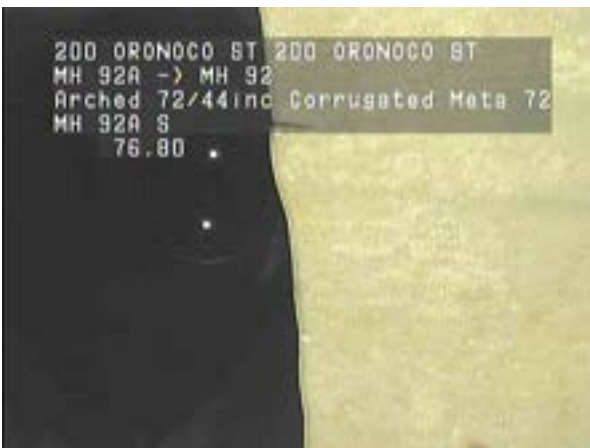
MH 92A
S_071cab8b-8870-44a9-900b-d8acf657cc20_20241217_1503
12_896.jpg, 00:09:12, 76.80ft
Miscellaneous General Observation / AEP

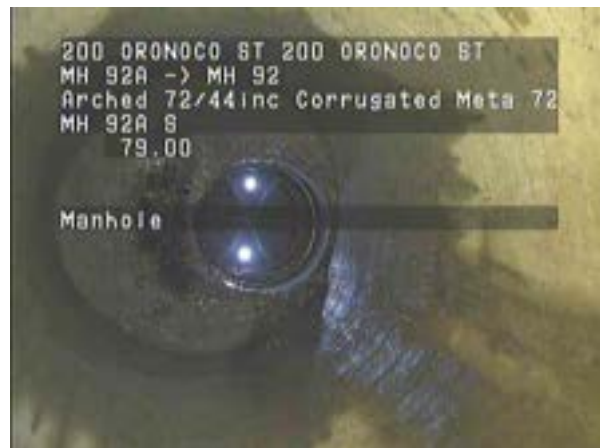
MH 92A
S_17afb2dd-e2df-4c3d-a063-f4c8d0588fc7_20241217_13353
0_225.jpg, 00:09:21, 78.90ft
Manhole / MH 92

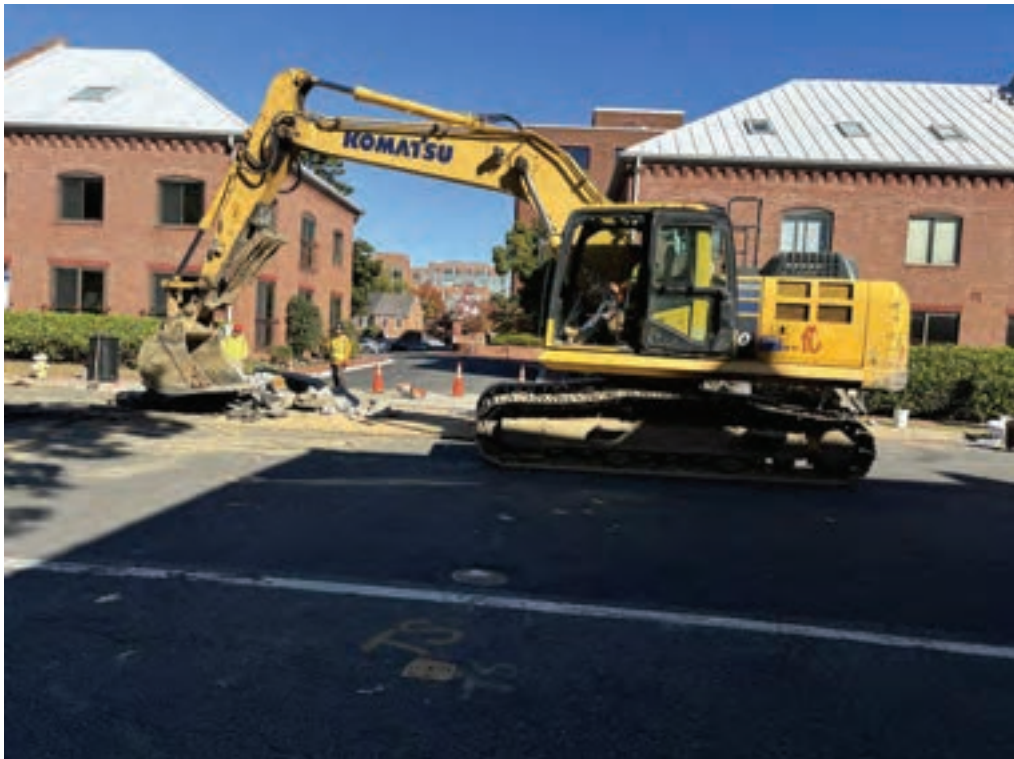
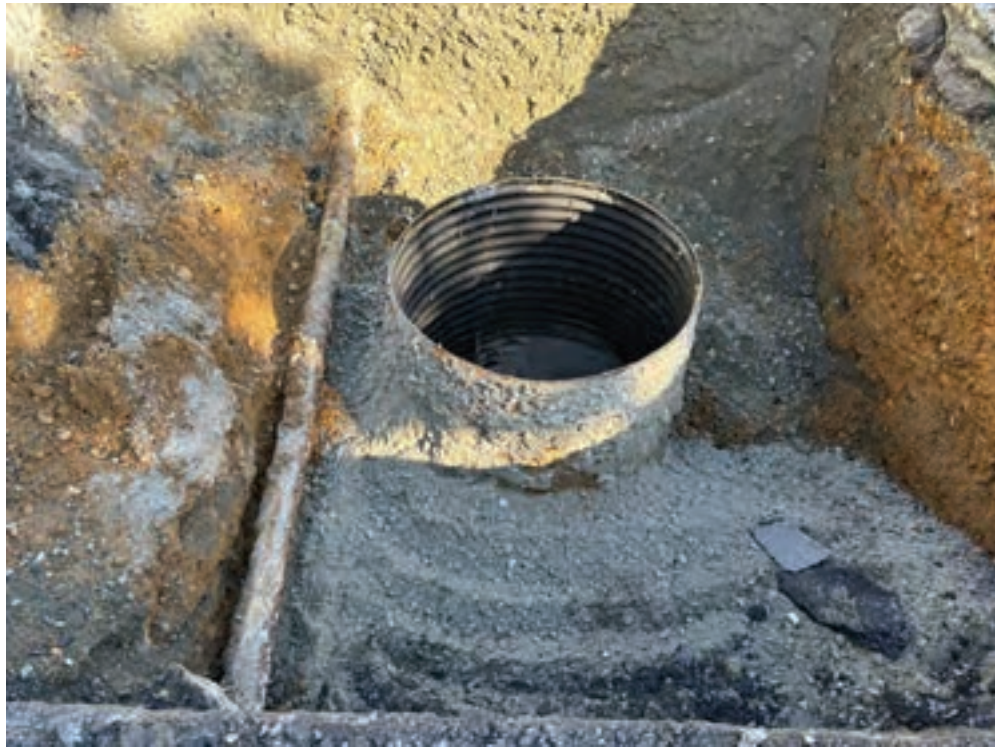
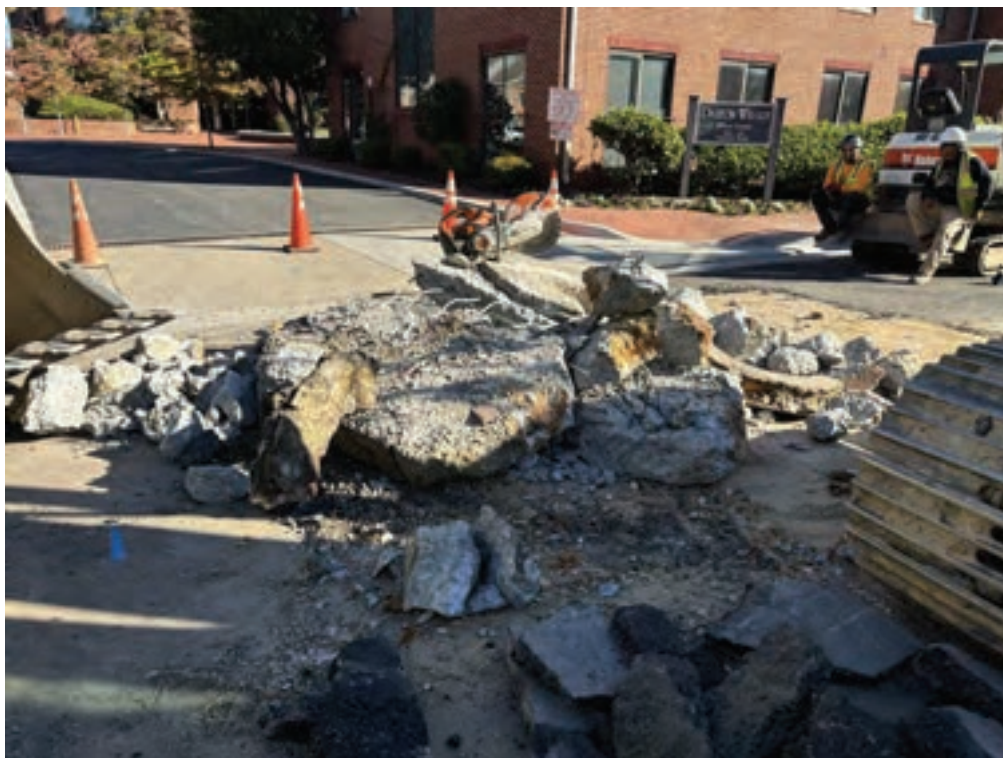
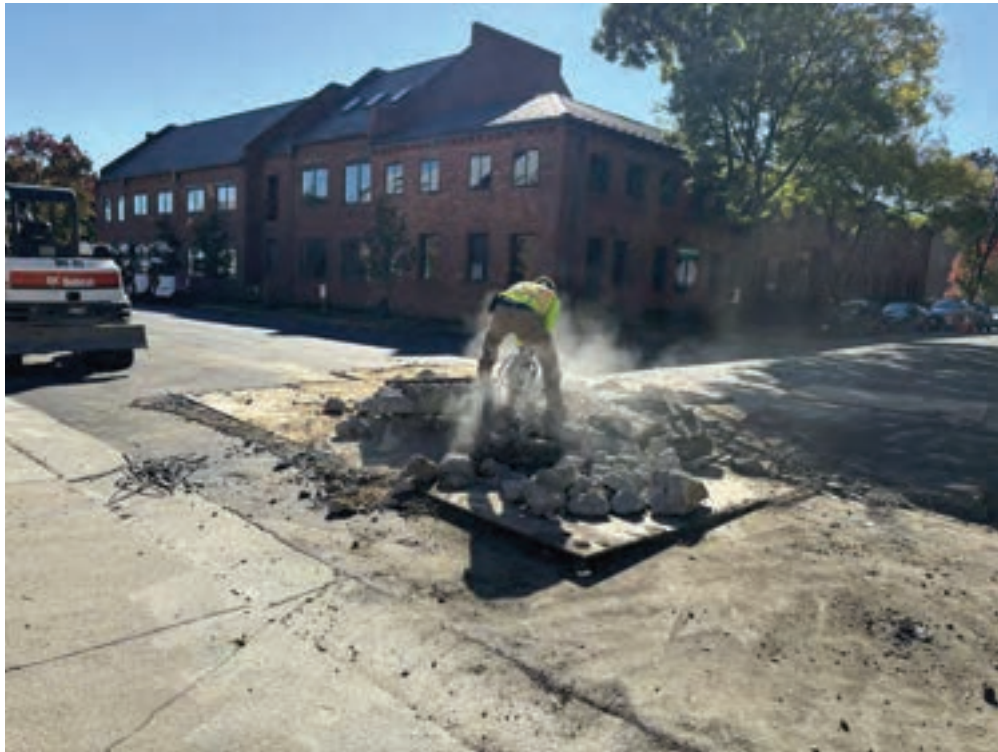
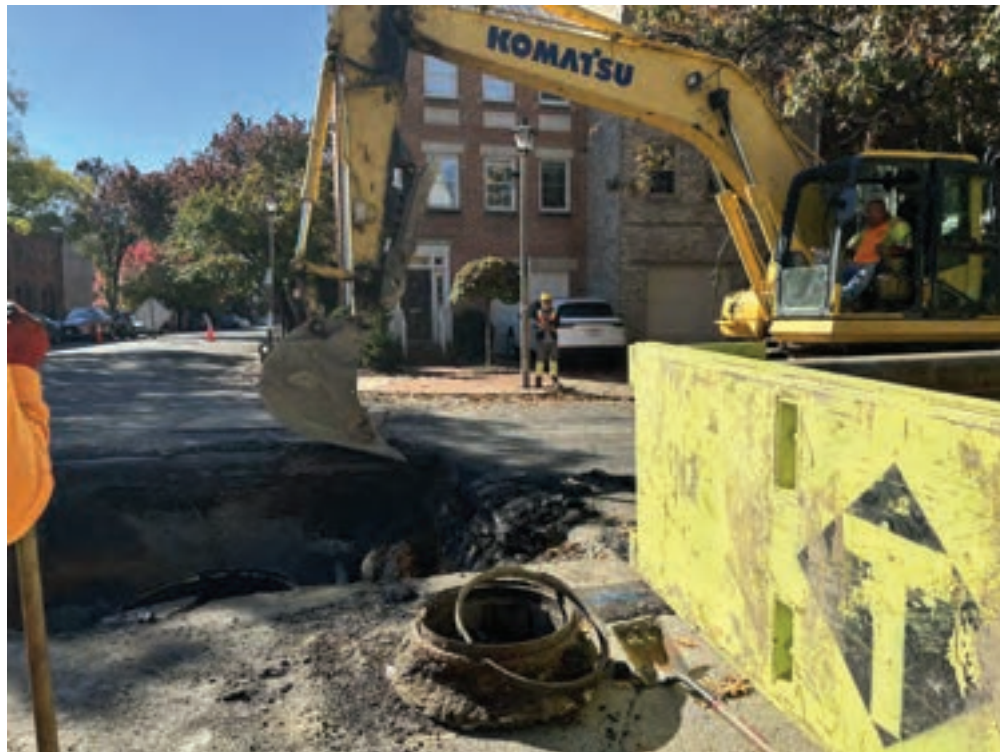
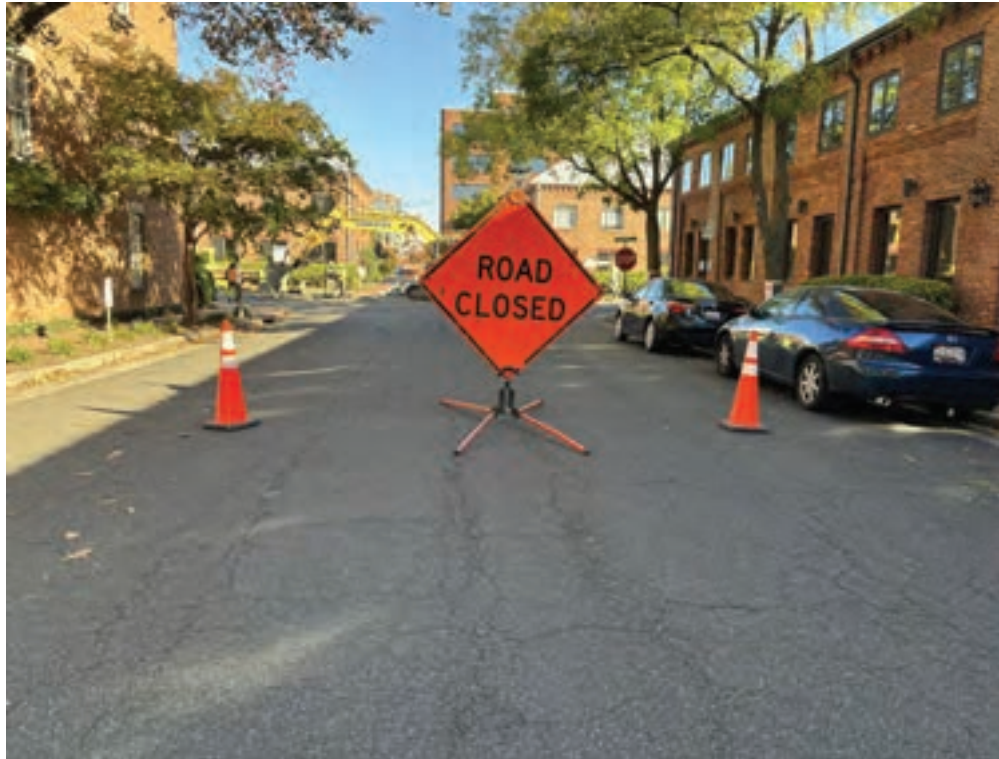
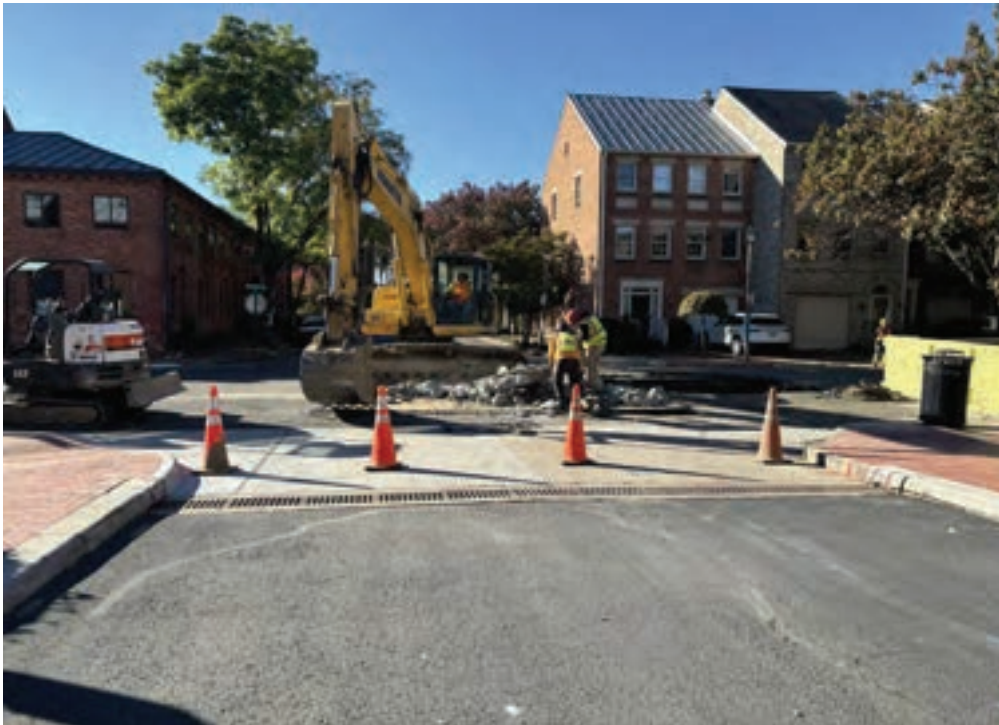
INSPECTION ACTIVITY: Remove and Replace storm water manhole MH92A for CIPP lining access.

NOTE: Due to unknown utility found during excavation, Triangle needed to verify pipe owner and the active status. If pipe is active it will need to be rerouted to allow work to be completed. If abandoned the utility owner or contractor (if permitted) will remove the pipe. Utility locator could not verify asset and it wasn't in their records. Washington Gas was on site to verify that this asset was not theirs. Dominion Energy was to be contacted to verify ownership but waiting to hear back.

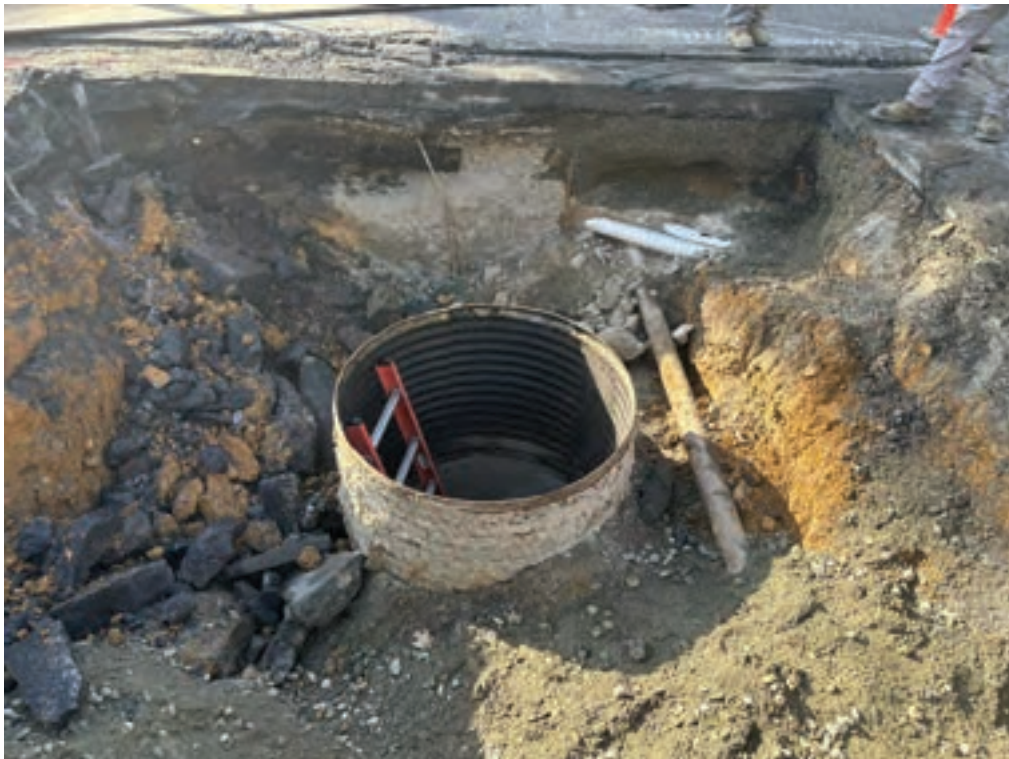
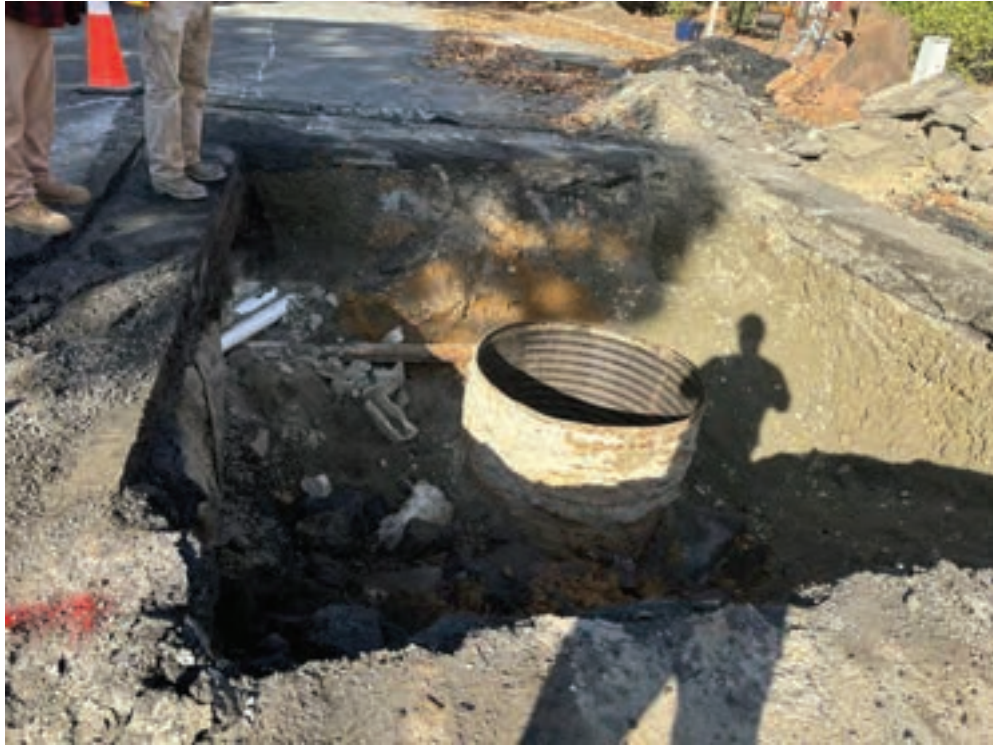
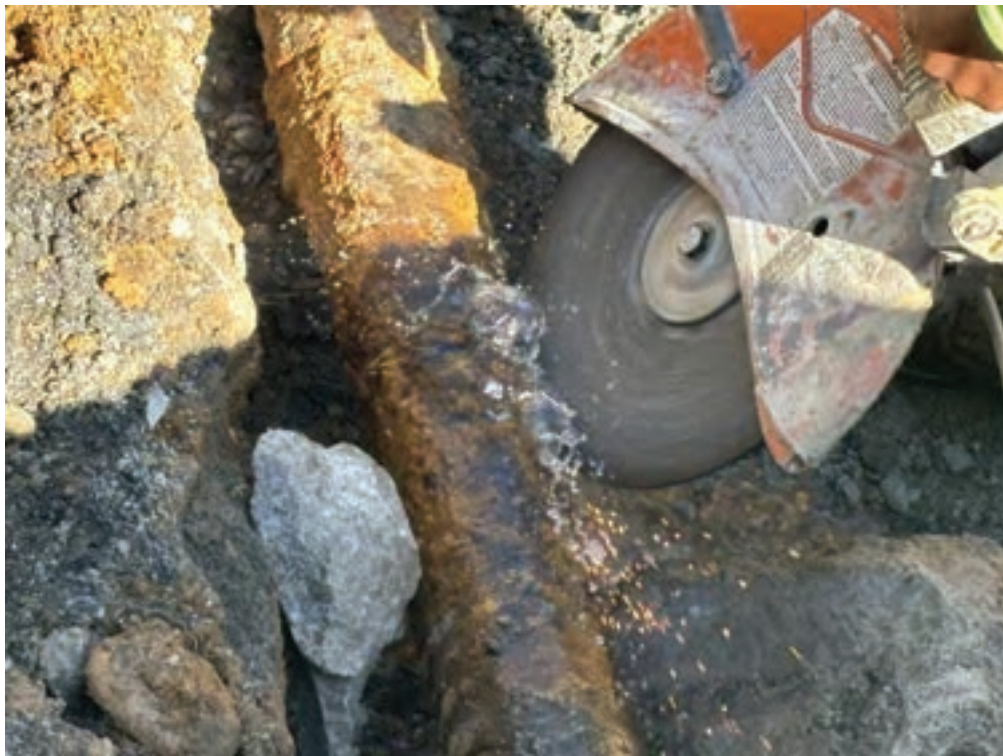
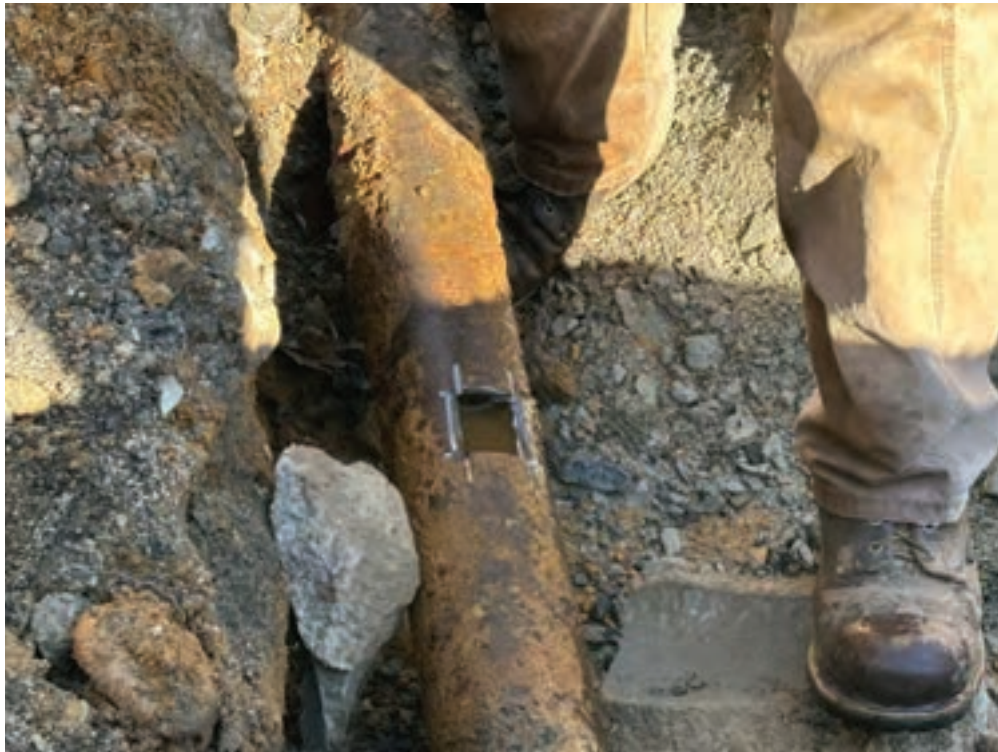
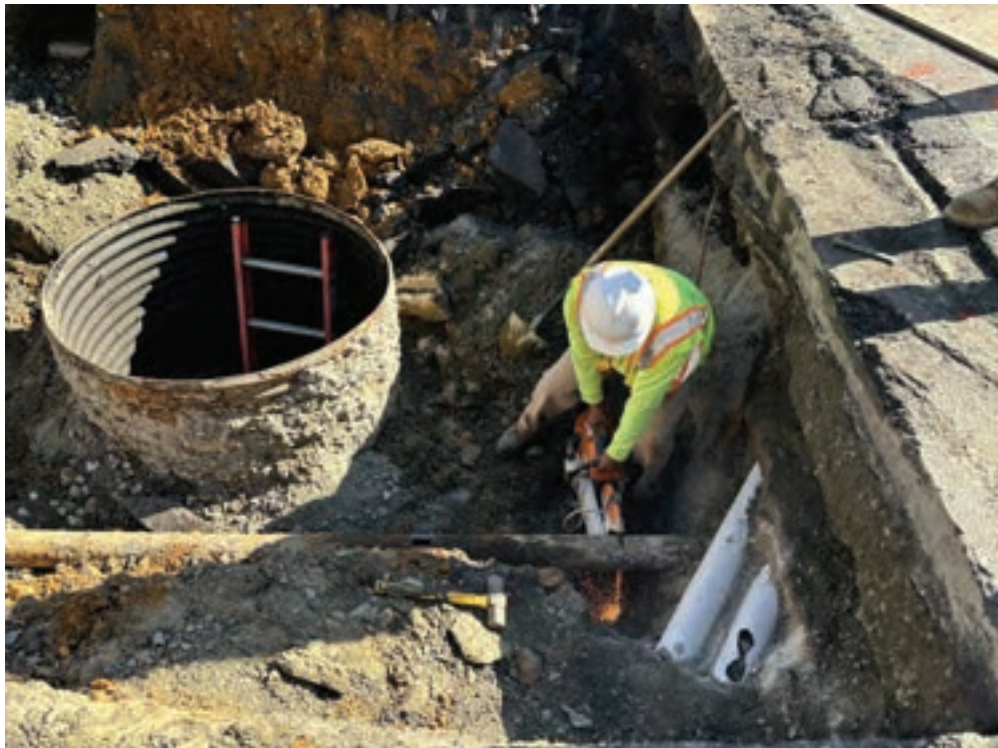
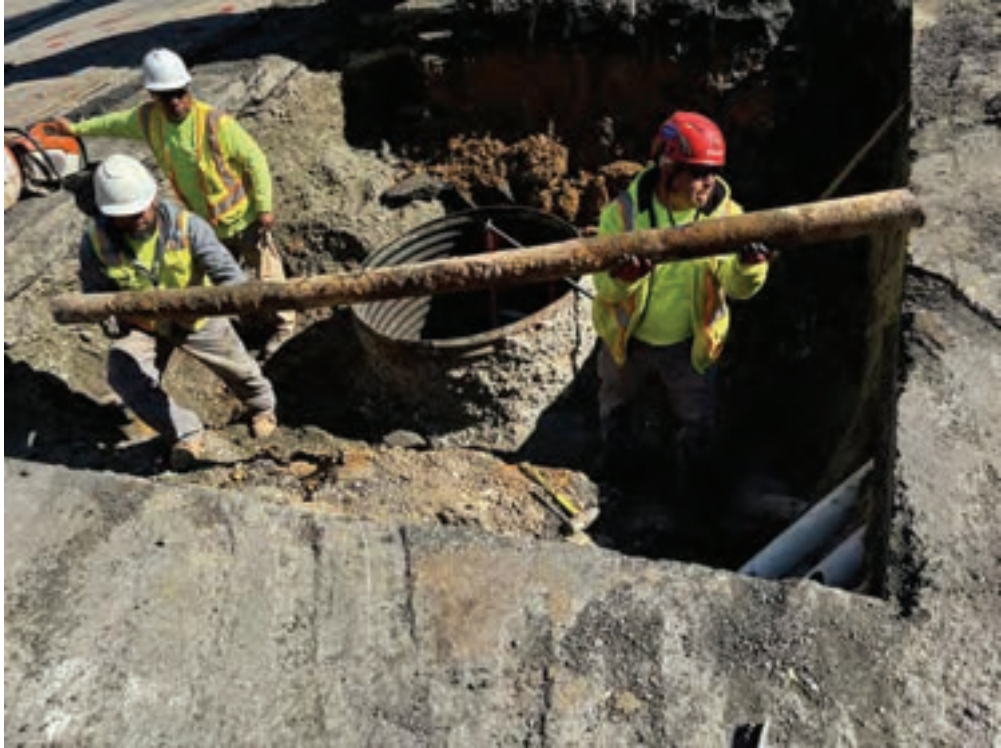
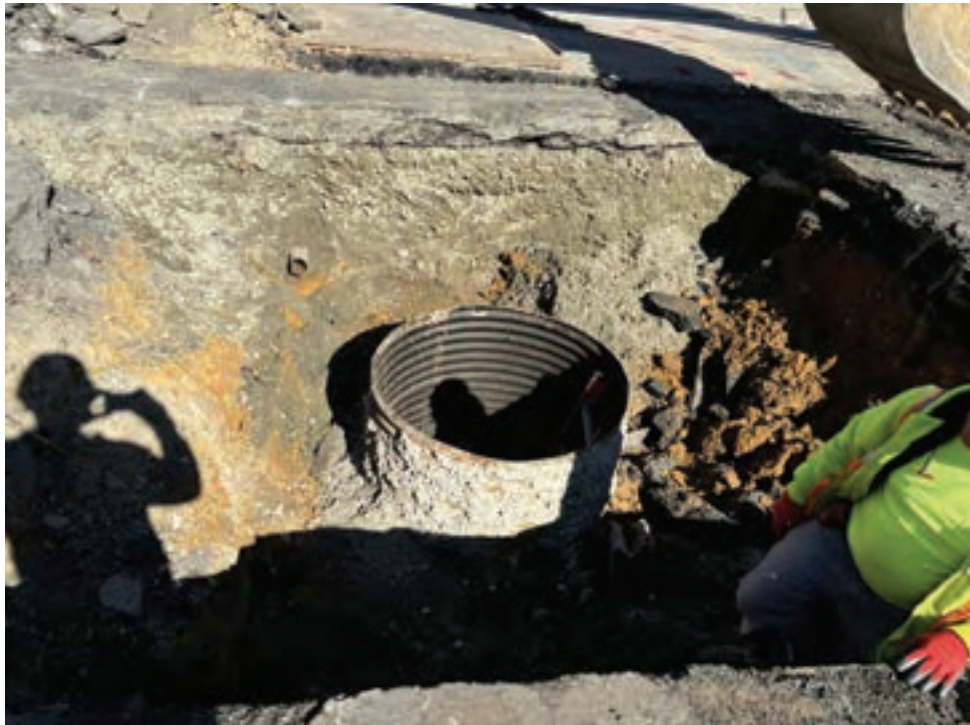
Unused Verizon conduit was uncovered and slightly damaged (Utility locator did not previously find this Verizon conduit).

ISSUES: During the further excavation, an unused PVC Verizon conduit was damaged but will be repaired.

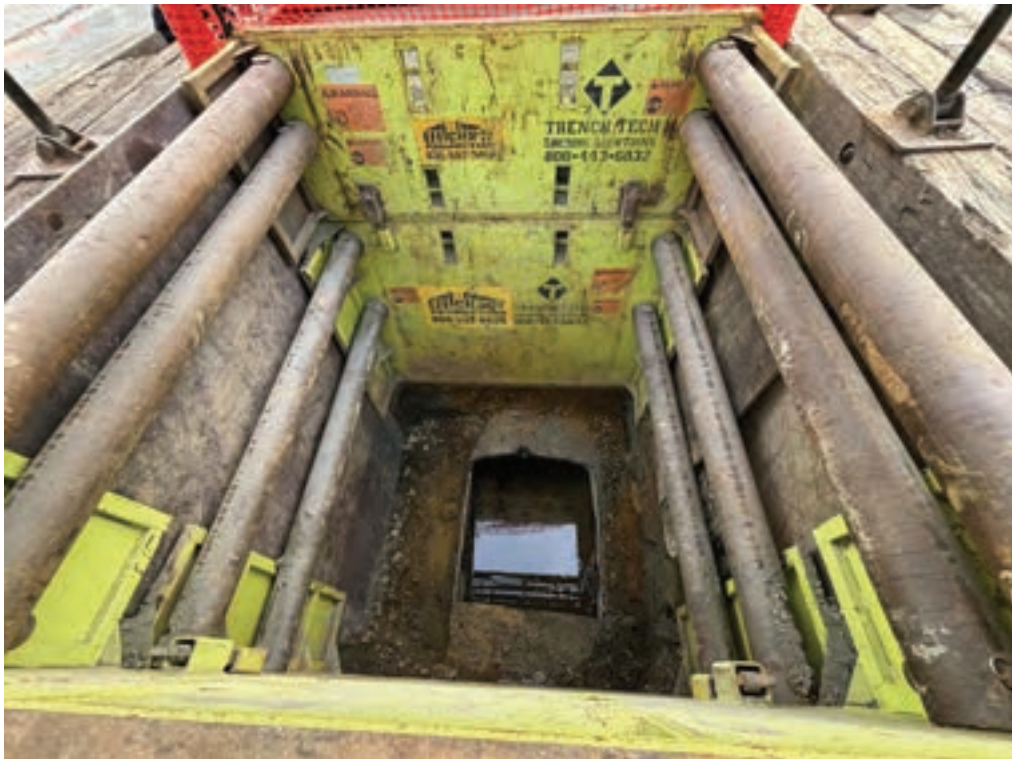
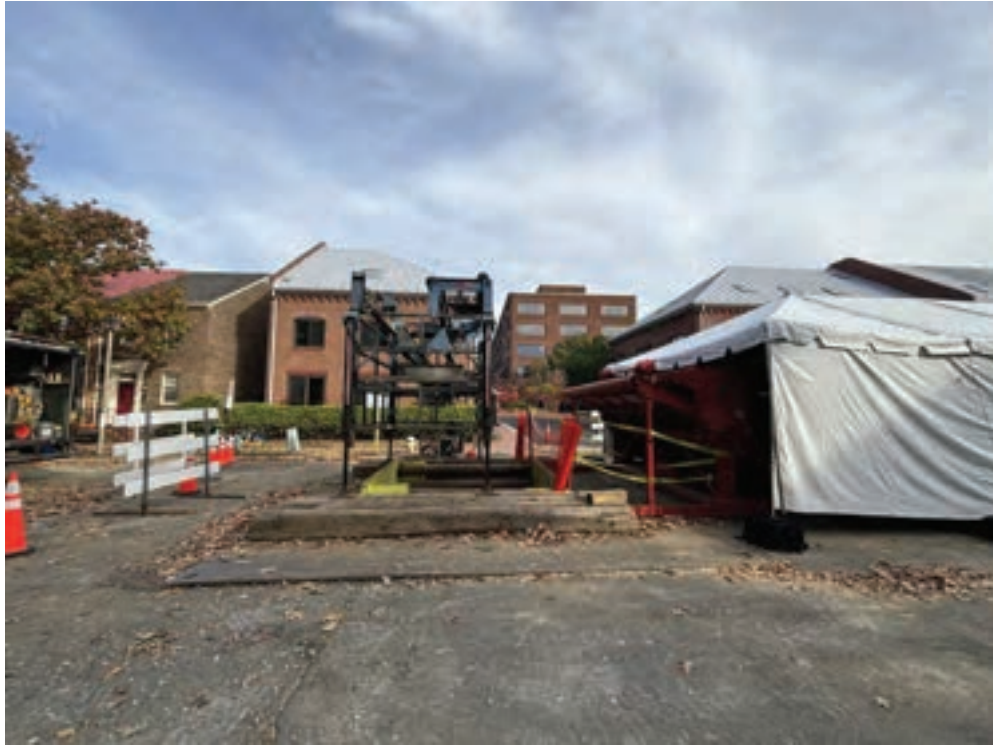
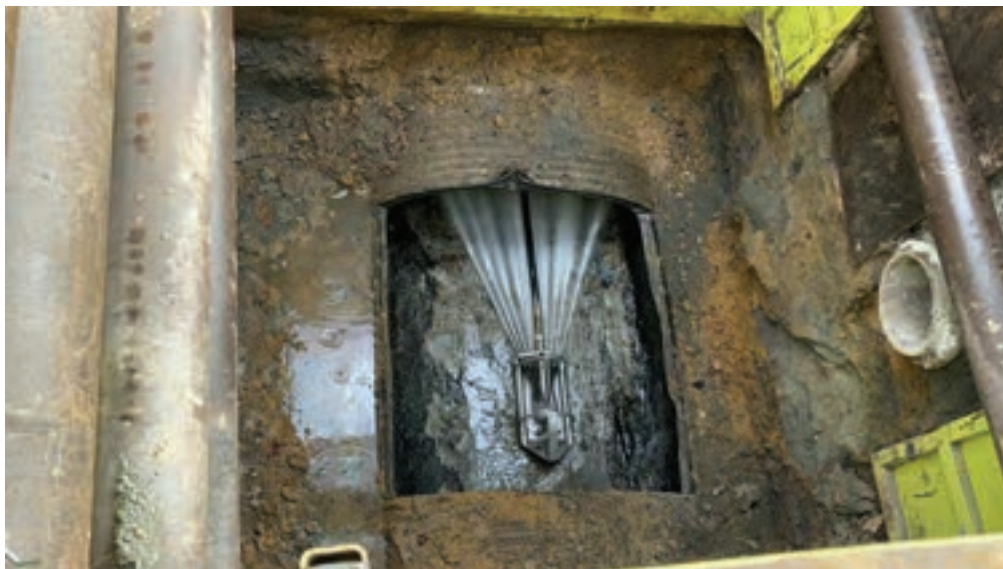
NOTE: Triangle Contracting attempted to seal the leak at the cofferdam. Leak was from water entering through the dry stacked stone at the base of outfall. MDVP cleaned and performed CCTV for the upstream pipes. The outfall pipe could not be cleaned or CCTV'd until low tide. AM Liner completed water sampling at the outfall during the pipe cleaning.

Cofferdam repair and reseal.
