City of Alexandria's Semi-Annual Report
ATG-Oronoco Site Summary
July 1, 2024 to December 31, 2024

This Semi-Annual Report summarizes site remedial activities for the former Alexandria Town Gas – Oronoco manufactured gas plant site (ATG-Oronoco) as described in Appendices A, B, and C of the Consent Decree between Potomac Riverkeeper Network and the City of Alexandria, Virginia, as filed January 9, 2024 in the U.S. District Court for the Eastern District of Virginia (Case No. 1:22-cv-00506-CMH-WEF).

March 1, 2025

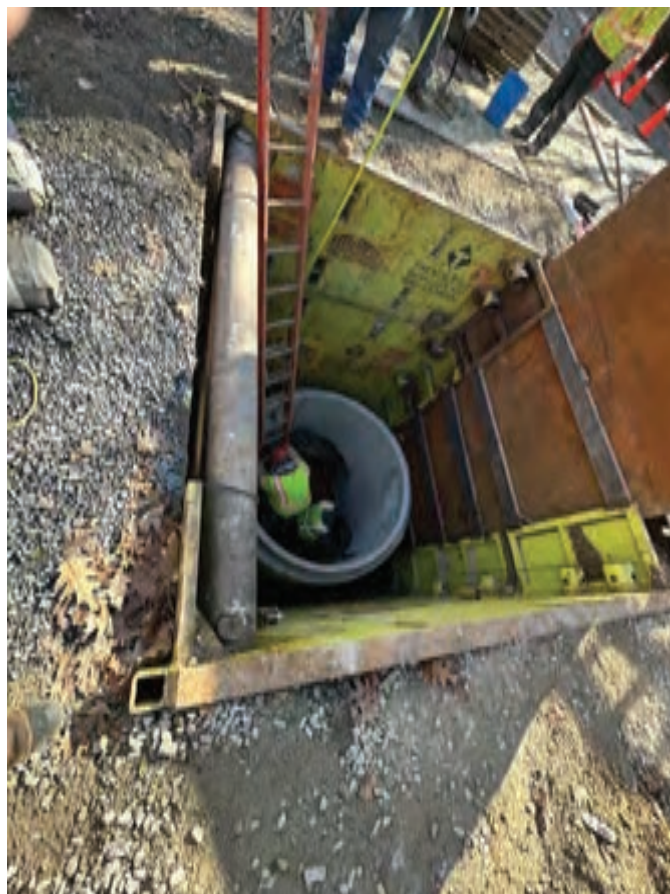
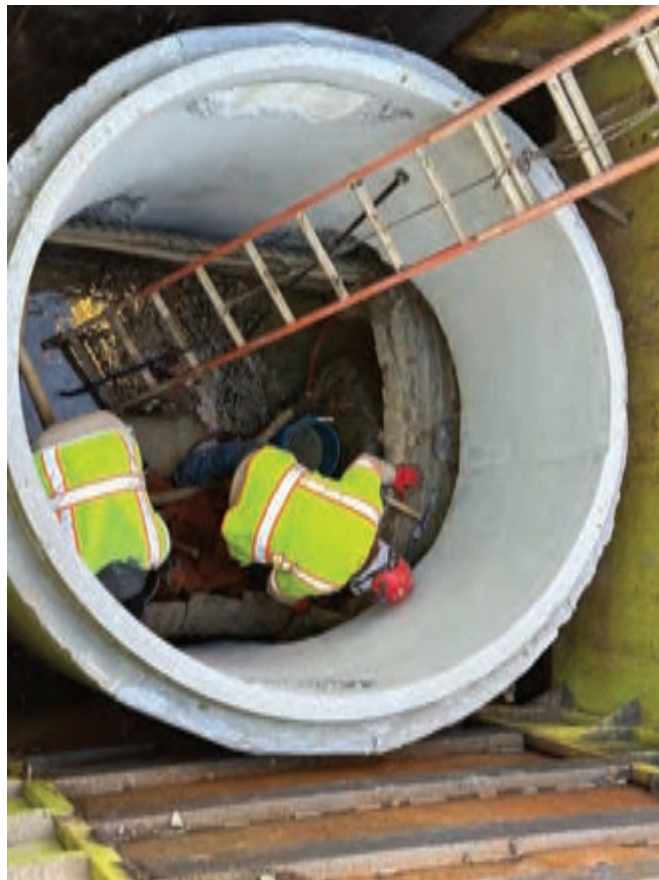
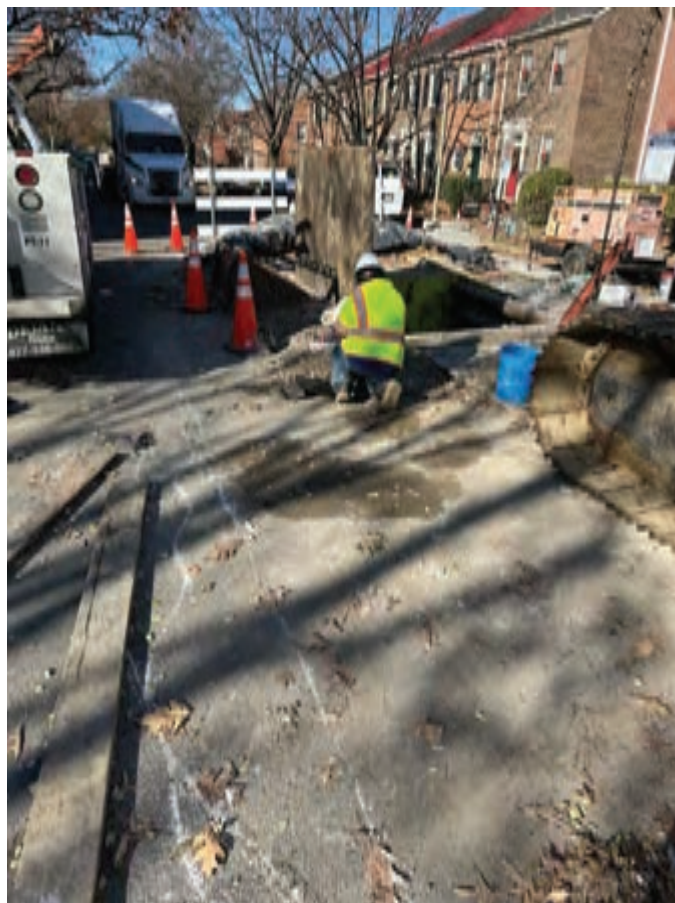
- Triangle Contracting will be installing the Manhole today,
- The sides of the manhole was cut in order to fit over the pipe l.
- Triangle Contracting will be building a stable base around the manhole to ensure a solid foundation for the manhole cover and frame. ensuring proper support and preventing any potential settling or movement of the structure.

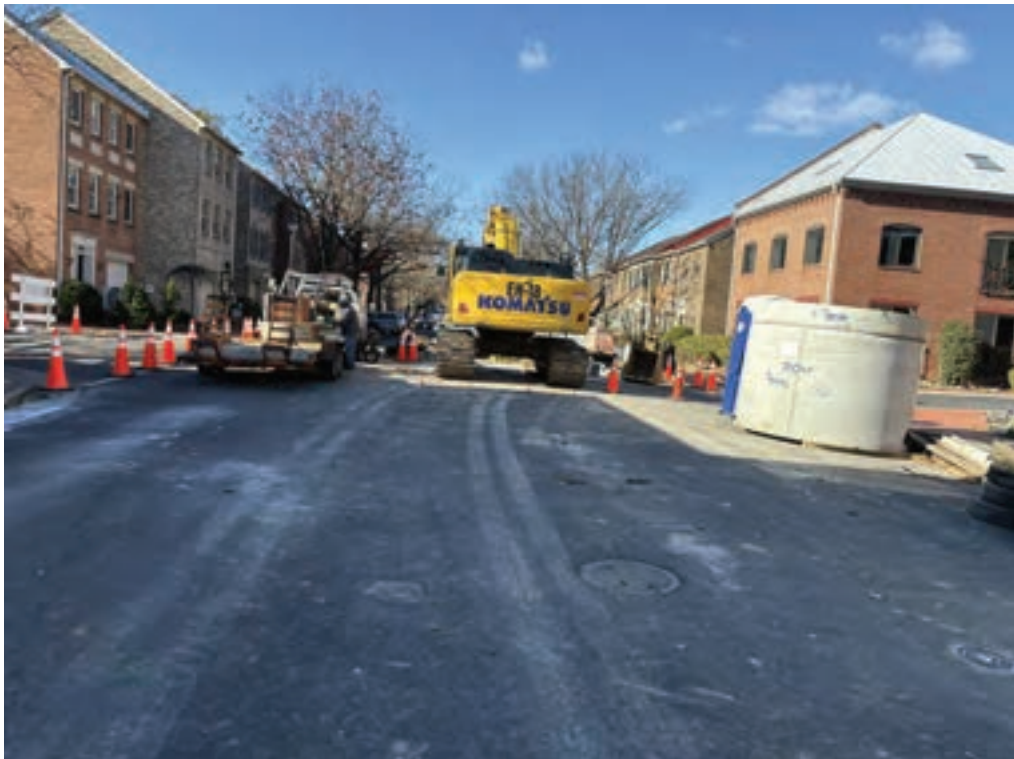
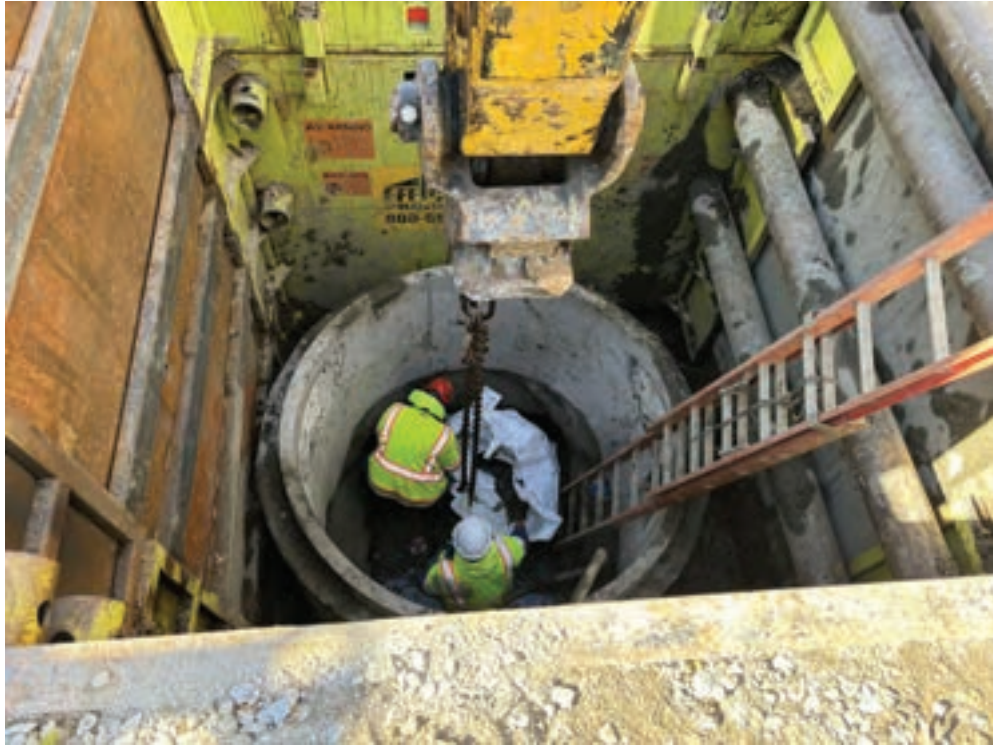
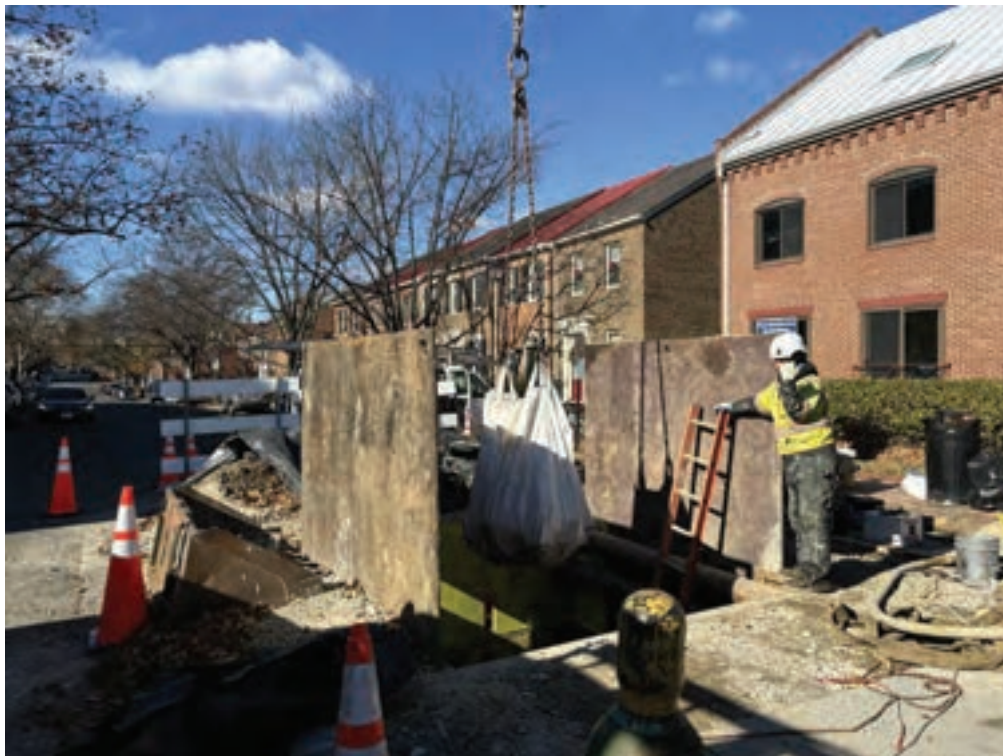
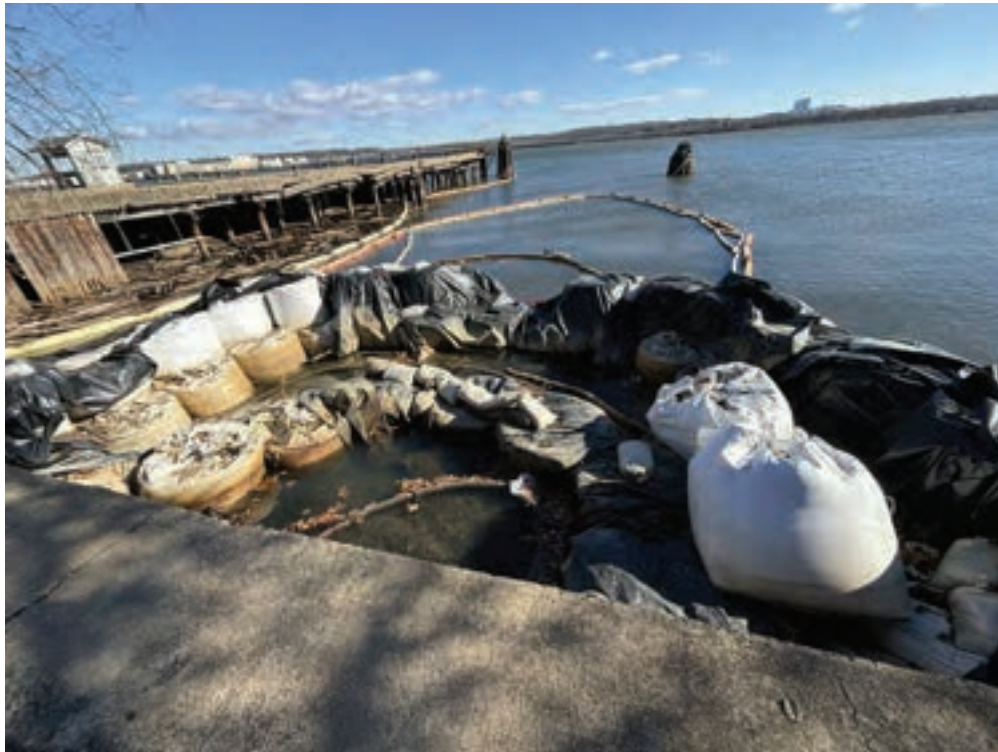
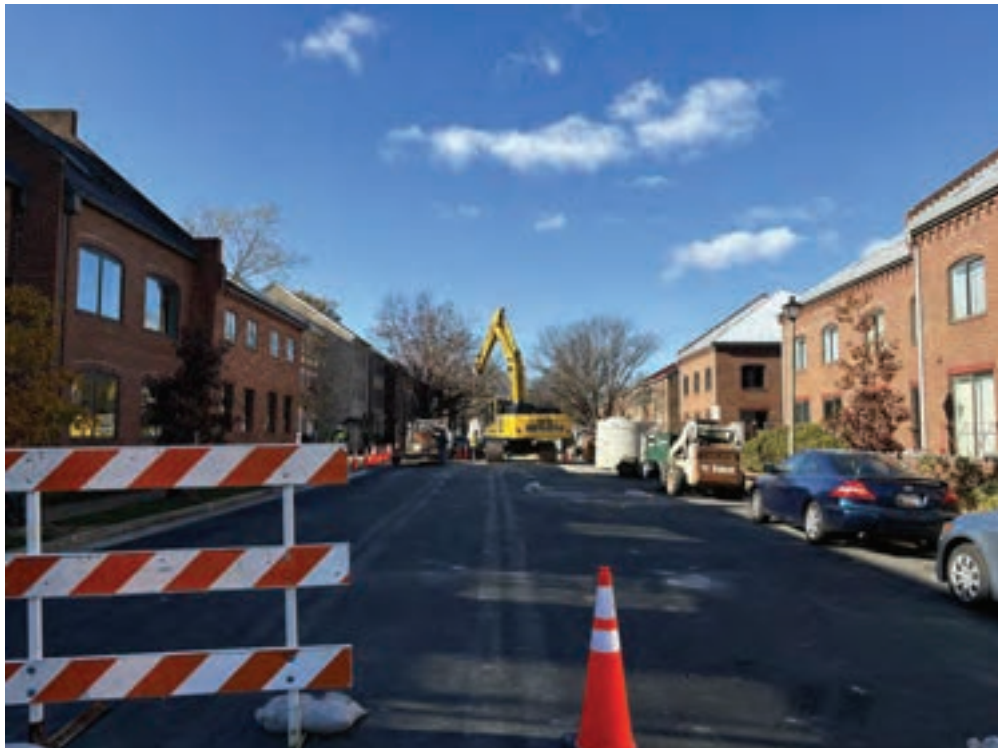
INSPECTION ACTIVITY: Clean, backfill and Replace storm water manhole MH92A.
