BAR Review Levels

Introduction

MASONRY

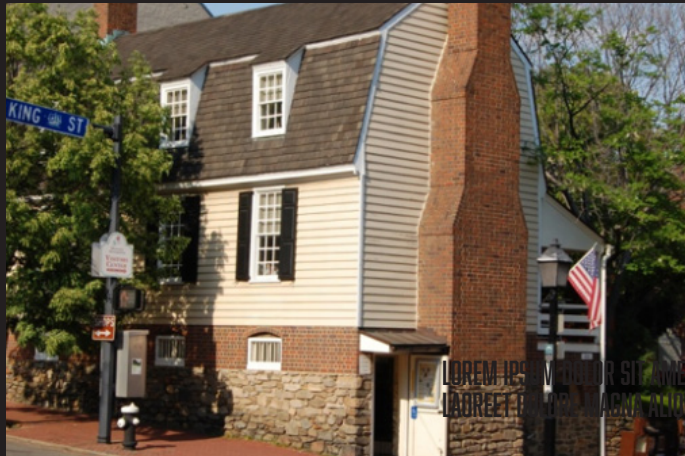
The now exposed stone foundation of the 18th-century Ramsay House shows the original height before King Street was regraded in the early 19th Century.

The foundations of 18th-century buildings in Alexandria were typically constructed with locally sourced stone. With rare exception, this stone was always installed below grade; where it is exposed today, it often indicates the original sidewalk elevation. A notable example of these stone foundations can be seen on the Ramsay House. The Carlyle House is the only building in Alexandria that was originally constructed of Aquia Creek sandstone, although it was later refinished with Indiana limestone in the 1970s. Sandstone, limestone, marble, and granite were commonly used for stoops throughout the 18th and 19th Centuries. Precast concrete was not used as a building material until the early 20th Century.

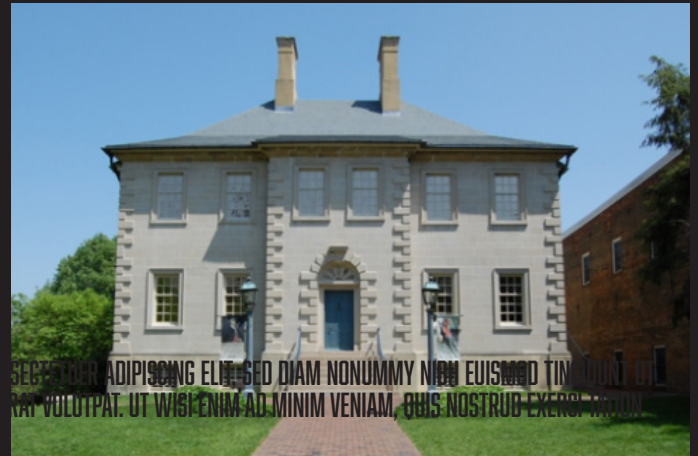
The Carlyle House was originally constructed in the 18th Century with Aquia Creek sandstone.

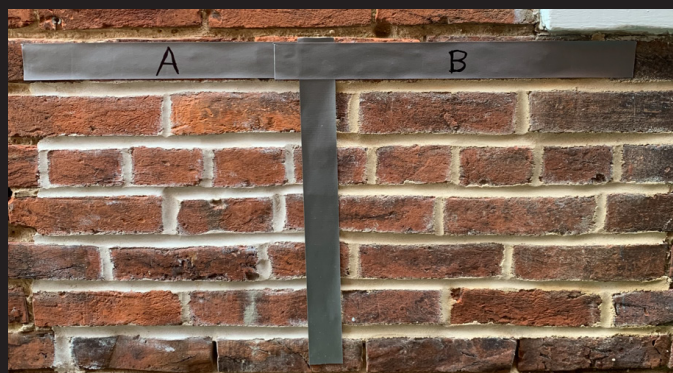
An example of a mock-up that Staff will evaluate. In this photo, sample B more closely matches the existing mortar in color and profile.

A mock-up is required before repointing a masonry wall. Staff will evaluate the mock-up in the field to confirm that the appropriate tools and mortar were used and the masonry units were not damaged. The mock-up should match the historic mortar in color, composition, texture, and joint profile. Repointing should not take place if the temperature is less than 40 degrees Fahrenheit during application and curing. Additional mock-ups may be needed if the mortar is not correctly replicated. Allow extra time for this review so that mortar samples are dry enough to represent their final color. When repairing or replacing historic masonry surfaces, limit the repairs to the damaged areas only. It is often unnecessary and potentially damaging to repoint intact areas.

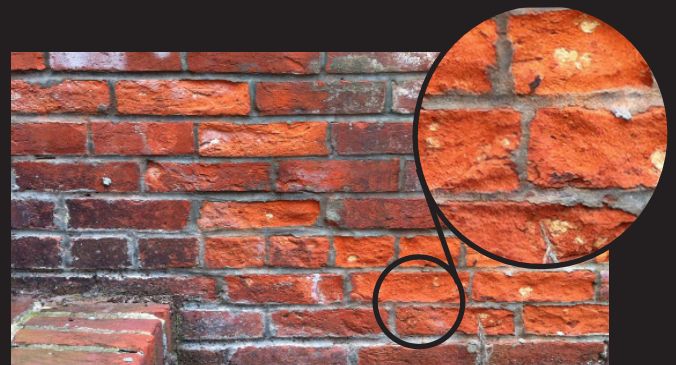
In this example, repointing with a Portland cement mortar has irreversibly damaged the historic brick, causing spalling. Spalling is when the hard-fired face of the brick breaks off due to an impermeable mortar joint.

In masonry walls, mortar is intended to be softer and more porous than the adjacent masonry. The use of an incorrect mortar that is harder than the brick or stone units impedes their normal expansion and contraction. This can cause irreparable damage, resulting in the full or partial loss of the individual masonry units. Using incorrect mortar is considered a demolition. When repointing a historic masonry wall, a lime-based mortar should be used to prevent this damage. Only buildings constructed of hard-fired brick in the 20th Century or later can use a high percentage of Portland cement in the mortar mix without risking damage to the masonry units.

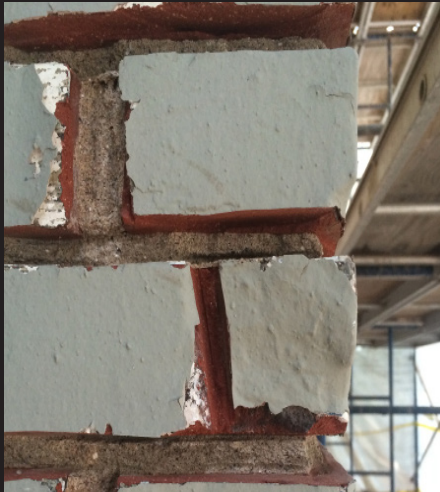
The result of using power tools on mortar joints - the grinders sliced off 1/4 inch sections of brick. The facade is irreversibly damaged, resulting in the loss of the original, handmade bricks. The aesthetic and historic character of the building is lost, as the joints are now twice the original width. In addition, the softer and more absorbant interior of the brick is exposed, leading to future deterioration.

Power tools should only be used to remove mortar from horizontal joints by scoring the middle of the joint and using hand tools to remove the remaining mortar. Only hand tools should be used on horizontal joints less than 3/8 inches tall and on all vertical joints. Mortar should be removed to a depth of 2 and 1/2 times the height of the joint. Masonry damaged by improper mortar removal is considered a demolition.

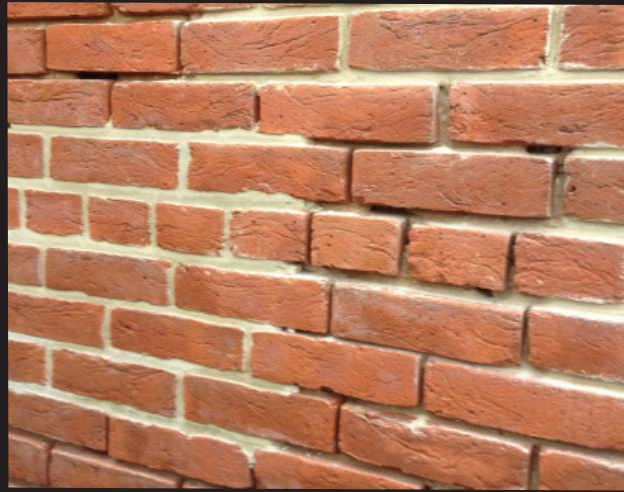
An example of appropriate mortar removal using hand chisels. The width of the original joint and the integrity of the brick are maintained.

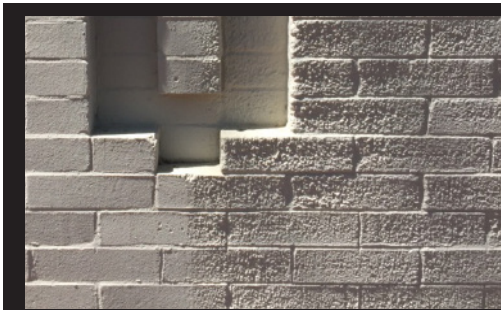
The brick on the right side in the photo has been sandblasted, causing the outer hard fired layer to be removed and making it more susceptible to further damage and destroying its historic architectural character. The Board considers this demolition of the masonry.

Improper paint removal or cleaning can irreversibly damage masonry. Harsh methods like sandblasting or power washing can remove the hard-fired brick surface, exposing the soft interior of the brick to weather. Milder abrasive cleaning methods like soda or media blasting may only be approved by Staff when a skilled architectural conservator has demonstrated it on a test patch to be the best and safest method. There are several environmentally friendly paint strippers available that can remove multiple layers of paint relatively easily. The use of a paint stripper usually requires the use of low pressure water to remove and neutralize the chemicals and paint residue. It is important that you consult with Staff on the proper water pressure (psi) to prevent mechanical damage to the masonry surface and avoid penetrating the masonry with the water and chemical residue, which can lead to interior damage or damage to the masonry. Control of water runoff and dust may require a separate permit from Transportation & Environmental Services.

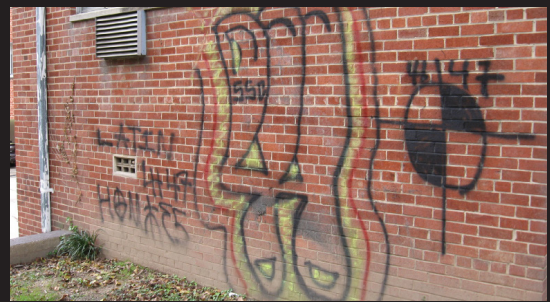
Graffiti should be removed using the same gentle cleaning methods.

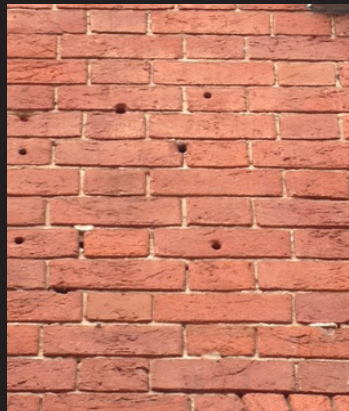
Holes from previous signs.

Masonry is often damaged due to water-related issues. Some common causes of water damage include interior water leaks, leaking air conditioning units, pipes, drains, clogged gutters and downspouts, and moisture caused by rising damp from below grade. Masonry can also be damaged by drilling holes into the masonry surface or using silicone glue. Anchors should always be installed in the mortar joint rather than the body of the masonry unit, and should be smaller than the mortar joint, if possible. Like mortar repairs, masonry repairs should use material matching in color and texture. Never use caulk to fill masonry holes.

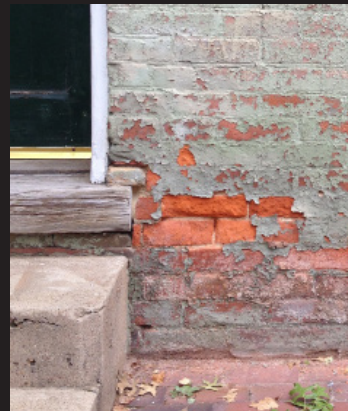
Rising damp (water wicking from below) has caused the face of this early brick to crumble from the freeze-thaw cycle.

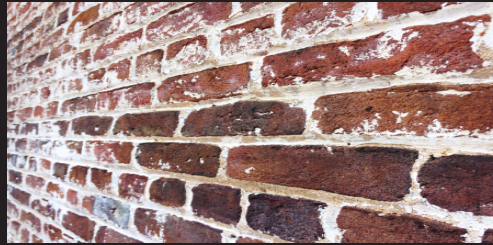
STRUCK JOINT

18th and 19th Centuries
Used on secondary facades

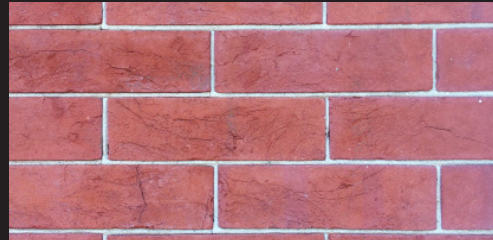
BUTTER JOINT

Mid-19th Century
Used on primary facades
3/16-inch lime putty

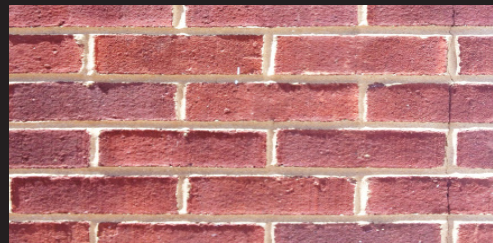
CONCAVE JOINT

20th Century

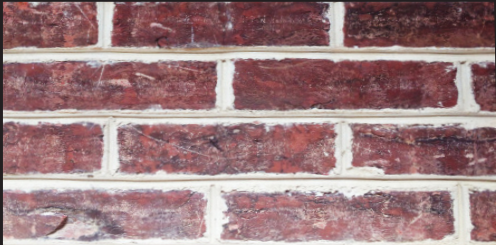
<p>GRAPEVINE JOINT 20th Century Colonial Revival structures</p>

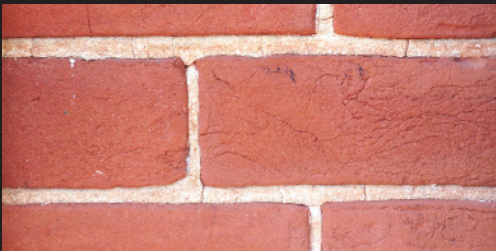
<p>FLUSH JOINT All years</p>

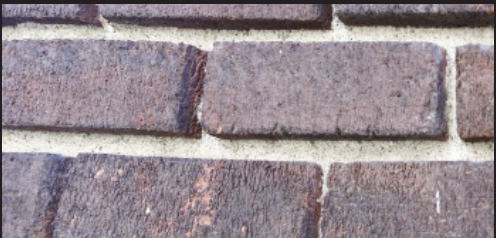
<p>RAKED JOINT All years</p>

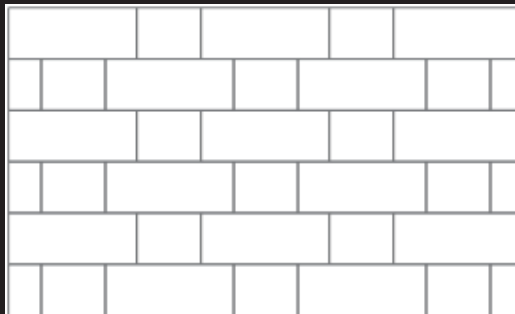
FLEMISH BOND

Flemish bond was primarily used in the mid-18th Century in Virginia and was typically used on more “high-style” primary façades.

Bonding is the term used for the pattern in which bricks are laid. Headers are bricks which are laid perpendicular to the face of a brick wall. Stretchers are bricks which are laid parallel to the face of a wall. The use of header brick declined as stronger brick and mortar became available. By using a combination of headers and stretchers, a wall not only gains strength but also the possibility of decorative patterns arises. Each row of bricks laid one upon another in a wall is referred to as a course.

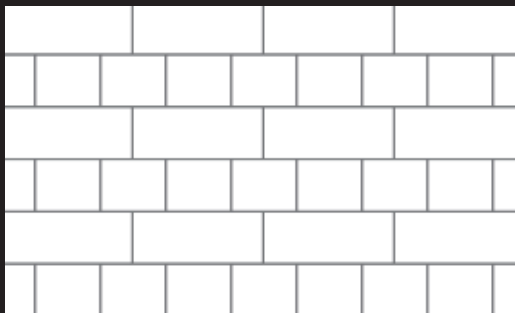
ENGLISH BOND

English bond was primarily used in the mid-18th Century in Virginia on foundations, but was rarely used in Alexandria.

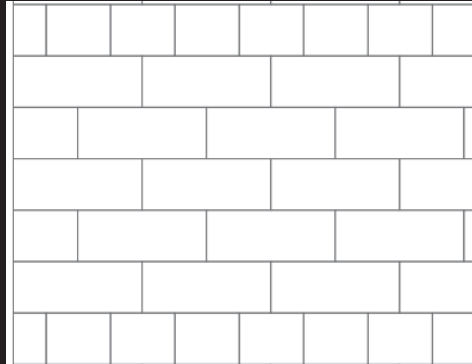
COMMON BOND

Common bond used a header course every 4th, 6th, or 7th courses and was used in Alexandria on secondary elevations from the 18th to early 20th Centuries.

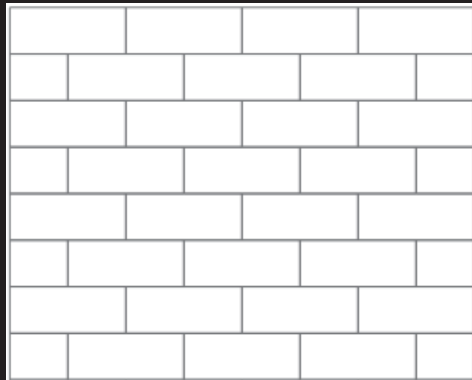
RUNNING BOND

Running bond was first used in Alexandria on the primary façade of Greek Revival structures in the 1840s, and is the bond pattern most commonly used today.

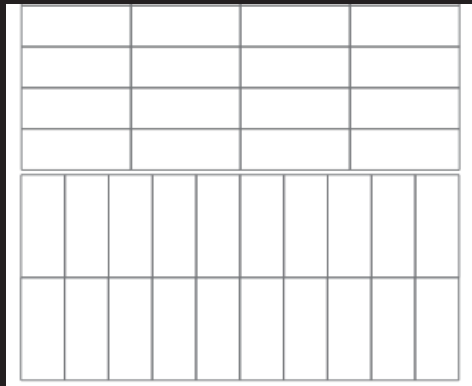
STACK BOND

Stack bond was first used in the mid-20th Century. It is a non-structural bond, typically used in decorative applications such as veneers.
