The Tale of Spa Spring

The tale of Spa Spring nearly ended in 1843, when construction of the Alexandria Canal turning basin began. Over 25 feet of soil was dumped into the Spa Creek valley to create the 190-foot wide, 650-foot long turning basin for the canal. A brick and stone-lined culvert was built to carry the creek under the new turning basin.

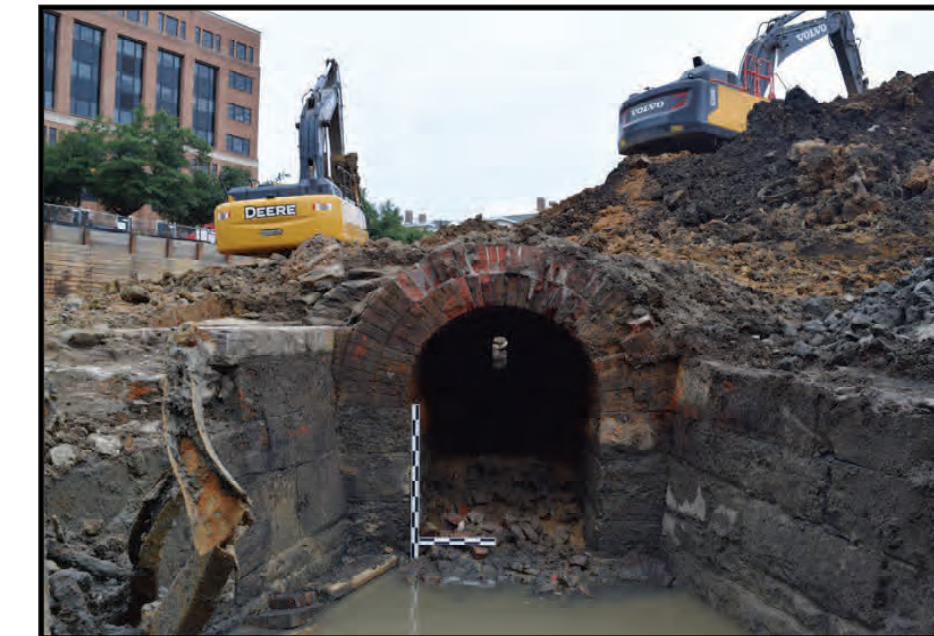
(RCGA 2017)

The culvert built in 1843 to convey Spa Creek beneath the canal turning basin was discovered during construction. Sadly, no evidence of goosepigs was found.

The culvert was so well-built that it never collapsed and water continued to flow through it long after it was abandoned. The cut stone foundation rested on thick wooden cribbing and supported a brick barrel-style roof. A protective layer of stone rubble covered the outside of the culvert, while stone wing walls framed the culvert opening as it spilled into the Spa Spring.

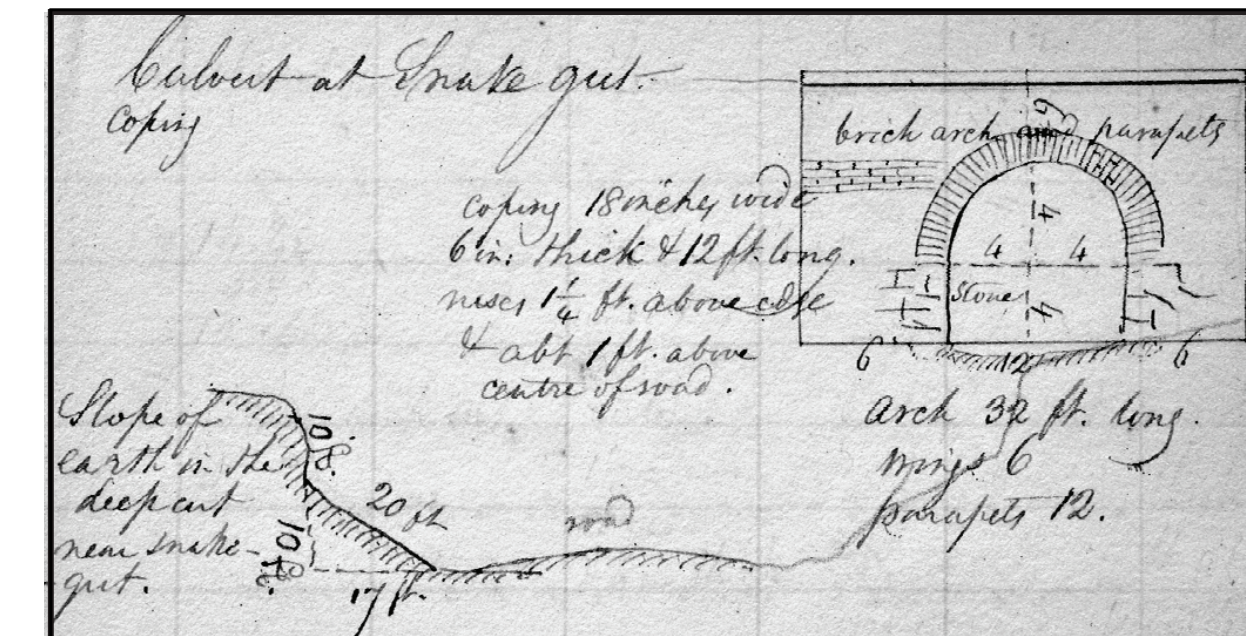
(The Library of Virginia, Special Collections)

Wilson M.C. Fairfax surveyed the proposed route of the canal for the Alexandria Canal Company in 1831. His survey log includes drawings such as this culvert near Four Mile Creek, virtually identical to the culvert found by archaeologists beneath the turning basin.
