SIDING + TRIM

Steps for Siding Analysis

PARKER - GRAY DISTRICT

CITY OF ALEXANDRIA

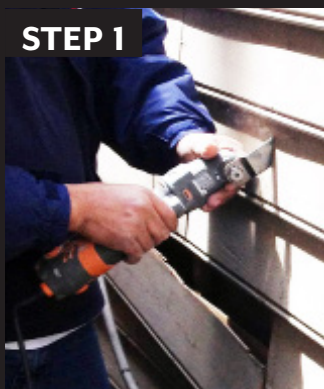
STEP 1

Carefully remove a 2 foot by 2 foot portion of the surface siding.

Intact historic siding may be hidden beneath layers of siding, such as aluminum, vinyl, artificial brick, or stone. To determine if multiple layers of siding exist, remove at least one portion a minimum of 2 feet by 2 feet to reveal the first layer of siding. Staff will inspect the mock-up in the field prior to any approval. The graphic on the following page gives an overview of this process.

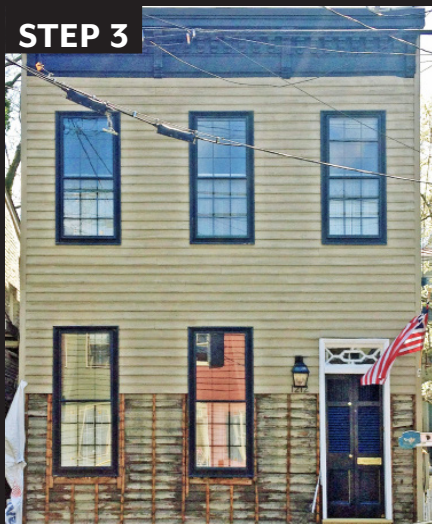
STEP 3

^ BEFORE

More of the historic siding is exposed for Staff to assess its condition. In this case, the historic siding is in very good condition and will be stripped and painted for reuse on this building.

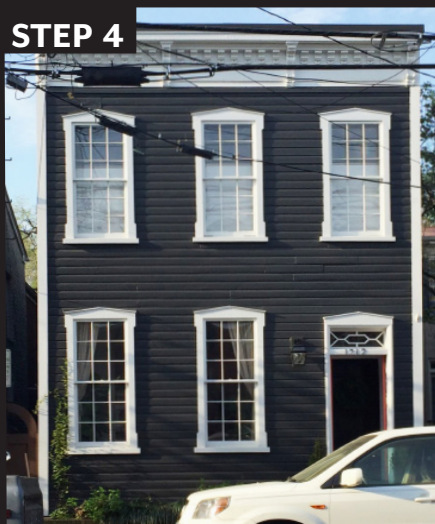
STEP 4

^ AFTER

In this case, removal of the contemporary siding also revealed ghost marks in the old paint from which the original window and door trim was able to be recreated.
